STATE OF ALASKA  
Department of Transportation  
and Public Facilities

2015  
Alaska Marine Highway System  
**SHORE FACILITIES CONDITION  
SURVEY REPORT**

Prepared by  
Southeast Region  
Marine Engineering Section

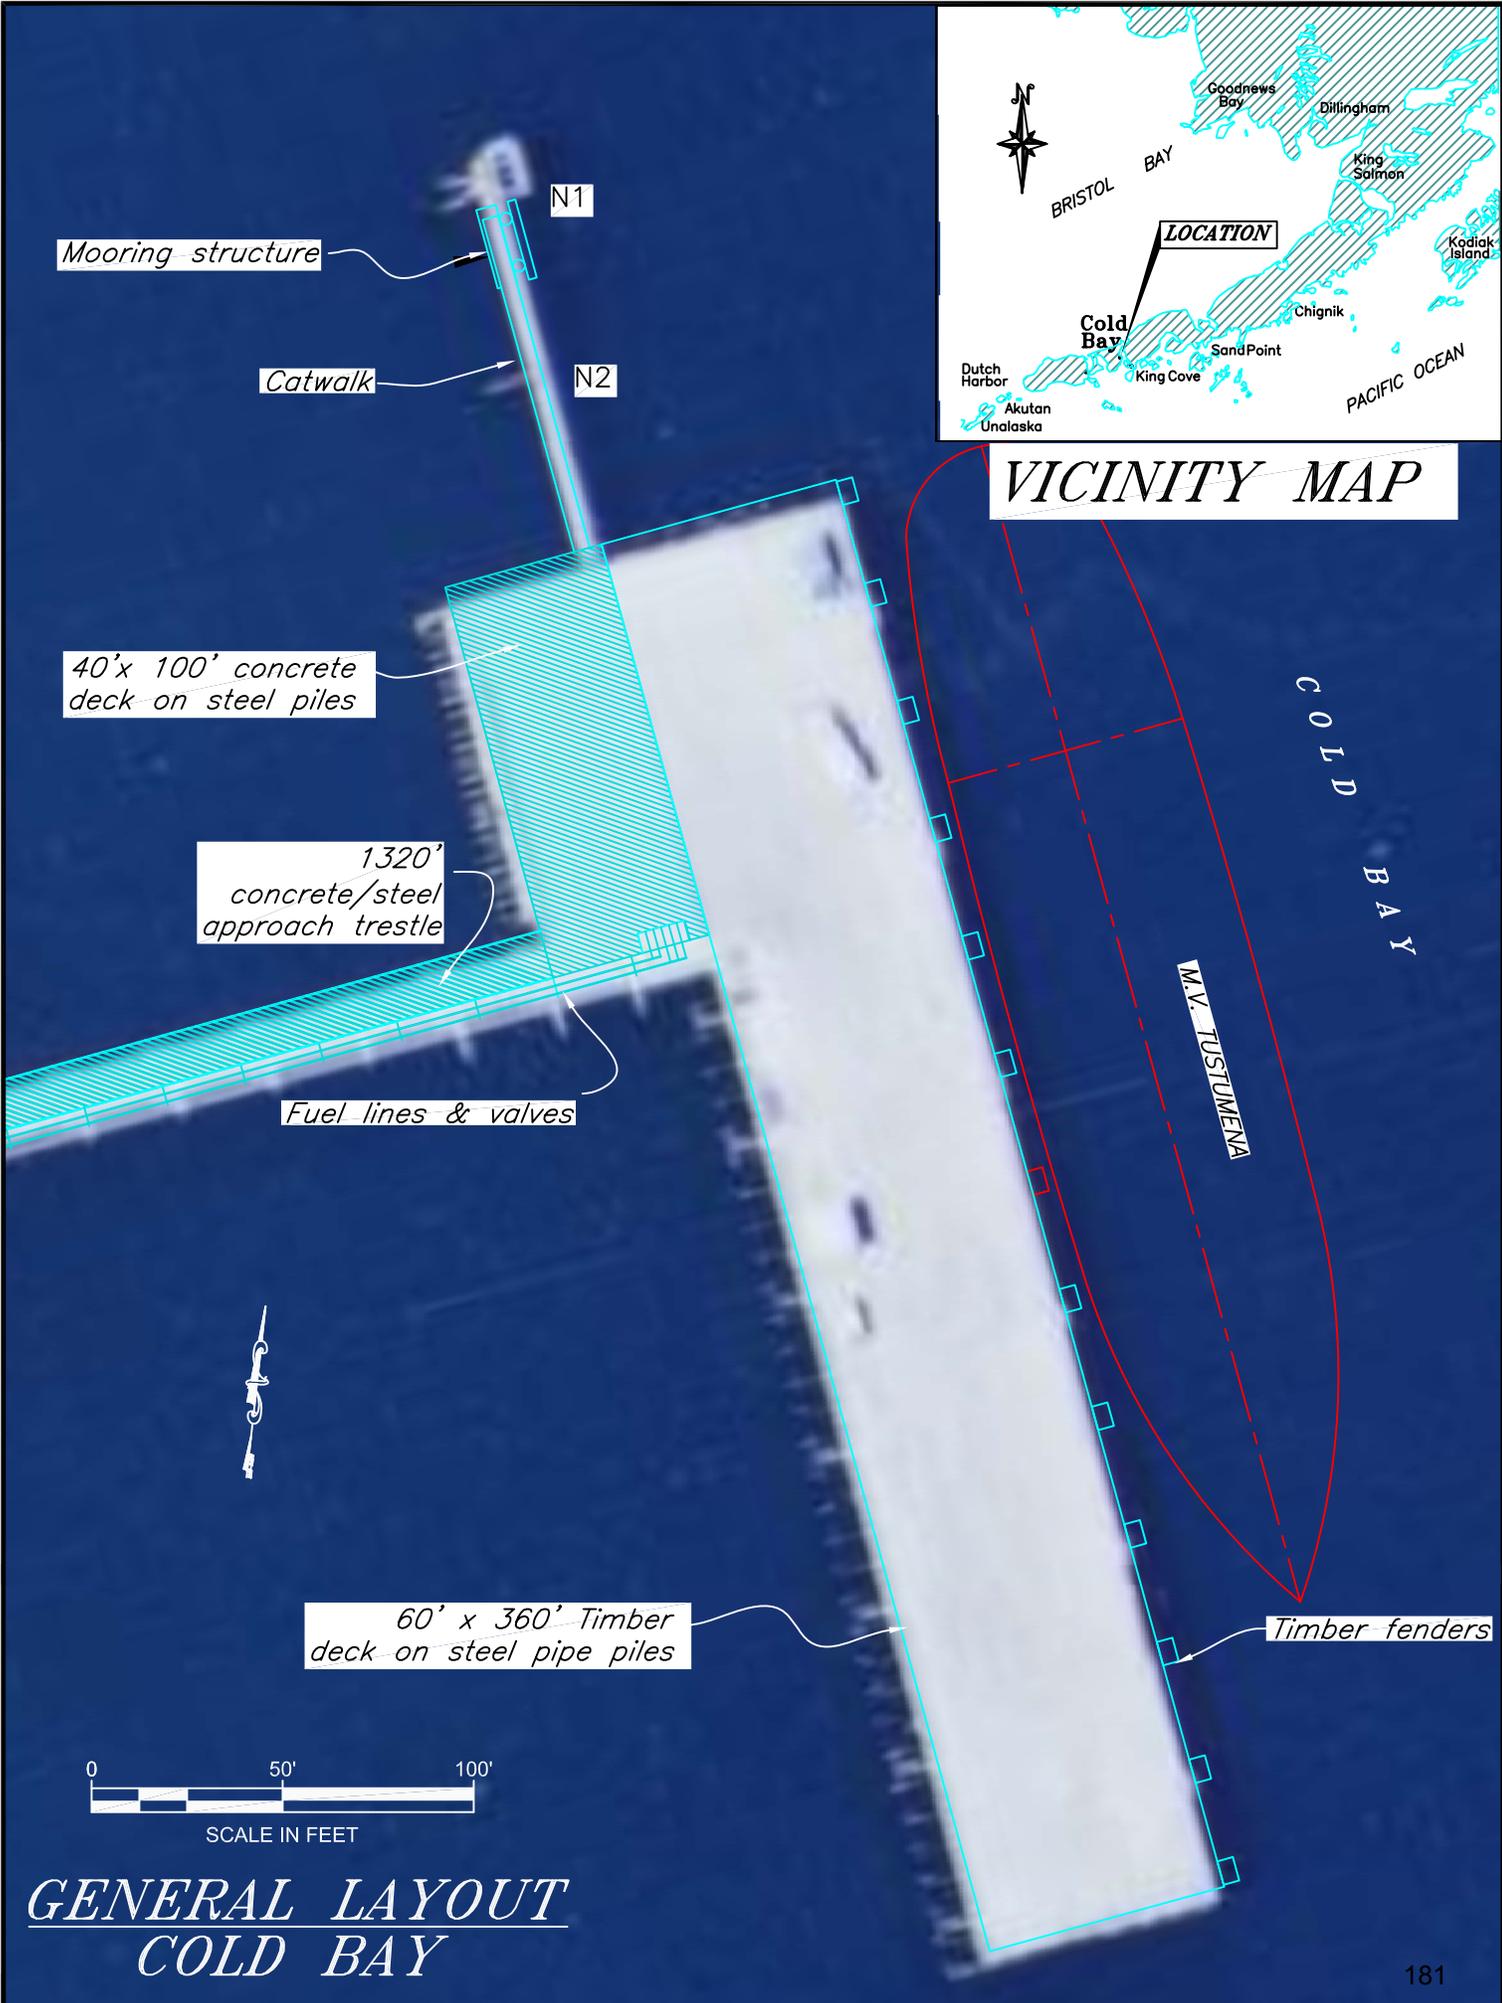
Mooring structure

**Terminal Description:** The M/V TUSTUMENA docks at the Cold Bay Dock during its East/West passage through the Aleutian Chain. The Cold Bay facility is made up of two dock sections that were constructed at different times. The original structure, designed and built by the State in 1978 consisted of a 100' x 40' concrete panel dock and a 1,320' long concrete panel approach. There is a mooring dolphin and catwalk northwest of the original dock. In 1993, a 360' x 60' addition was constructed to the northeast of the original dock; the newer dock abuts the face of the original structure. The facility is owned by the Aleutian East Borough and managed by the City of Cold Bay. The past 10 years of total passenger and vehicle traffic at Cold Bay is shown below. The M/V Tustumena was out of service most of 2013, causing a steep dropoff in traffic at the terminal.

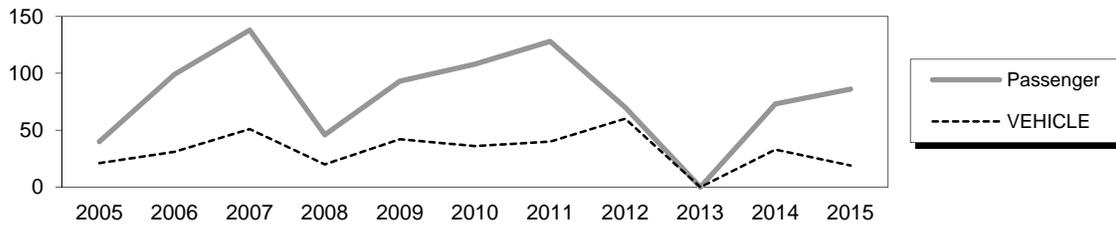
**Terminal Description:** The M/V Tustumena docks at the False Pass Dock during its East/West passage through the Aleutian Chain. Service to False Pass was initiated in 1993. The False Pass facility consists of an L-shaped 175' x 40' dock, 450' long approach trestle, with a mooring dolphin located on each end of the dock and connected via a steel catwalk. There is a 100' x 100' staging area upland of the dock. The facility is a multi-purpose facility and could be in use by other vessels when the ferry arrives. AMHS is not in control of the operation or maintenance of this facility. The past 10 years of total passenger and vehicle traffic at False Pass is shown below. False Pass had no ferry service in summer 2013 while the M/V Tustumena was in the shipyard for repairs.

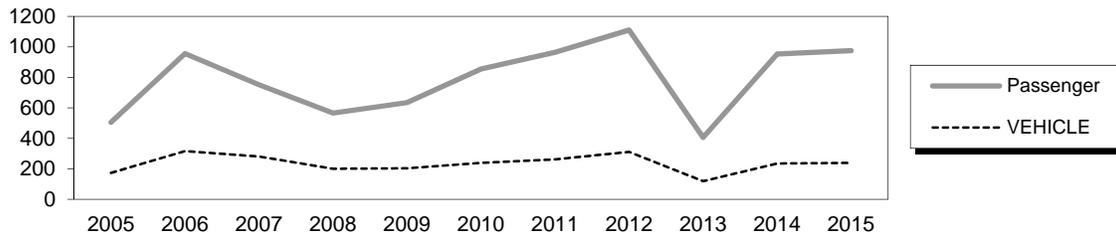
**Terminal Description:** The M/V Tustumena docks at the Aleutians East Borough facility in King Cove on its east/west passage through the Aleutian Chain. The King Cove facility consists of a sheet pile cell structure with a face approximately 125' long, and 4 steel pile mooring dolphins (two on each side of the dock) connected to the dock by steel catwalks. Access to the dock is via an embankment and paved roadway. There is a breach in the embankment at about its midpoint to permit juvenile fish migration. A steel girder/concrete deck bridge spans the breach; open sheet pile cells protect the abutments. The facility is a multi-purpose facility and could be in use by other vessels when the ferry arrives. AMHS is not in control of operation or maintenance of this facility. The past 10 years of total passenger and vehicle traffic at King Cove is shown below. The M/V Tustumena was out of service most of 2013, causing a steep dropoff in traffic at the terminal.

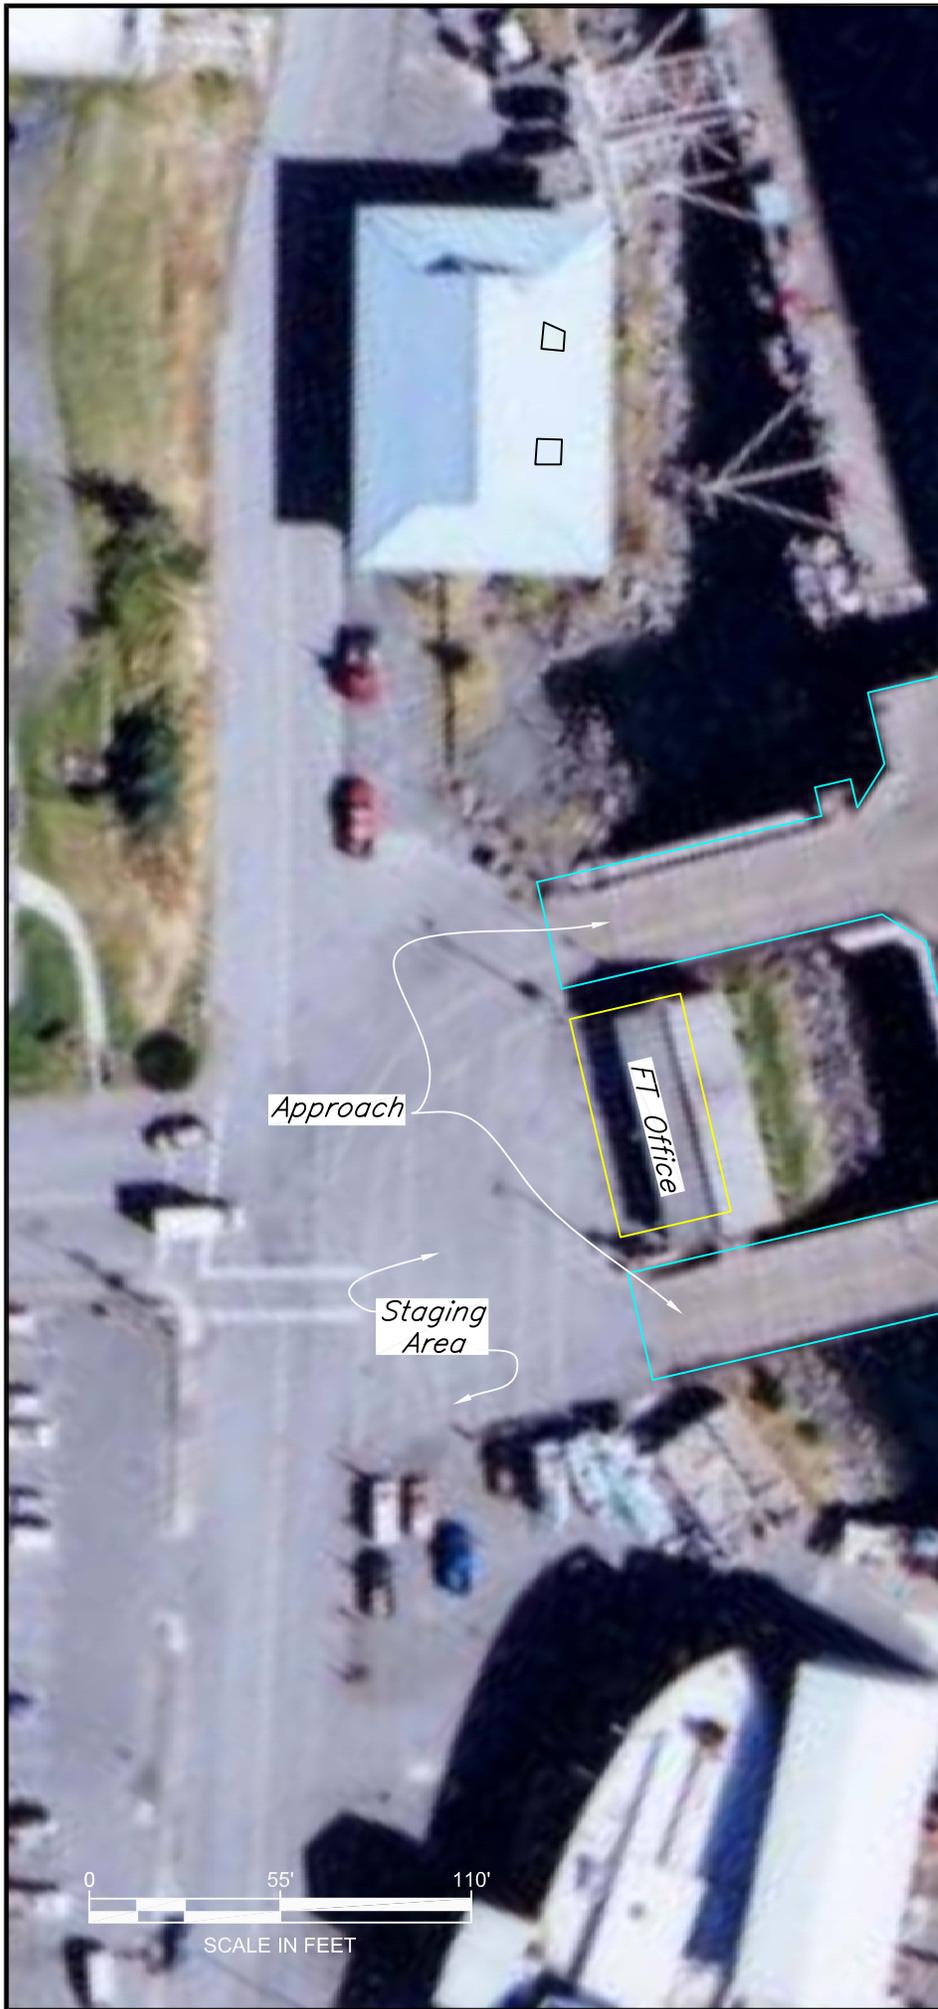
Approach

Staging Area

Some of the dock elements along the face are damaged. The ladder and timber pile between F2 and F3 are still damaged. The ladder between fenders F3 & F4 is damaged. The southernmost timber fender pile was dislodged from its upper bracket and is gone. Several of the fenders appear to have been damaged by large loads bearing on the tops of the fenders. The ends of the timber fenders are splintered and the upper fasteners for two of the rubber cylinders have failed.

3. Line loads on dolphins N1 and S1 appear to have exceeded their capacities. Dolphin N1 was pulled to the southeast and the dolphin leans to the south. Dolphin S1 was pulled to the northeast and leans to the northwest. Dolphin S1 does not appear to have leaned further north or northwest since the 2006 inspection based on catwalk misalignments. Displacing these dolphins caused failure of the bolts securing the catwalks to the dolphin caps and the catwalks no longer bear equally on the caps. The

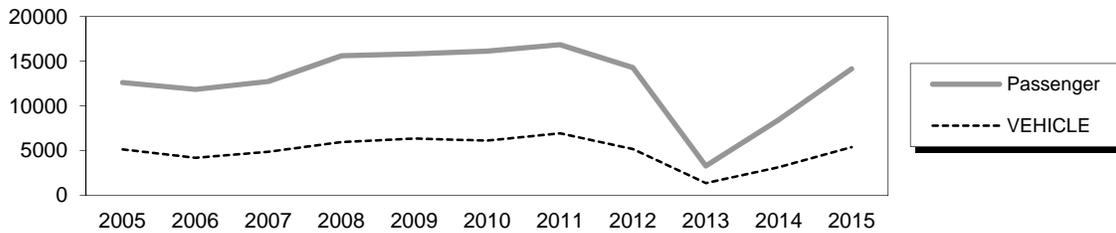
**Terminal Description:** The M/V Tustumena docks at the Kodiak City Dock (also called Pier 1) on its east/west passage between Homer and the Aleutian Chain. The Kodiak facility is a horse-shaped timber structure with a main dock section approximately 200'x 30', and two 100' approach trestles, one at each end of the dock. The dock is currently used for transfer of general cargo and fuel, in addition to ferry operations. The facility does not have sufficient vehicle staging areas and the uplands are shared with parking and other uses. Embarking vehicles line up on the adjacent city street and in the parking lot. The contractor operated ticket office is located in a city owned building, on shore, between the two access trestles. The wharf is crowded between a marine fuel service depot to the north and a shore based seafood processor to the south. Vessels moored at the adjacent facilities encroach on berthing the dock. The past 10 years of total passenger and vehicle traffic at Kodiak City Dock is shown below. The M/V Tustumena was out of service most of 2013, causing a steep dropoff in traffic at the terminal.

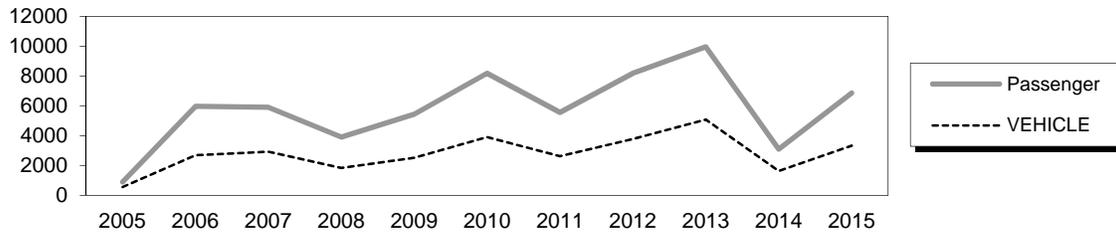
**Terminal Description:** The M/V Kennicott docks at Pier 2 on its turnaround between Homer and Kodiak. The facility is a rectangular dock comprised of two adjacent dock sections: AMHS primarily uses the West dock which was constructed in 1988 (approximately 418'x 75'). The East dock was constructed in 2006 and is approximately 475'x 73'. There is no apparent division or break between the two dock sections. The past 10 years of total passenger and vehicle traffic at Kodiak Pier 2 is shown below. The M/V Kennicott was only in service for 7 months in 2014, resulting in a steep dropoff in traffic at the terminal.

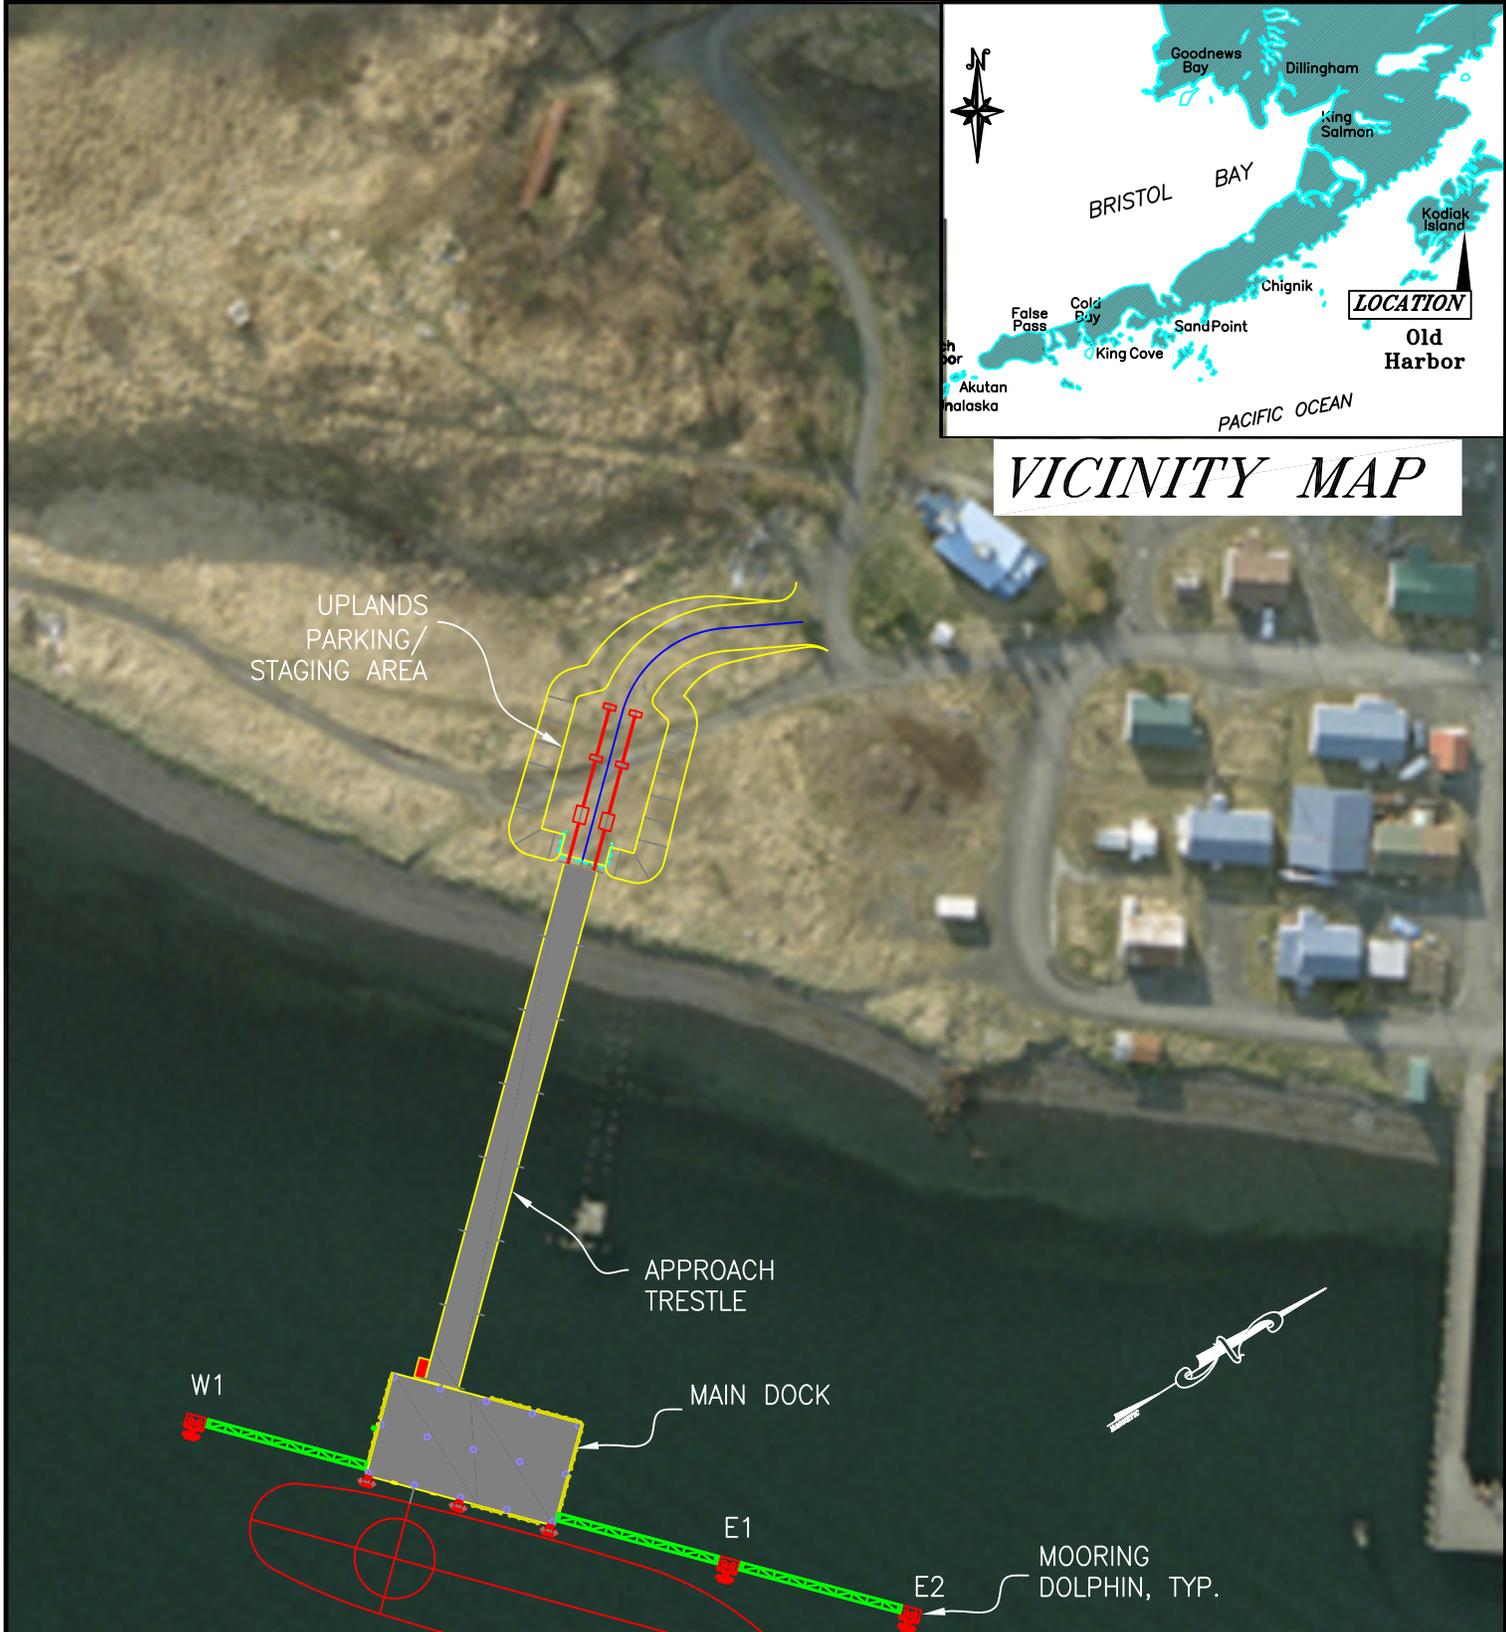
***GENERAL LAYOUT  
OLD HARBOR***

**SITKALIDAK STRAIT**

**Terminal Description:** A new multi-use dock facility was recently constructed by the City of Old Harbor on Kodiak Island (50 miles southwest of City of Kodiak). The M/V Tustumena provided ferry service on four occasions in 2012. The frequency of future scheduled service is unknown as Old Harbor is out of the way of the normal route that the ferry takes from Kodiak to Chignik. The facility consists of a 55'x102' pile-supported dock with 3 fender panels, 3 mooring dolphins with access to the dock by steel catwalks, and an 18'x 280' pile-supported approach trestle connected to shore. The dock was built in 2012 to replace the aging timber freight dock. This is a multi-purpose facility utilized by other vessels. AMHS is not in control of operation or maintenance of this facility. The most recent annual passenger and vehicle traffic at Old Harbor is shown below.

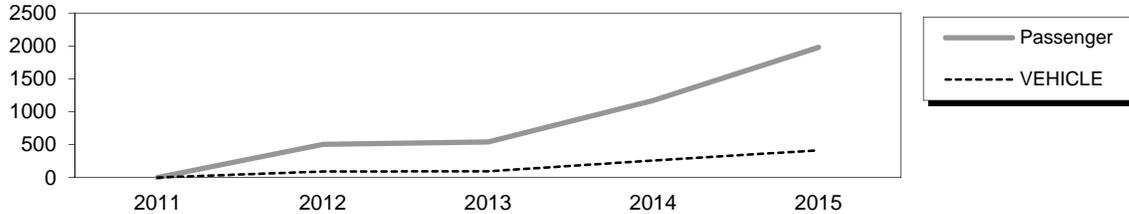
**Terminal Description:** The M/V Tustumena stops in Ouzinkie, on Spruce Island (15 miles northwest of Kodiak) as part of its scheduled voyage between Kodiak and Homer. This is a new port of call for AMHS as of 2012. The open-cell sheet pile wharf was built in 2012 to replace an aging timber dock. The ship breasts against four (4) fender panels on the 175-foot long southeast dock face. This is a multi-purpose facility utilized by other vessels. AMHS is not in control of operation or maintenance. The most recent annual passenger and vehicle traffic at Ouzinkie is shown below.

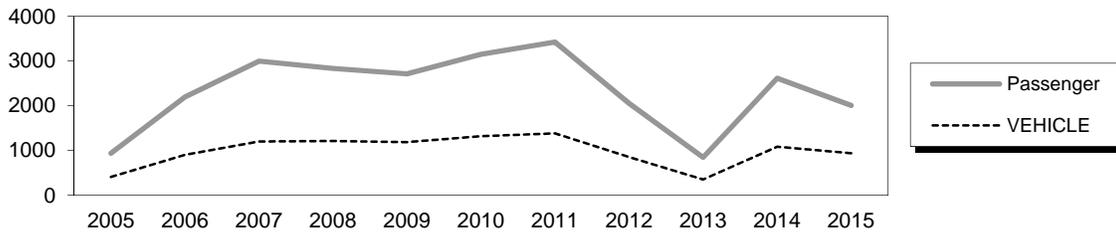
**Terminal Description:** The M/V Tustumena docks at Port Lions on its east/west passage between Kodiak and Homer. Port Lions is the second busiest port of call along the southwest route after Kodiak. The Port Lions facility is an earth-filled open-cell sheet pile wharf constructed in summer 2014. The dock has an approximately 214' berthing face with two mooring dolphins along the north end. Access to the dock is via a rubble-mound breakwater. The facility is a multi-purpose dock and could be in use by other vessels when the ferry arrives. AMHS is not in control of the operation or maintenance of this facility. The past 10 years of total passenger and vehicle traffic at Port Lions is shown below. The M/V Tustumena was out of service most of 2013, causing a steep dropoff in traffic at the terminal.

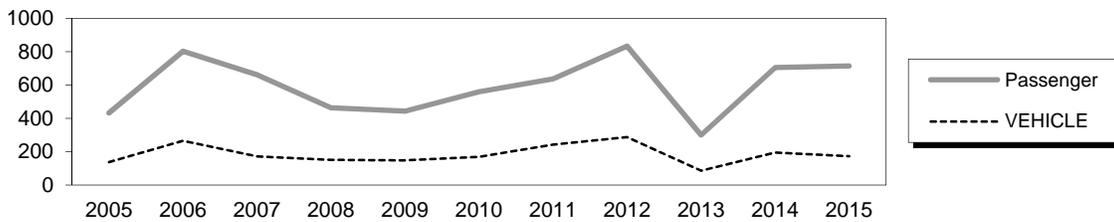
**Terminal Description:** The M/V TUSTUMENA docks at the Sand Point city dock on its east/west passage through the Aleutian Chain. The Sand Point facility is a multi-use freight wharf, constructed in 1983 by the City of Sand Point. It is located at the northeast end of the small boat harbor breakwater. The dock is approximately 200' long and 60' wide and consists of pre-stressed concrete deck panels supported by steel beams and steel pipe piles. There are six fenders along the dock face. Each fender has two steel pin piles, a steel framework with timber face and is attached to the dock with rubber cylinders. Steel mooring dolphins with fender systems are located at each end of the dock and accessed by catwalks. The US Army Corps of Engineers extended the riprap breakwater around to the East to protect the City's small boat harbor in 2006. The breakwater serves as a new single-lane access road. The facility is a multi-purpose facility and is utilized by other vessels. AMHS is not in control of the operation or maintenance of this facility. The past 10 years of total passenger and vehicle traffic at Sand Point is shown below. The M/V Tustumena was out of service most of 2013, causing a steep dropoff in traffic at the terminal.

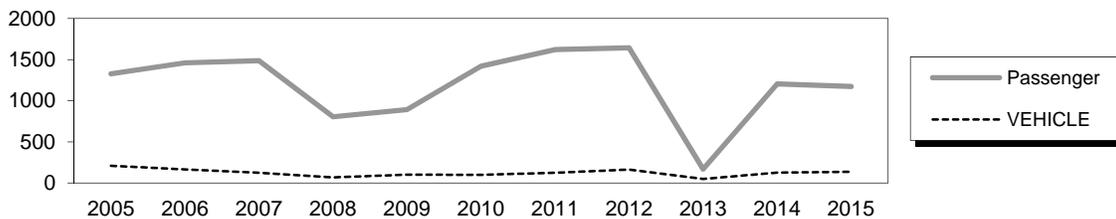
These are multi-purpose facilities utilized by other vessels. AMHS is not in control of operation or maintenance of these facilities. The past 10 years of total passenger and vehicle traffic is shown below. The M/V Tustumena was out of service most of 2013, causing a steep dropoff in traffic at the terminal.

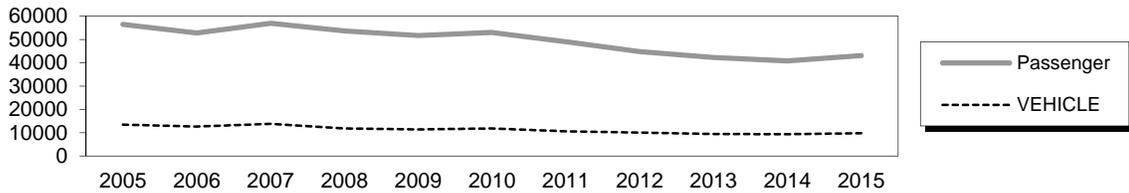
**Terminal Description:** Clark Bay Ferry Terminal is a side-berth facility consisting of a transfer bridge, steel support float, and 6 steel mooring dolphins. Uplands include a terminal building, maintenance warehouse, secure (fenced) staging area, paved parking and overhead lighting. The Clark Bay facility links Prince of Wales Island to Ketchikan with ferry service via the InterIsland Ferry Authority (IFA). The IFA has had operation and maintenance responsibility of this ferry terminal since 2002. AMHS provided ferry service prior to 2002. IFA operates one of two vessels to this port, the MV Prince of Wales and the MV Stikine. Total passenger and vehicle traffic counts for the past 10 years at Clark Bay are shown below.

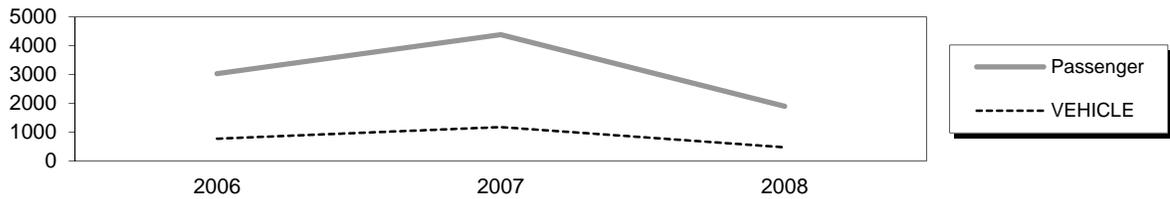
Coffman Cove’s total passenger and vehicle traffic from 2006 through 2008 is shown below.

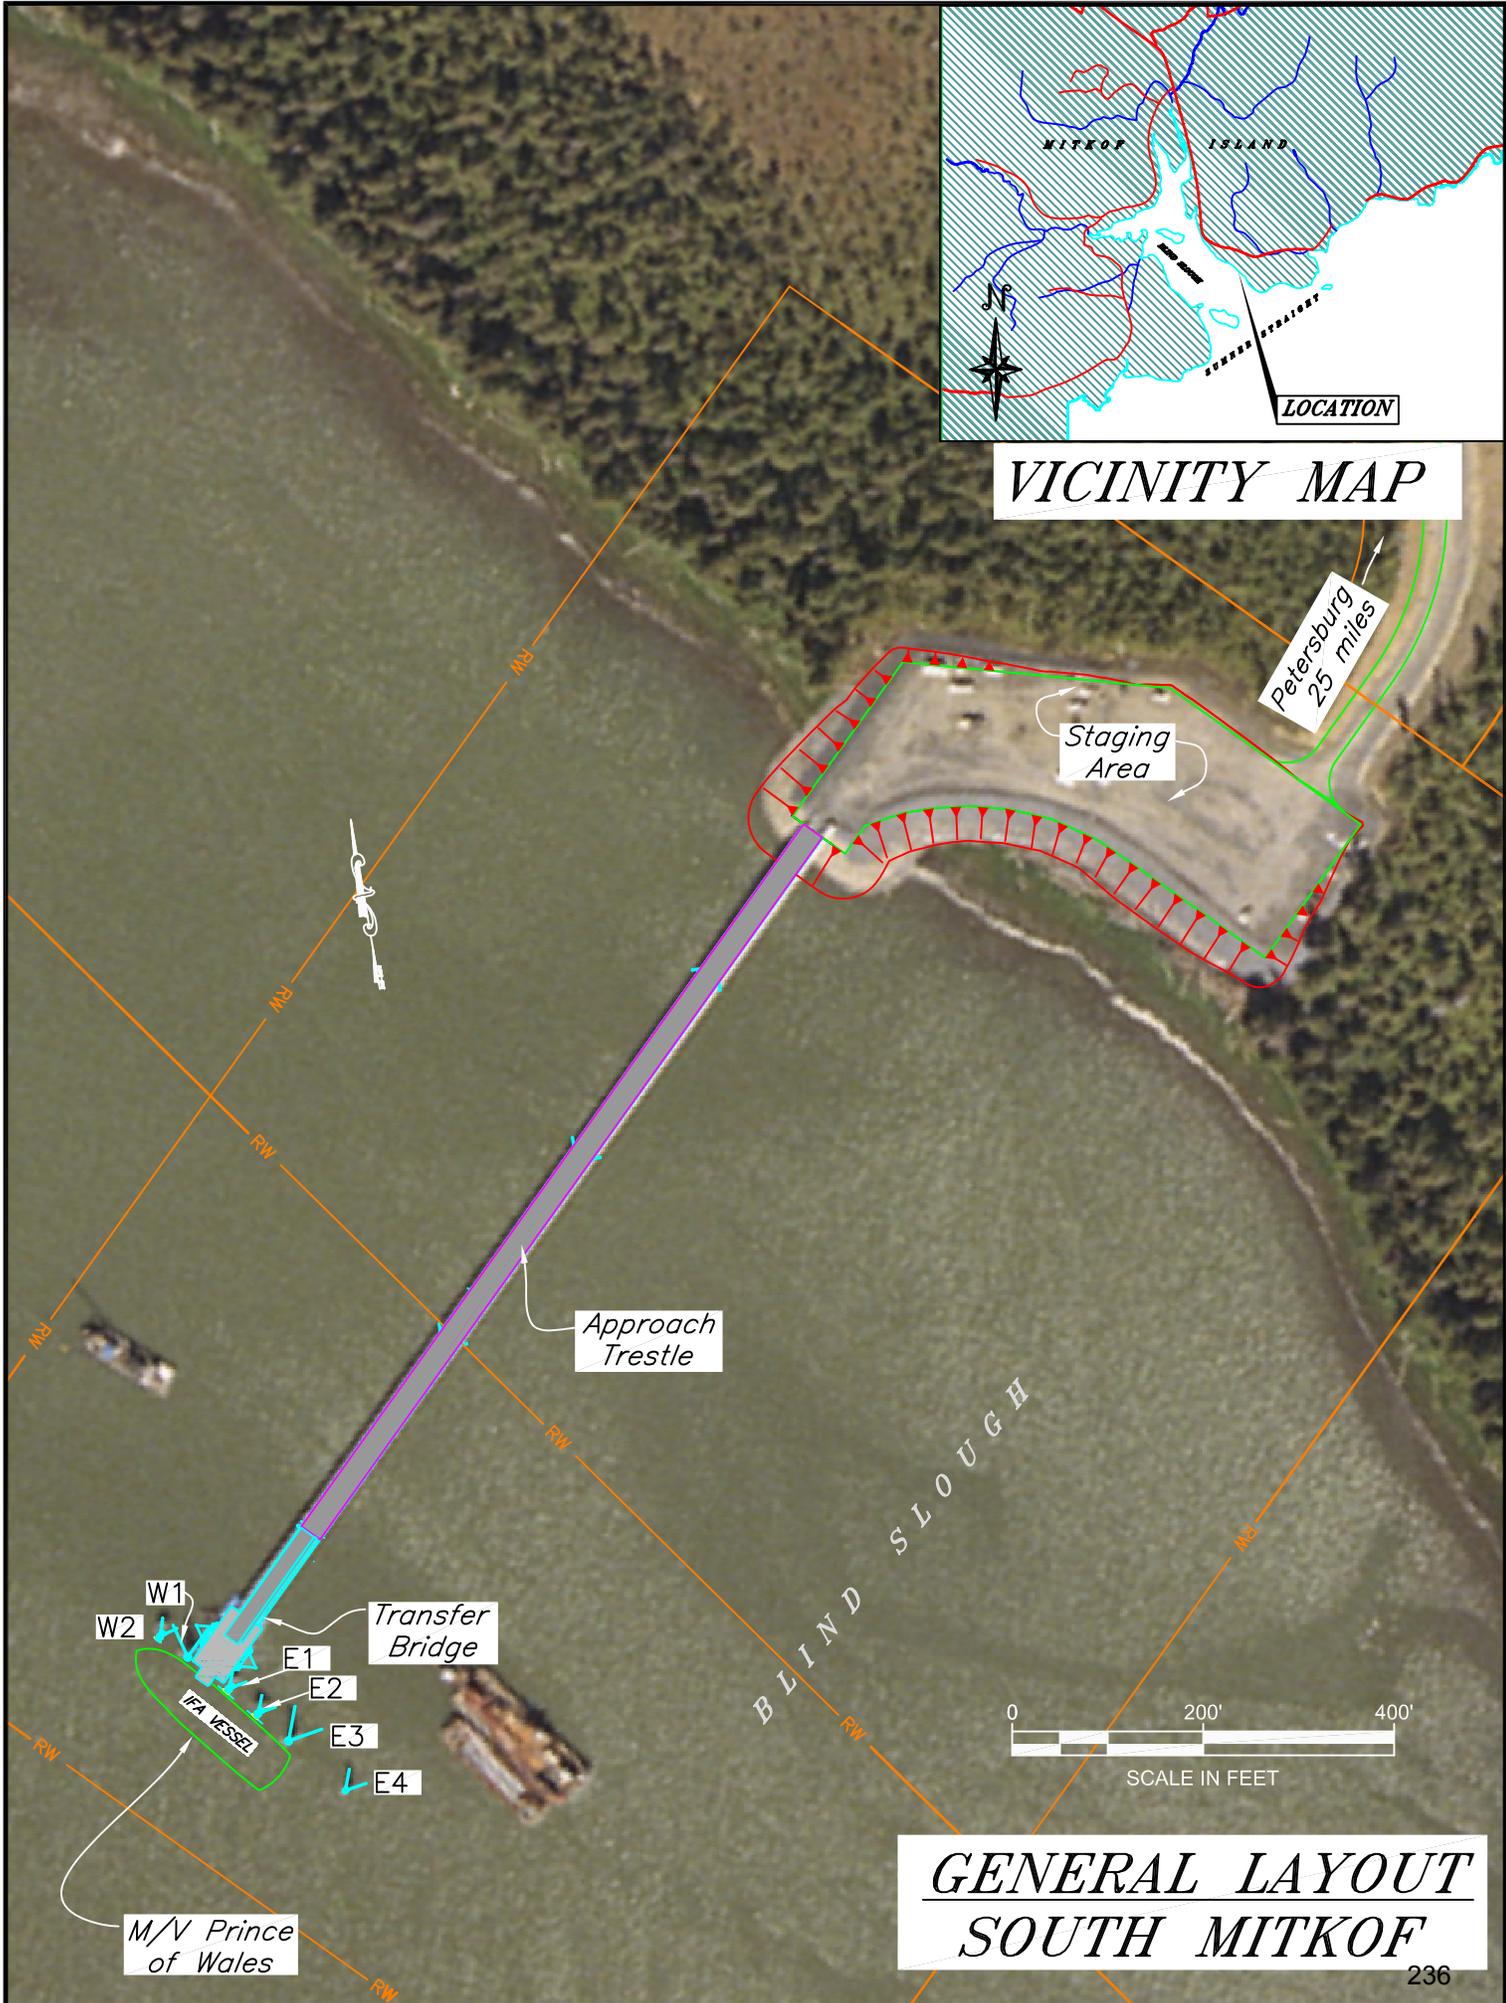
# GENERAL LAYOUT SOUTH MITKOF

# South Mitkof Ferry Terminal

**Terminal Description:** South Mitkof is a new side-loading facility constructed in 2006 consisting of a modular ticketing office, secure (fenced) staging area, 900-foot long steel approach, steel transfer bridge, steel support float and five steel pile mooring dolphins. The IFA northern route has not been operational since 2008. South Mitkof's total passenger and vehicle traffic between 2006 and 2008 is shown below.
