**GENERAL LAYOUT
CLARK BAY** 225

Clark Bay Ferry Terminal

Mile 31 Hollis-Klawock Hwy.

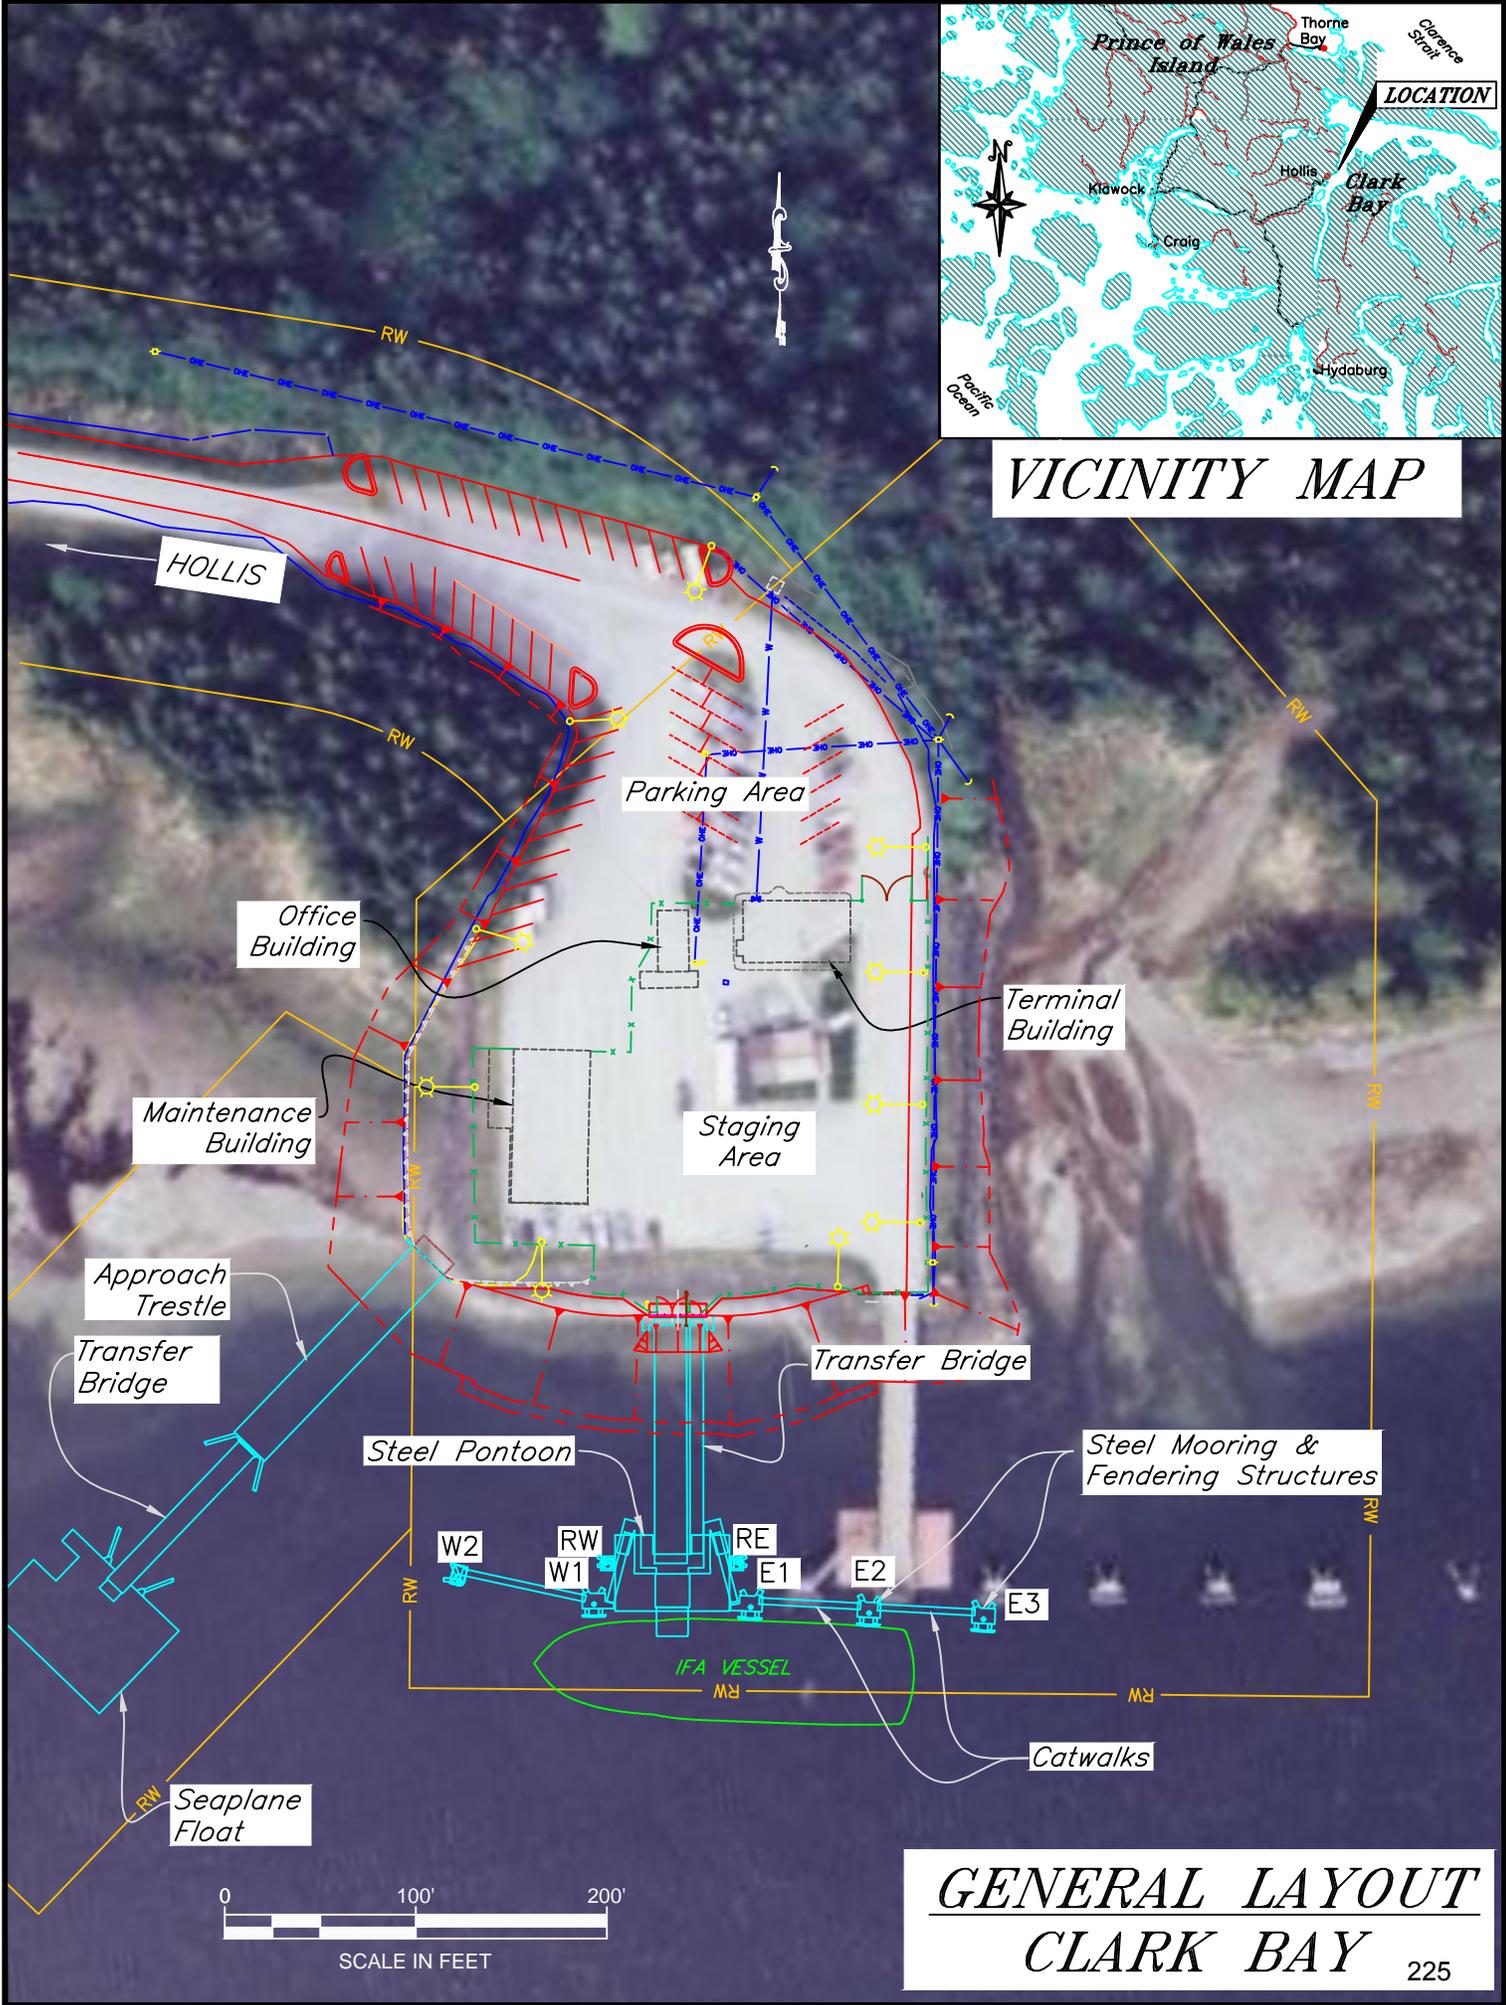
Terminal Description: Clark Bay Ferry Terminal is a side-berth facility consisting of a transfer bridge, steel support float, and 6 steel mooring dolphins. Uplands include a terminal building, maintenance warehouse, secure (fenced) staging area, paved parking and overhead lighting. The Clark Bay facility links Prince of Wales Island to Ketchikan with ferry service via the InterIsland Ferry Authority (IFA). The IFA has had operation and maintenance responsibility of this ferry terminal since 2002. AMHS provided ferry service prior to 2002. IFA operates one of two vessels to this port, the MV Prince of Wales and the MV Stikine. Total passenger and vehicle traffic counts for the past 10 years at Clark Bay are shown below.
