GENERAL LAYOUT HOMER

Homer City Dock

Terminal Description: Homer is a modern U-shaped concrete dock, built around the original timber city dock in 2001. It is owned and maintained by the City of Homer. The facility consists of terminal building and uplands staging area, east and west approach trestles connected to the main dock, two breasting dolphins and one mooring dolphin with one access catwalk. Vehicle and passenger transfer takes place on the city dock. The Coast Guard (USCG) uses the north end of the dock as a berth for their buoy tender. The presence of nearby Homer Harbor traffic has produced docking conflicts in the past. The State provided a portion of construction funding, has priority use and does not pay a docking fee per the MOA with the City.

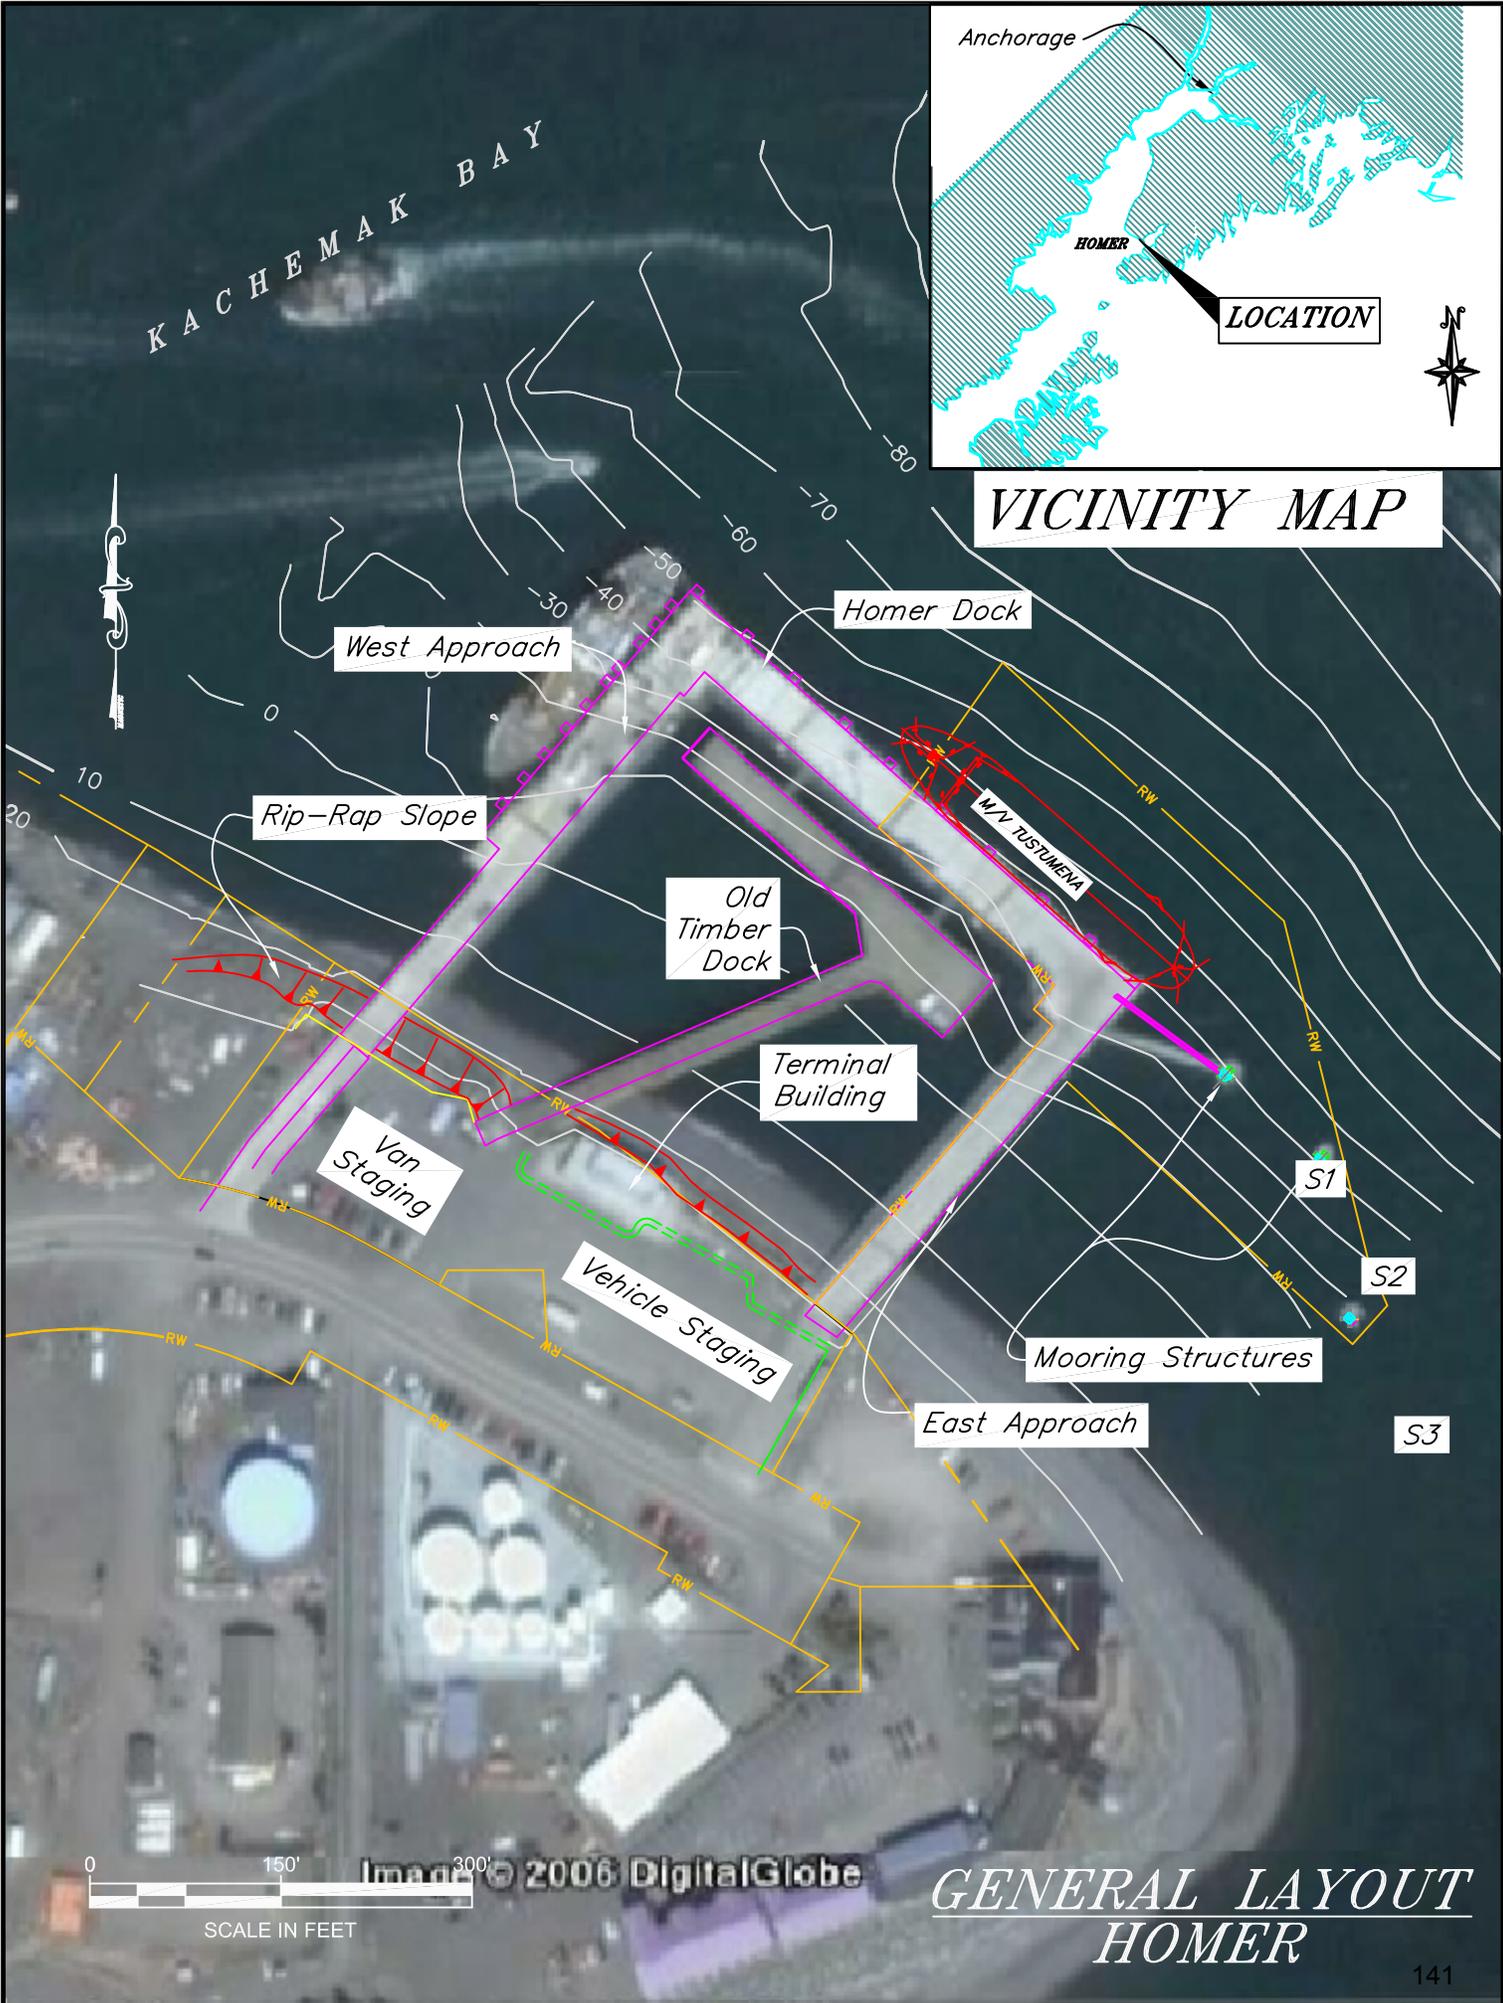
West Approach

Homer Dock

Rip-Rap Slope

Old Timber Dock

Terminal Building

Van Staging

Vehicle Staging

Mooring Structures

East Approach
