# Gustavus Ferry Terminal

State Dock Road

**Terminal Description:** The Gustavus Ferry Terminal is a side-berth loading facility consisting of a 600' long trestle, 0.75 acre staging/parking island, 175' long approach trestle with a 75'x75' dock and sheet pile wave barrier, pontoon-supported transfer bridge with adjustable ramp and apron, six steel pile dolphins and catwalks/gangways for linehandling access. This facility was recently constructed in 2011 as a multi-purpose community dock and for use as a ferry terminal by AMHS. This facility is presently operated and maintained by DOT&PF, SE Region – not AMHS. Gustavus's total passenger and vehicle traffic are shown below.

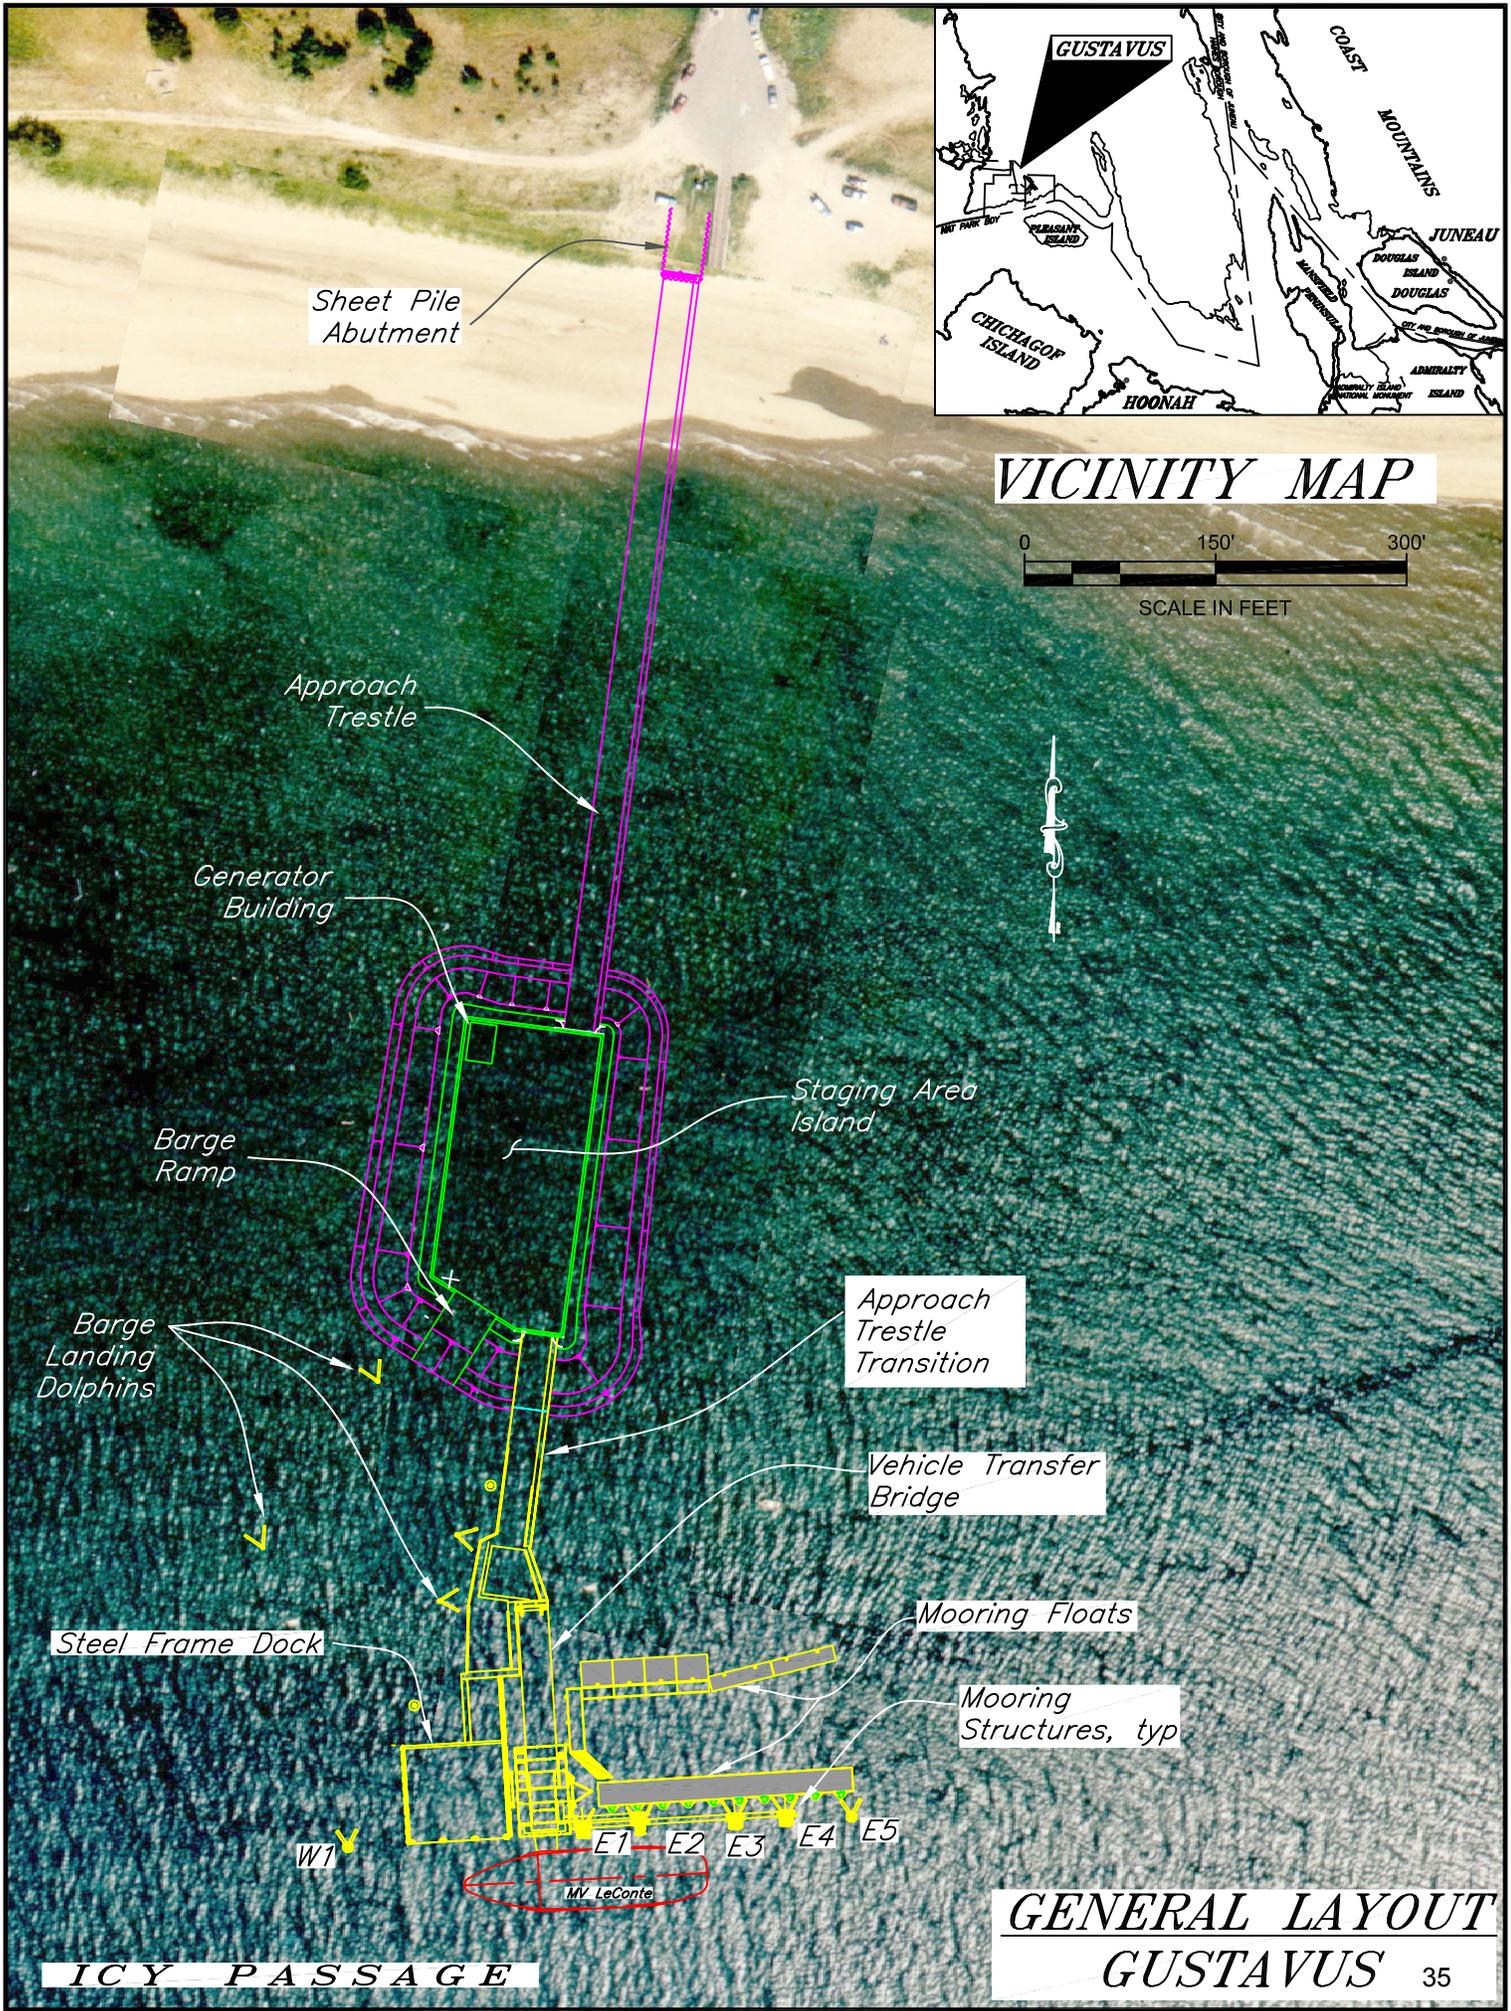
GENERAL LAYOUT

Sheet Pile Abutment

Approach Trestle

Generator Building

Staging Area Island

Barge Ramp

Approach Trestle Transition

Barge Landing Dolphins

Vehicle Transfer Bridge

Mooring Floats

Steel Frame Dock

Mooring Structures, typ
