**GENERAL LAYOUT**  
**HAINES**

# Haines Ferry Terminal

4 Mile Lutak Road

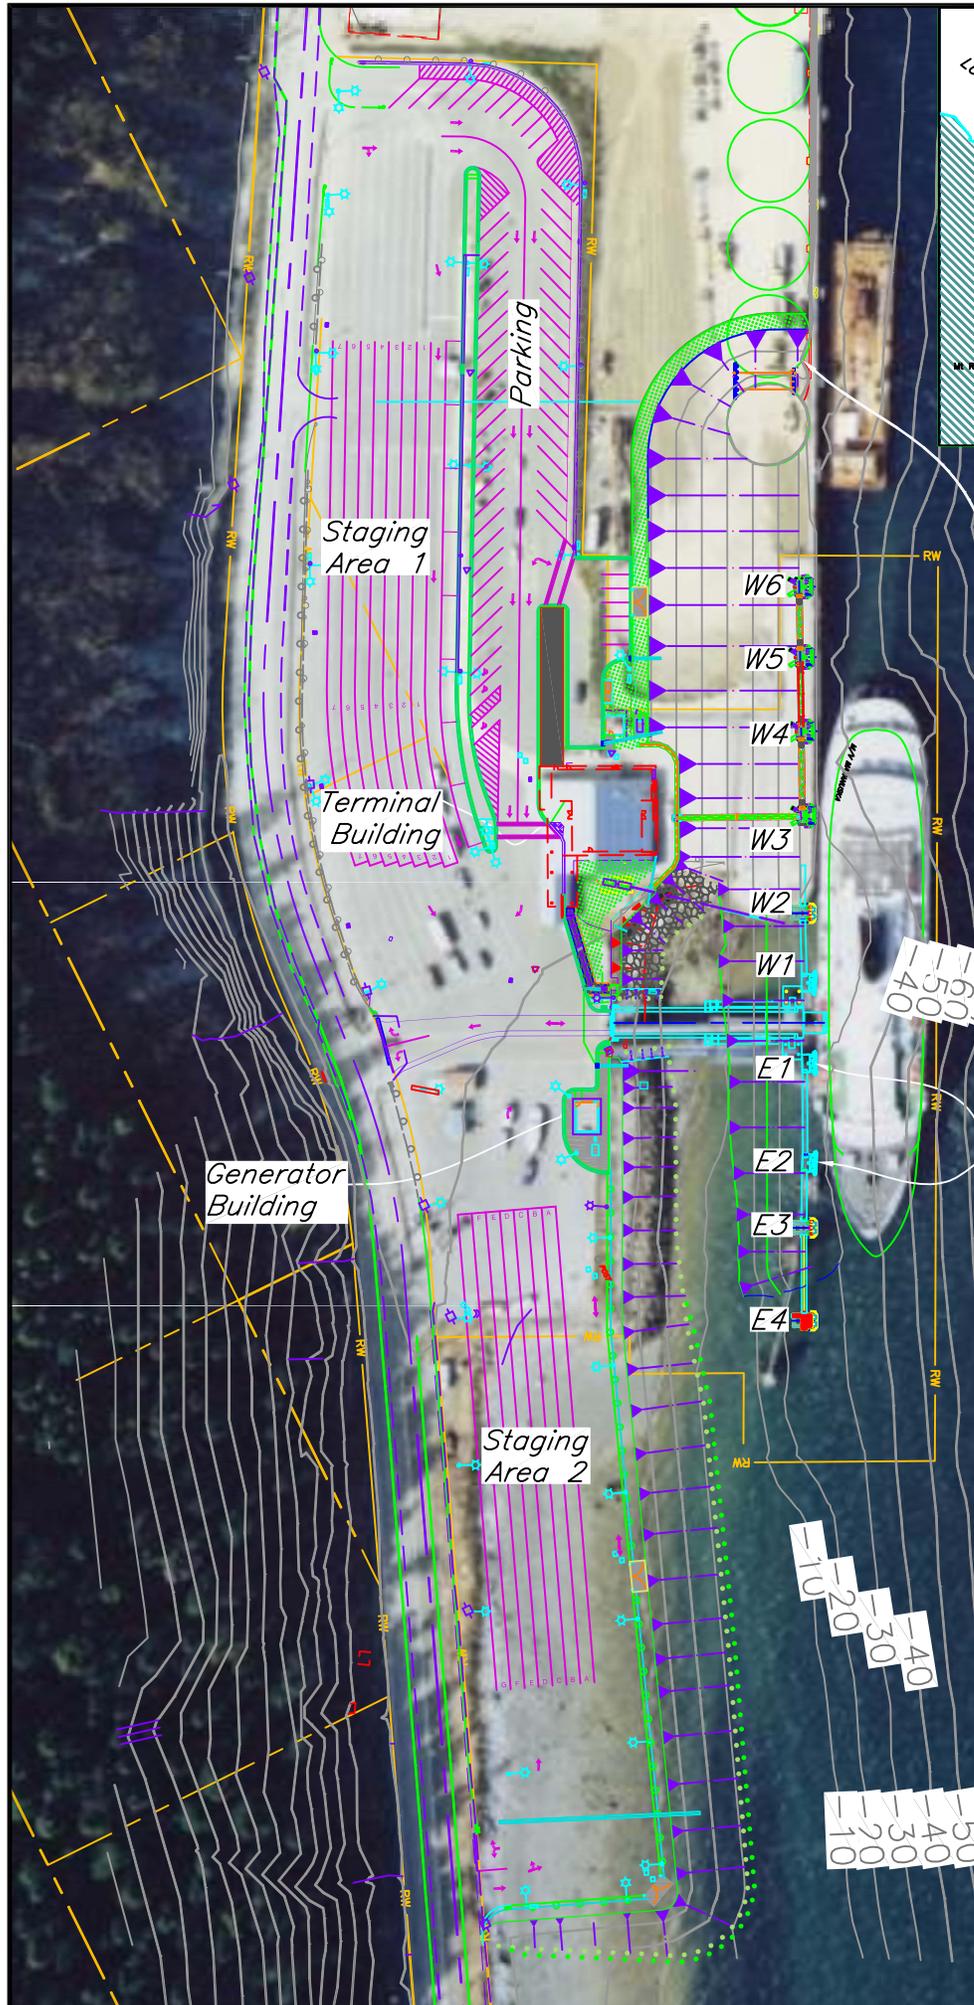
Mooring Structures, typ.  
 -120  
 -110  
 -105  
 -90  
 -80  
 -60  
 -50  
 -40  
 -30  
 -20  
 -10

Mooring Structures, typ.

-120  
 -110  
 -100  
 -90  
 -80  
 -70  
 -60  
 -50  
 -40  
 -30  
 -20  
 -10

**Terminal Description:** Haines is a side-loading facility consisting of a transfer bridge, twin lift tower syncrolift, three steel pile and two timber dolphins, sheet pile cell structure with timber fenders and catwalks/gangways for line-handling access. The terminal structures were originally constructed in 1980 and it is the second busiest facility in the AMHS system; only Juneau surpasses it for combined passenger and vehicle traffic. Haines past 10 years of total passenger and vehicle traffic is shown below.
