**GENERAL LAYOUT
TENAKEE**

Tenakee Ferry Terminal

Owner: State of Alaska

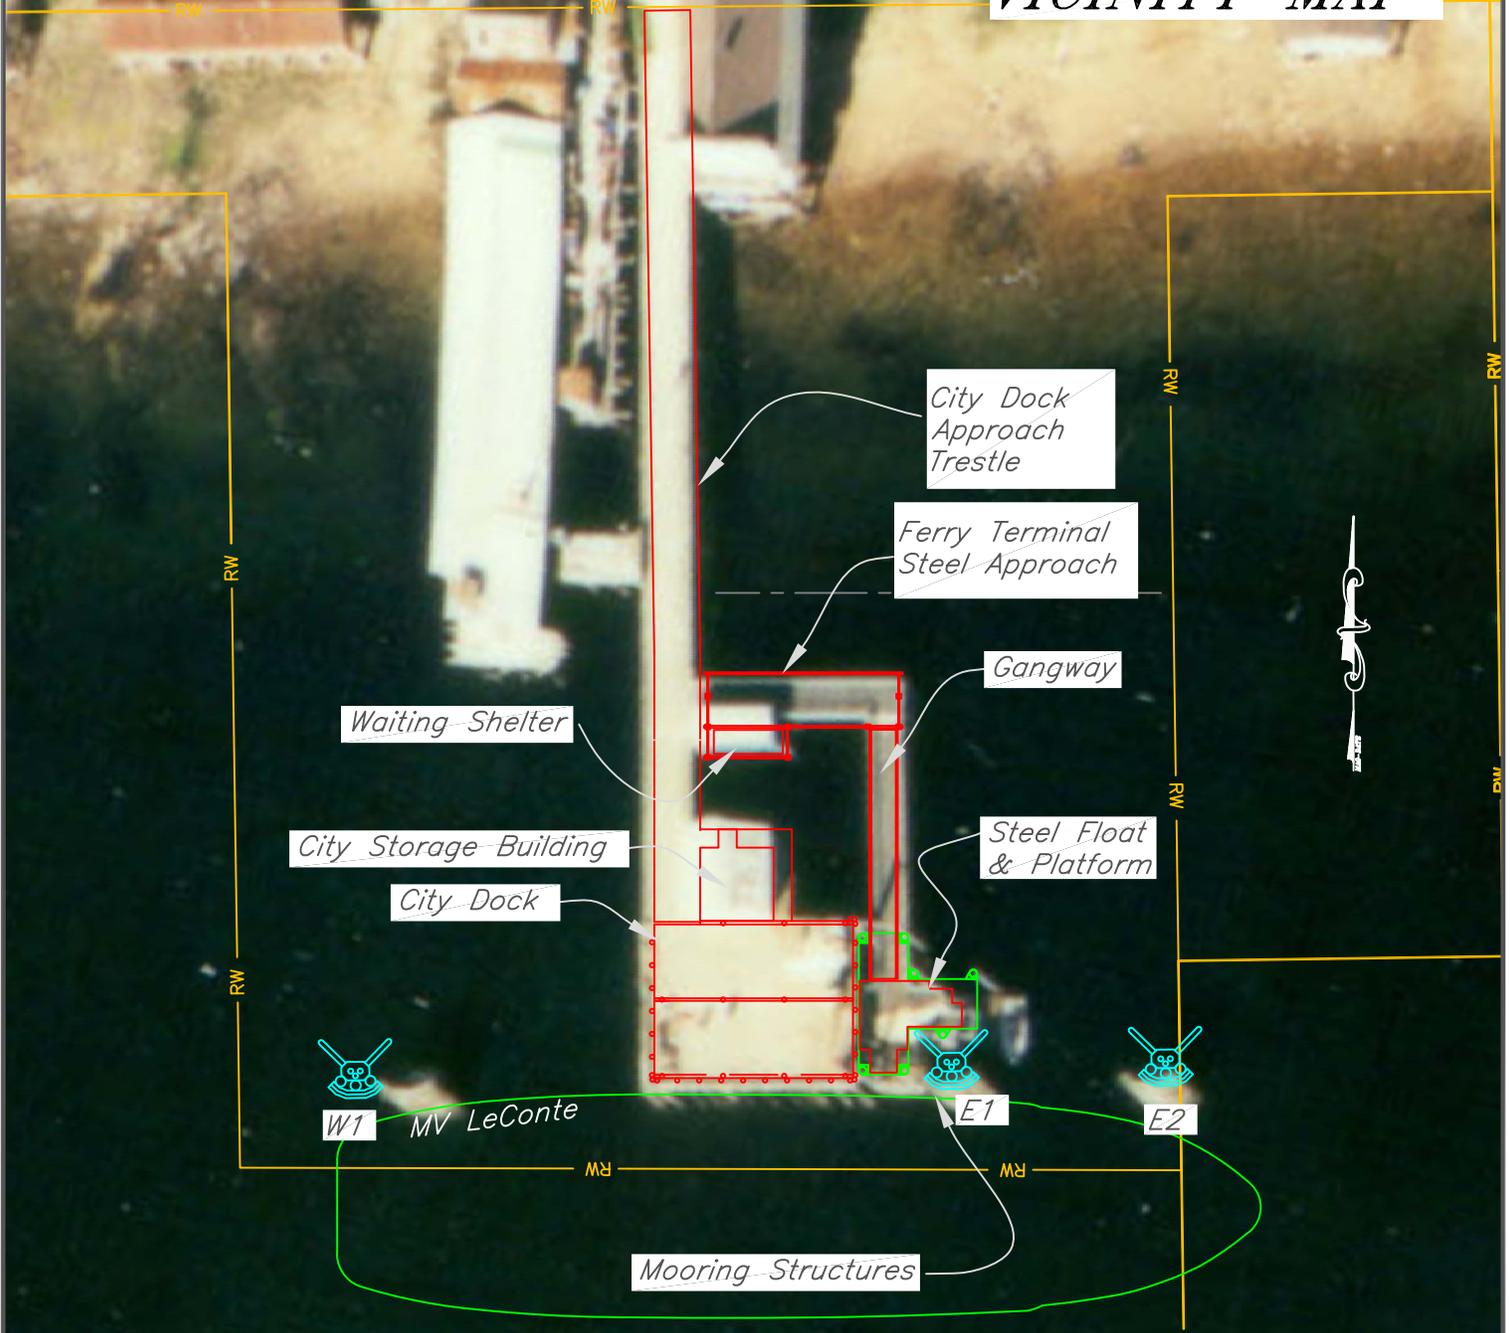
TENAKEE INLET

Terminal Description: The Tenakee Springs city dock was constructed in 1978 to provide passenger and light freight service to Tenakee Springs. The dock facility is a 40' x 52' main dock section with a 12' x 240' approach span to shore and consists of concrete panels supported by steel pipe piles. Three, steel pile mooring dolphins with timber fenders are used by AMHS for port side mooring. By City ordinance, *Transfer of vehicles at Tenakee Springs is limited to motorcycles, all terrain vehicles and other small motorized vehicles under 10'-0" in length and under the maximum weight limit of 1000 pounds.* The City Dock also supports a fuel and freight operations, a small city storage building and a jib crane that is located on the southeast corner of the dock. The AMHS ferry terminal is accessed from the City Dock by a pile supported steel platform structure and steel gangway. This platform structure was widened by ADOT in 2011.

The passenger transfer facility was built in 1984 to service LeConte class vessels. An open steel grate approach extends to the east, perpendicular to the City Dock. At the end of the approach is a gangway down to a floating platform supported by a custom steel pontoon. A counter weighted, pull-down apron connected to the platform provides access to the ferry side deck. An 8' x 20' waiting shelter was constructed at the juncture of the City Dock and the ferry terminal approach. The past 10 years of total passenger and vehicle traffic at Tenakee is shown below.
