Wrangell Ferry Terminal

1/4 mile Stikine Ave.

Owner: State of Alaska

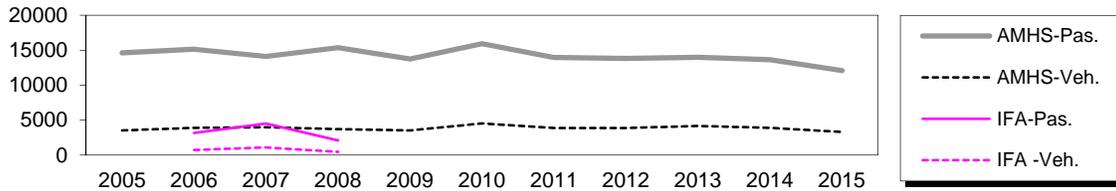
Terminal Description: The Wrangell Ferry Terminal is located at the north end of town, along Stikine Avenue. Wrangell is a side-loading facility consisting of a transfer bridge, cable supported bridge lift (Syncrolift), 10 steel pile dolphins and associated catwalks/gangways for line-handling access. Wrangell was also used by the IFA ferry from Coffman Cove and South Mitkof terminals but has not operated this route since 2008. The past 10 years of total passenger and vehicle traffic at Wrangell is shown below.
