AKUTAN HARBOR

GENERAL LAYOUT AKUTAN

Akutan City Dock

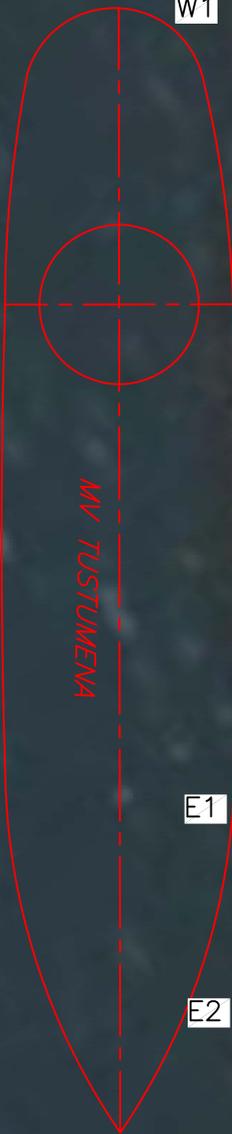
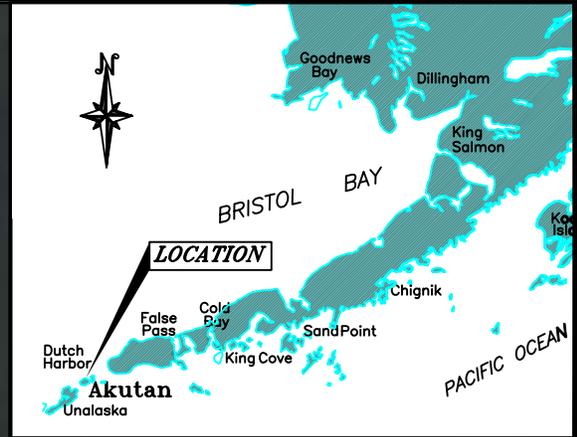
Mooring structure

Sheet pile wave barrier with catwalk

Sheet pile bulkhead wharf

Dock w/ concrete deck on steel pipe piles

Mooring dolphins w/ catwalk access

Dolphins							
Dolphin	Dolphin Piles	Fender Support	Fender Face	Anodes	Built	Cond.	Notes
W3	1B, 1V	-	-	No	2005	Good	
W2	1B, 1V	2V	Plastic Rub Strip	No	2002	Good	
W1	2B, 2V	2V	Plastic Rub Strip	No	2002	Good	Rubber Fenders & steel wale are severely damaged.
E1	3B	1H	Rubber donut, vertically mounted	Yes	1993	Fair	
E2	3B	1H	Rubber donut, vertically mounted	Yes	1993	Fair	Red Navlight

3. The rubber fender & steel wale on dolphin W1 were severely damaged by a hard vessel impact several years ago. No backup cushioning is available in this dolphin. The seaward railing on the catwalk between the dock and dolphin W1 is also damaged.

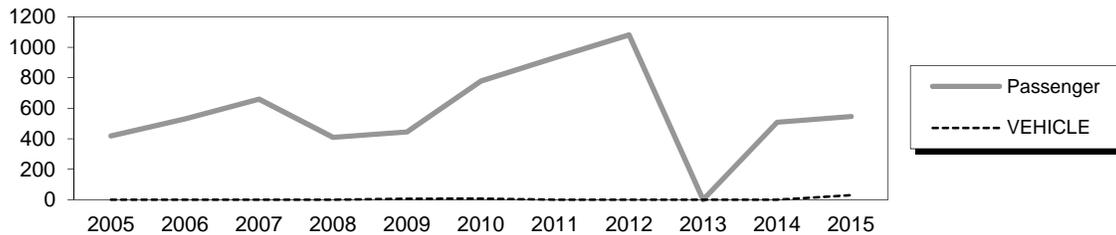
Terminal Description: The M/V TUSTUMENA docks in Akutan during its May through September Aleutian Chain trips. AMHS has previously discharged only passengers at this facility; however, sailings now include some vehicles. The Akutan City Dock is a platform dock constructed of concrete panels, steel pile caps and steel support piling. Abutting the back of the dock is an earth filled sheet pile bulkhead for the full length of the dock. There are two mooring dolphins with fender units on each side of the dock. In line with the western dolphins is a sheet pile wall that acts as a wave barrier for a small boat harbor, with a 50-foot extension installed in 2005. The past 10 years of total passenger and vehicle traffic at Akutan is shown below. Akutan had no ferry service in summer 2013 while the M/V Tustumena was in the shipyard for repairs.
