Sitka Ferry Terminal

5307 Halibut Point Road

Owner: State of Alaska

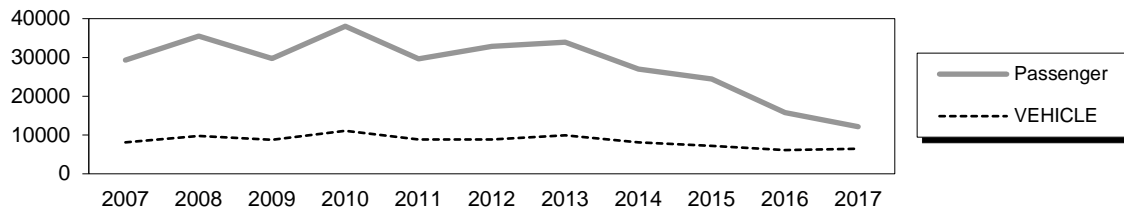
Terminal Description: The Sitka Terminal is located on Starrigavan Bay, approximately seven miles from the city center on Halibut Point Road. The inside waters of Southeast Alaska are reached via Olga/Neva Straits and Sergius Narrows. The mainline ferries must traverse the narrows at slack water. The Sitka Ferry Terminal is a side-berth facility consisting of staging and parking areas, terminal building, emergency generator facilities, transfer bridge, covered walkways, and five steel mooring structures connected by catwalks. The past 10 years of total passenger and vehicle traffic at Sitka is shown below.
