GENERAL LAYOUT
YAKUTAT

Yakutat City Dock

Terminal Description: The M/V KENNICOTT calls in Yakutat during its cross-gulf trips. The dock is L-shape in plan with a face 237 feet long by 50 feet wide and an approach 70 feet wide by 169 feet long. The dock is constructed of precast concrete deck panels atop cast-in-place concrete caps and steel support piles. Two mooring dolphins are located at each end of the dock and lie off-line from the dock face. The facility is a multi-purpose dock and could be in use by other vessels when the ferry arrives. AMHS is not in control of the operation or maintenance of this facility. The past 10 years of total passenger and vehicle traffic at Yakutat is shown below. The KENNICOTT began its service in 1998.

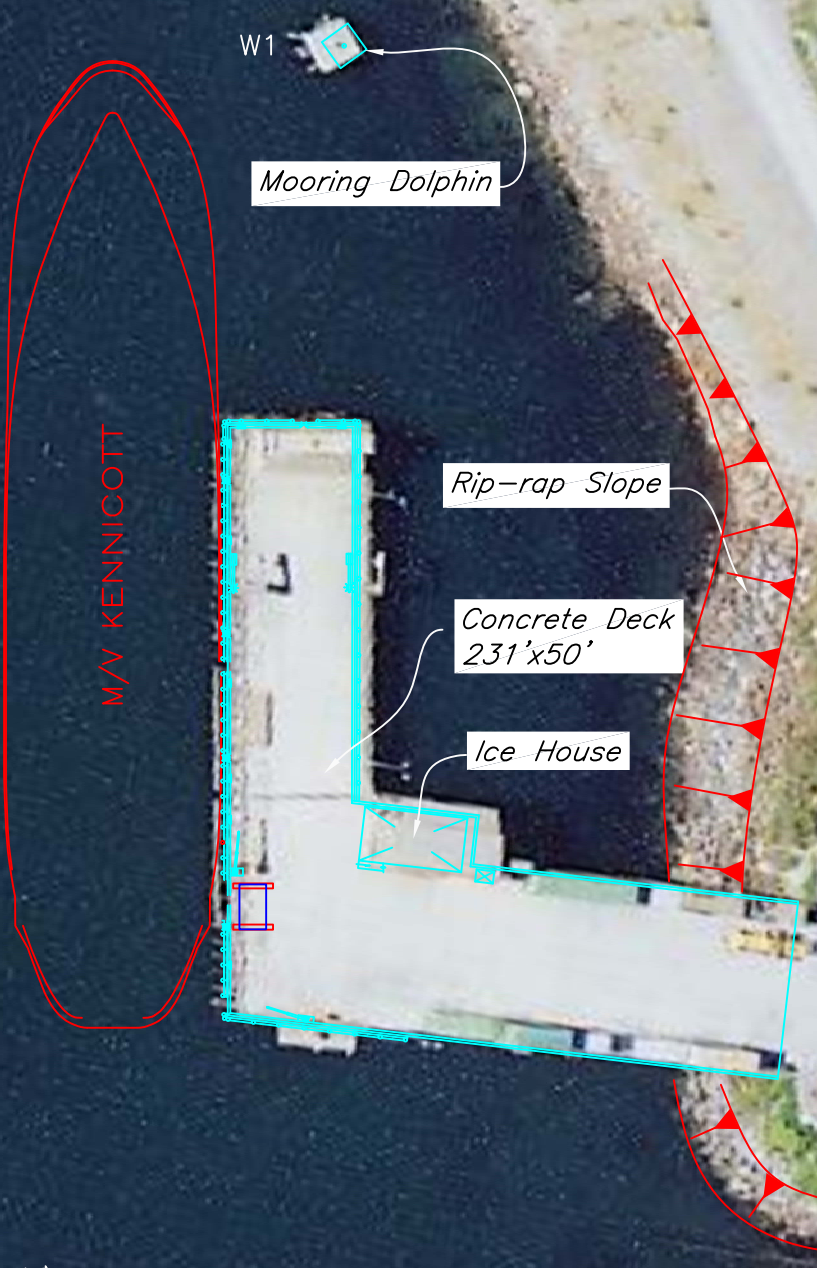
L-Shaped Dock - #2094	
Type:	L-Shaped 237'x50' concrete panel dock & 169'x70' concrete panel approach
Year Built:	1984
Dock Support:	Steel piles & concrete pile caps
Pile Coating:	Epoxy paint
Fender:	Timber creosote piling bolted to steel wale with 'V' style energy absorbing unit.
Anodes:	Cables hanging from end of angle (welded to pile near low-water line)
Lighting:	Light poles mounted at dock corners
Condition:	Good
Load Posting Sign:	N/A
Original Design Load:	HS 20-44/60 Ton Mobile Crane/25 Ton Forklift/600 psf

Dolphins							
Dolphins	Dolphin Piles	Fender Support	Fender Face	Anodes	Built	Cond.	Notes
E1	8B, 5V	Mooring Only		No	1984	Fair	
W1	8B, 5V	Mooring Only		No	1984	Fair

2. The steel support piling are epoxy-coated. The shoreward piling exhibit 75% coating loss with some laminating corrosion. Section loss is not known. Seaward piling are in fair condition, with 20% coating loss. The City installed new anodes on the piling recently, however a few of the anode cables have broken off at the support angles. Cathodic potential (CP) readings from the '16 underwater report for the dock support piles average -0.95V. The cutoff for adequate protection is -0.8V, so the steel piles are protected against corrosion. Depth to mudline elevations, taken with leadline readings at locations along the fender line in 2015, range from -33' to -36' MLLW.

4. The most recent underwater inspection (August 2016) found the timber piles at the east end of the dock from Bents 11 to 13 exhibit significant abrasion and decay from the low water mark to the high water mark. In two locations along the berthing face (Bents 20 to 23 and 15 Pile C to 15 Pile D) the timber fender walers were broken and dislodged. Additionally, two timber fender piles at Bent 15 Pile A and Bent 15 C were broken due to impact damage.
All damaged timber fender piles, walers & chocks were replaced in October/November, 2016 on a City of Yakutat project. The timber fender system is still substandard for taking AMHS vessel & heavy barge berthing loads.
