GENERAL LAYOUT
SELDOVIA

Seldovia City Dock

Owner: City of Seldovia

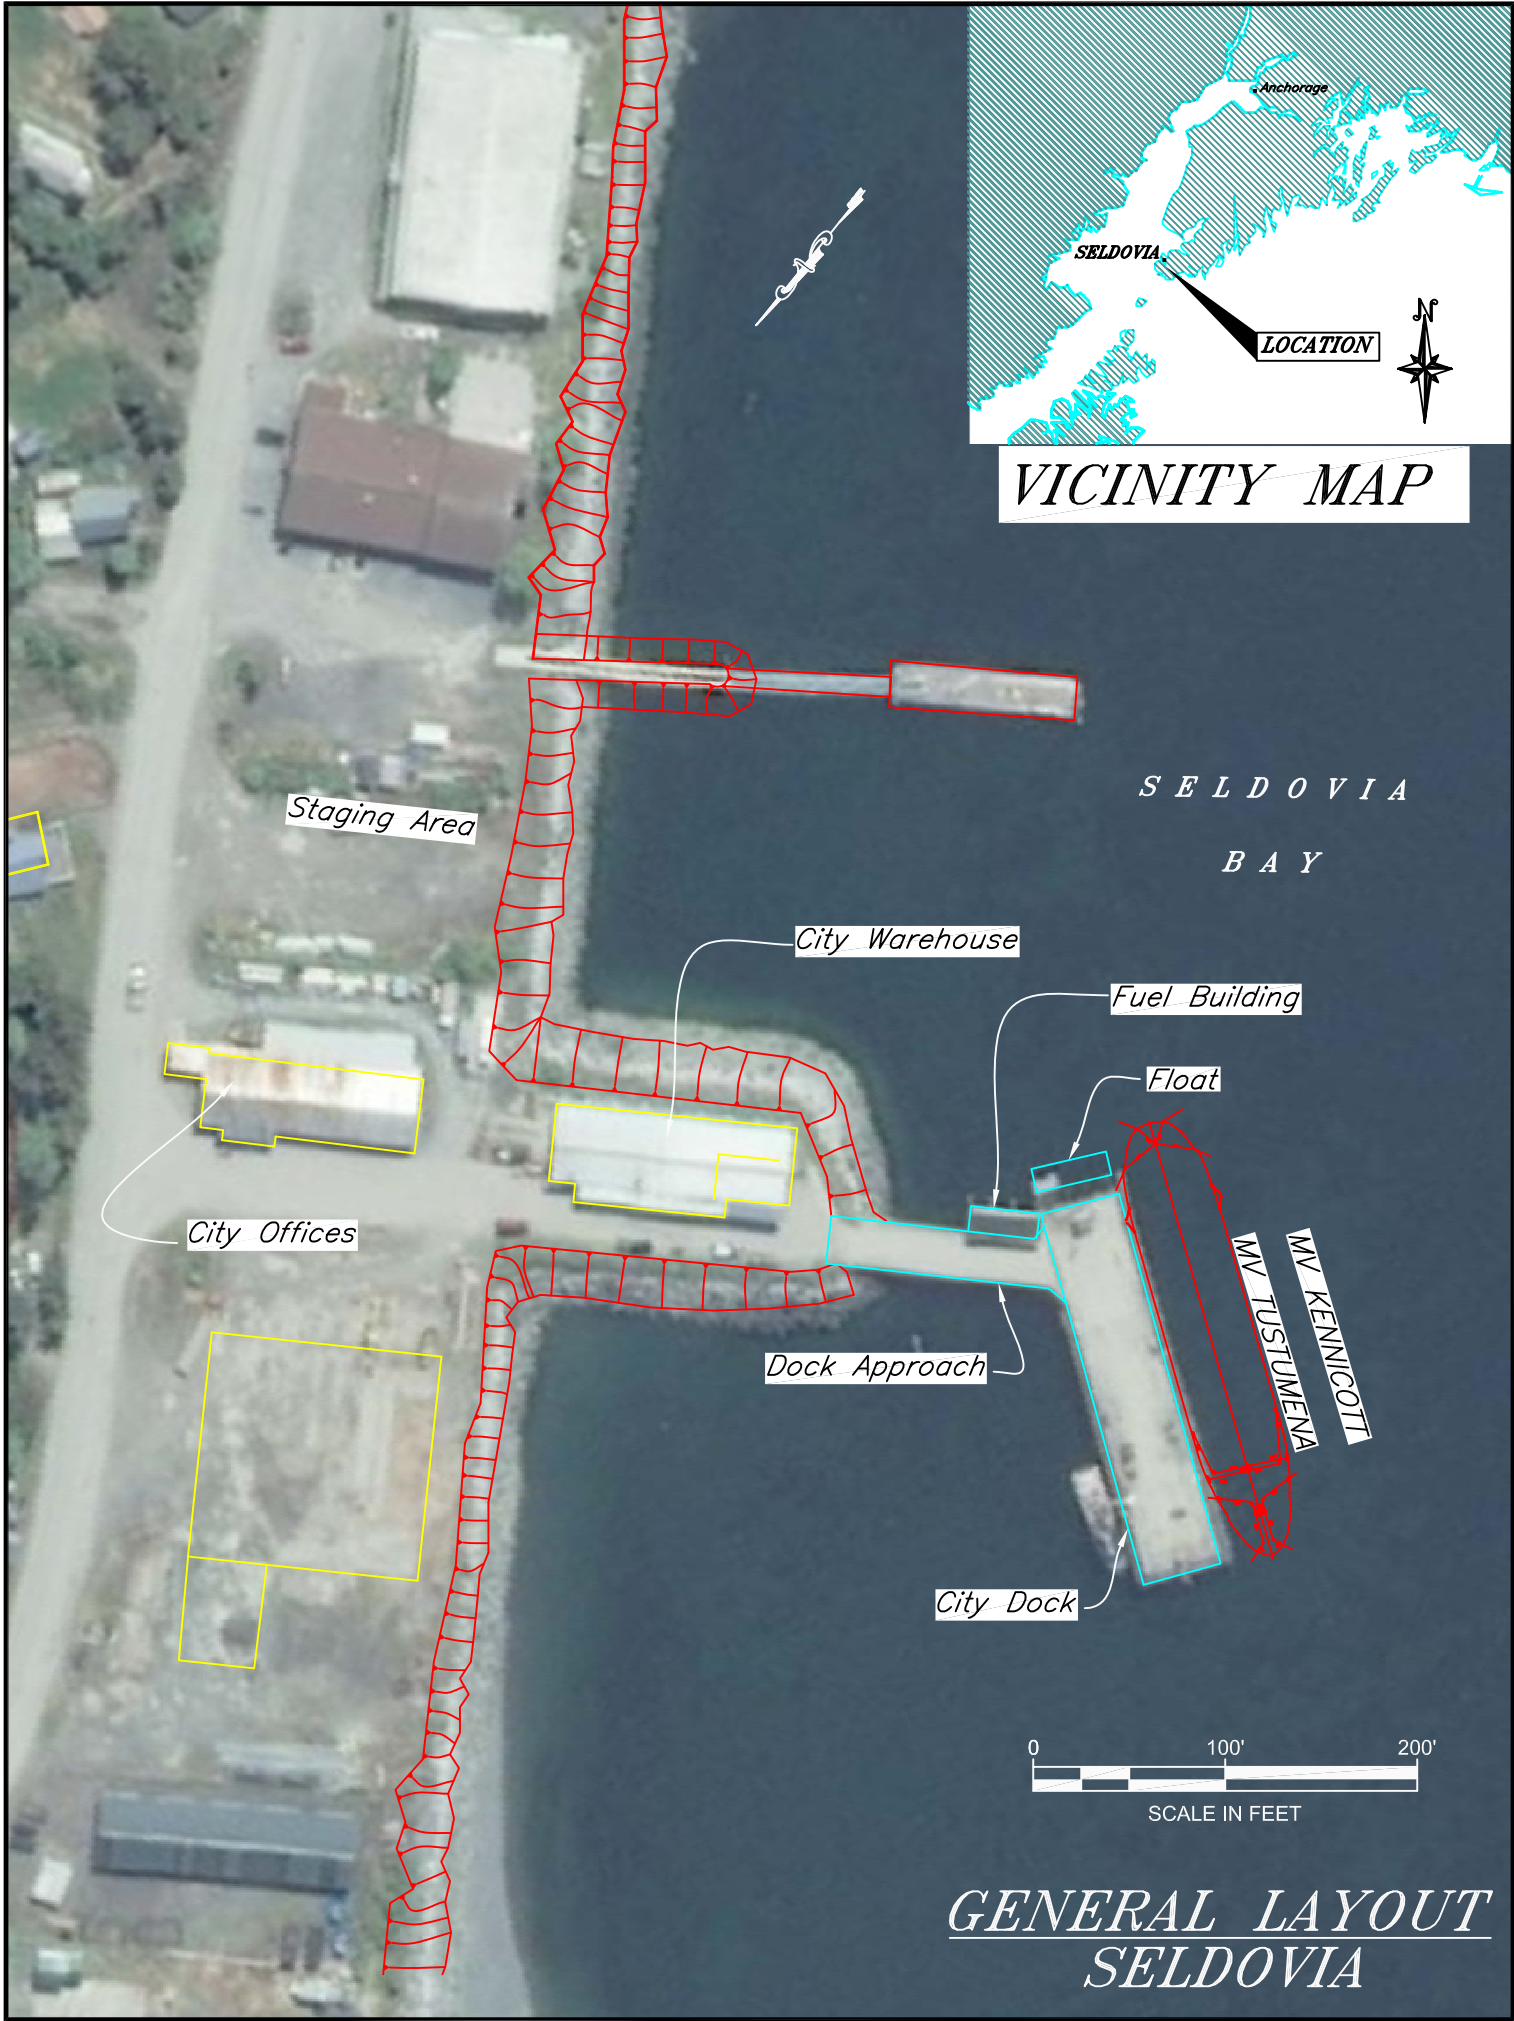
Terminal Description: Seldovia City Dock is a multi-purpose dock owned and operated by the City of Seldovia. The City & AMHS have an agreement for docking use. The dock is supported on steel pipe piling and has a steel and concrete superstructure with a steel wale, timber faced fender system. Vehicle access is via Dock Street and across a steel approach structure. There is a designated AMHS vehicle staging area (on City owned property), but no terminal building or other upland ferry terminal related facilities. This staging area does not appear to be utilized by ferry traffic. The dock and approach area has a fueling station, fuel storage facilities and serves as a freight wharf. The past 10 years of total passenger and vehicle traffic at Seldovia is shown below. The M/V Tustumena was out of service most of 2013, causing a steep dropoff in traffic at the terminal.
