# Tatitlek Dock

**Terminal Description:** The Tatitlek facility is a multipurpose dock structure that was originally constructed in 1995 to accommodate the M/V BARTLETT. The Tatitlek facility consists of a staging area, an approach, a dock and two tidal ramps constructed of concrete panels welded supported by steel beams and piles. AMHS has an MOA for use of the dock for ferry operations. Ownership of the facility was transferred to the North Pacific Rim Housing Authority (NPRHA) in 1999.

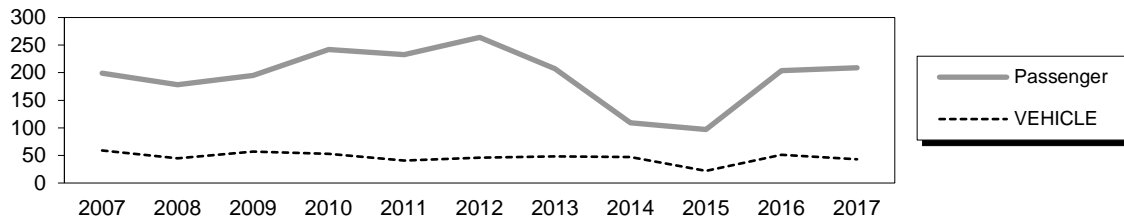
The past 10 years of total passenger and vehicle traffic at Tatitlek is shown below.
