*GENERAL LAYOUT
COLD BAY*

Cold Bay Dock

Owner: Aleutians East Borough

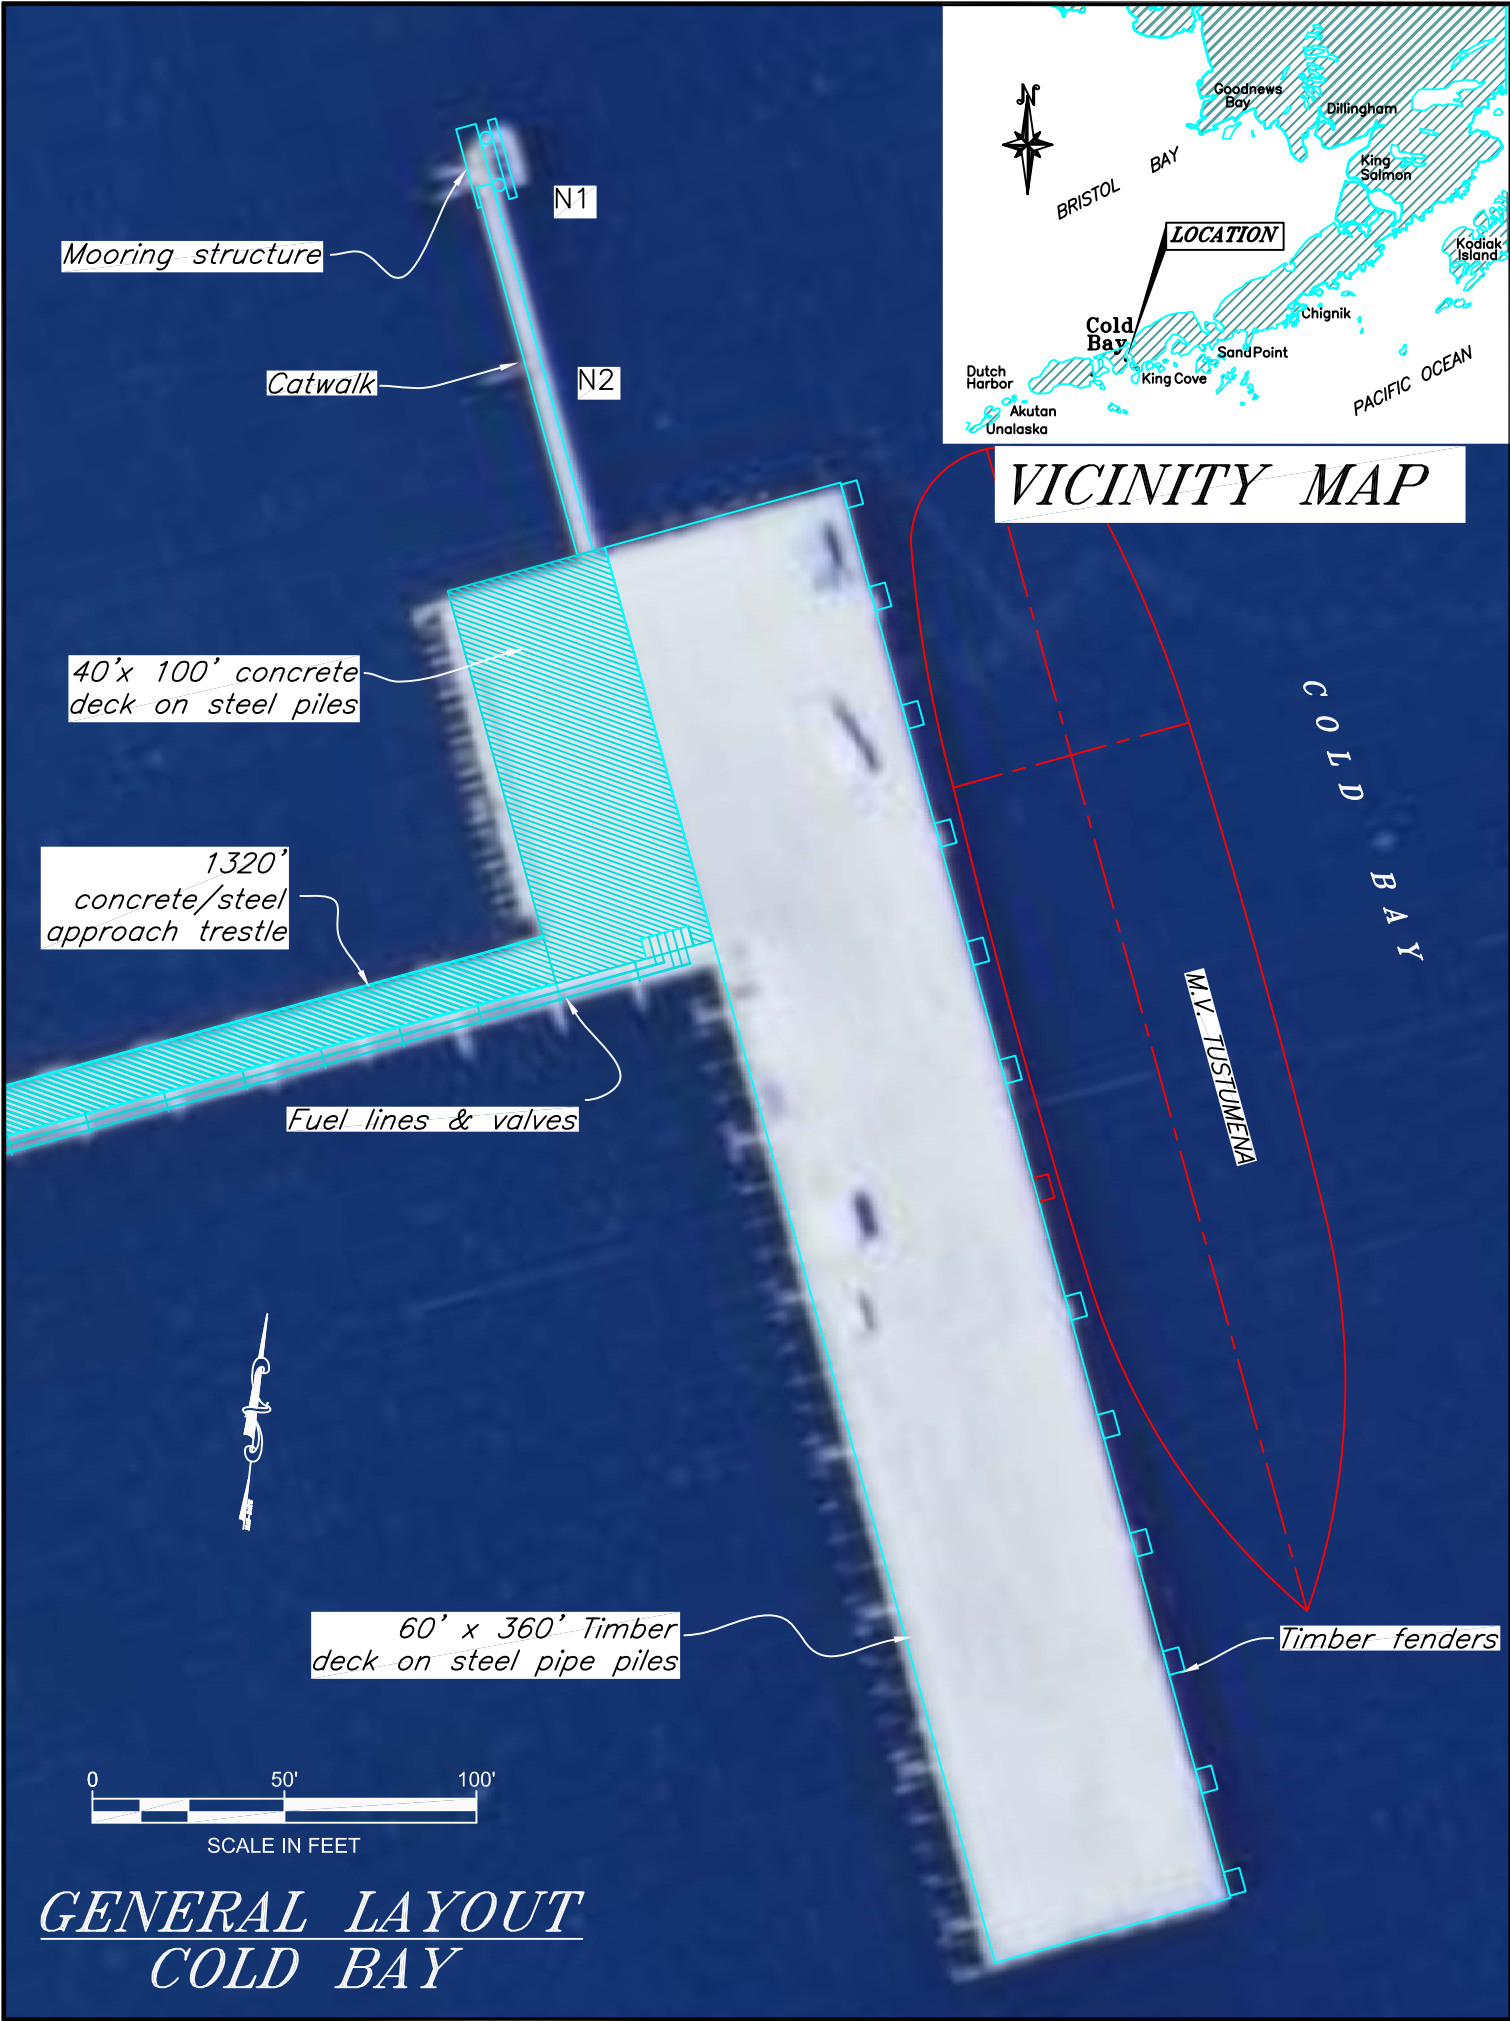
Mooring structure

Catwalk

40'x 100' concrete deck on steel piles

1320' concrete/steel approach trestle

Fuel lines & valves

60' x 360' Timber deck on steel pipe piles

Timber fenders

Terminal Description: The M/V TUSTUMENA docks at the Cold Bay Dock during its East/West passage through the Aleutian Chain. The Cold Bay facility is made up of two dock sections that were constructed at different times. The original structure, designed and built by the State in 1978 consisted of a 100' x 40' concrete panel dock and a 1,320' long concrete panel approach. There is a mooring dolphin and catwalk northwest of the original dock. In 1993, a 360' x 60' addition was constructed to the northeast of the original dock; the newer dock abuts the face of the original structure. The facility is owned by the Aleutian East Borough and managed by the City of Cold Bay. The past 10 years of total passenger and vehicle traffic at Cold Bay is shown below. The M/V Tustumena was out of service most of 2013, causing a steep dropoff in traffic at the terminal.

Original L-Shaped Dock - #1755	
Type:	12' x 1824' concrete panel approach & 42' x 100' concrete dy-core panel dock
Year Built:	1978
Dock Support:	16" dia. Steel piles with steel WF-beam pile caps
Pile Coating:	Epoxy/Galvanizing
Anodes:	Yes, welded directly to piling with bond cables to pile caps. Cables replaced in 1998.
Lighting:	None
Condition:	Fair
Notes:	The approach has two vehicle turnouts, located on the northwest side of the trestle.
Load Posting Sign:	20 Ton Max
Original Design Load:	HS 20-44 / 400 psf

Dock Addition	
Type:	360' x 60' steel beam and timber decking
Year Built:	1993
Dock Support:	Steel pile bents spaced ~30' o.c. Each bent has (4)-26"dia. Vertical steel piles & (1) batter pile connected to steel H-pile caps. Salvaged W36x182 bridge beams span the length, with pressure-treated 12x12 timber stringers and 4x12 timber decking above.
Pile Coating:	All steel is uncoated.
Fenders:	13 timber-faced pin pile fender units, spaced roughly 30' o.c. along northeast face of dock. The ends and southwest face of the dock are protected with treated timber pile fenders.
Anodes:	(39) 200# aluminum anodes suspended from the superstructures by galvanized wire rope. The City replaced the cables in 1998.
Lighting:	None
Condition:	Poor
Load Posting Sign:	N/A
Original Design Load:	HS 20-44 / 350 psf
