## GENERAL LAYOUT OLD HARBOR

# Old Harbor City Dock

**Terminal Description:** A new multi-use dock facility was recently constructed by the City of Old Harbor on Kodiak Island (50 miles southwest of City of Kodiak). The M/V Tustumena provided ferry service on four occasions in 2012. The frequency of future scheduled service is unknown as Old Harbor is out of the way of the normal route that the ferry takes from Kodiak to Chignik. The facility consists of a 55'x102' pile-supported dock with 3 fender panels, 3 mooring dolphins with access to the dock by steel catwalks, and an 18'x 280' pile-supported approach trestle connected to shore. The dock was built in 2012 to replace the aging timber freight dock. This is a multi-purpose facility utilized by other vessels. AMHS is not in control of operation or maintenance of this facility. The most recent annual passenger and vehicle traffic at Old Harbor is shown below.

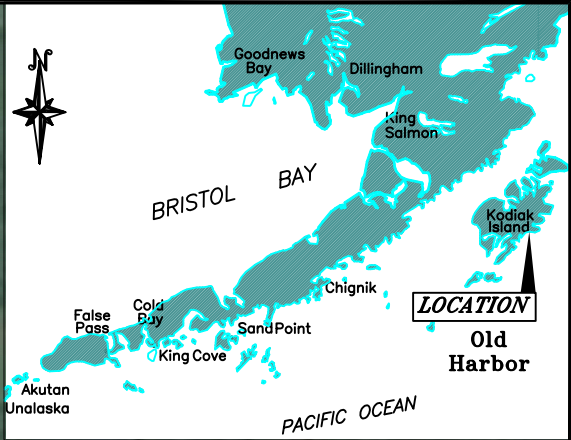
UPLANDS  
PARKING/  
STAGING AREA

APPROACH  
TRESTLE

MAIN DOCK

MOORING  
DOLPHIN, TYP.

M/V  
TUSTUMENA

SITKALIDAK STRAIT

Dock - #186	
Type:	55'x102' dock & 18'x280' approach trestle (prestressed concrete panels)
Year Built:	2012
Dock Support:	30" & 36" dia. steel pipe piles w/ steel w-beam pile caps
Pile Coating:	Galvanizing
Anodes:	Yes, welded directly to piling
Lighting:	Light poles on dock & trestle
Condition:	New
Notes:	
Load Posting Sign:	N/A
Original Design Load:	30-Ton forklift with 70-Ton front axle / HS25-44 Truck / 250 PSF

<b>Dolphins</b>							
<b>Dolphin</b>	<b>Dolphin Piles</b>	<b>Fender Support</b>	<b>Fender Face</b>	<b>Anodes</b>	<b>Built</b>	<b>Cond.</b>	<b>Notes</b>
W1	4B	2V	Sitka Spruce	Yes	2012	New	
E1	4B	2V	Sitka Spruce	Yes	2012	New	
E2	4B	2V	Sitka Spruce	Yes	2012	New

<b>Catwalks / Gangways</b>							
<b>#</b>	<b>From Struc.</b>	<b>To Struc.</b>	<b>Length / Style</b>	<b>Built</b>	<b>Safety Chains?</b>	<b>Cond.</b>	<b>Lighting</b>
C1	Dock	W1	4'x87' Catwalk / Tube Deck Truss	2012	Yes	New	None
C2	Dock	E1	4'x87' Catwalk / Tube Deck Truss	2012	Yes	New	None
C3	E1	E2	4'x87' Catwalk / Tube Deck Truss	2012	Yes	New	None
