GENERAL LAYOUT
AUKE BAY
15

Auke Bay East Berth

13.8 Mile Glacier Highway

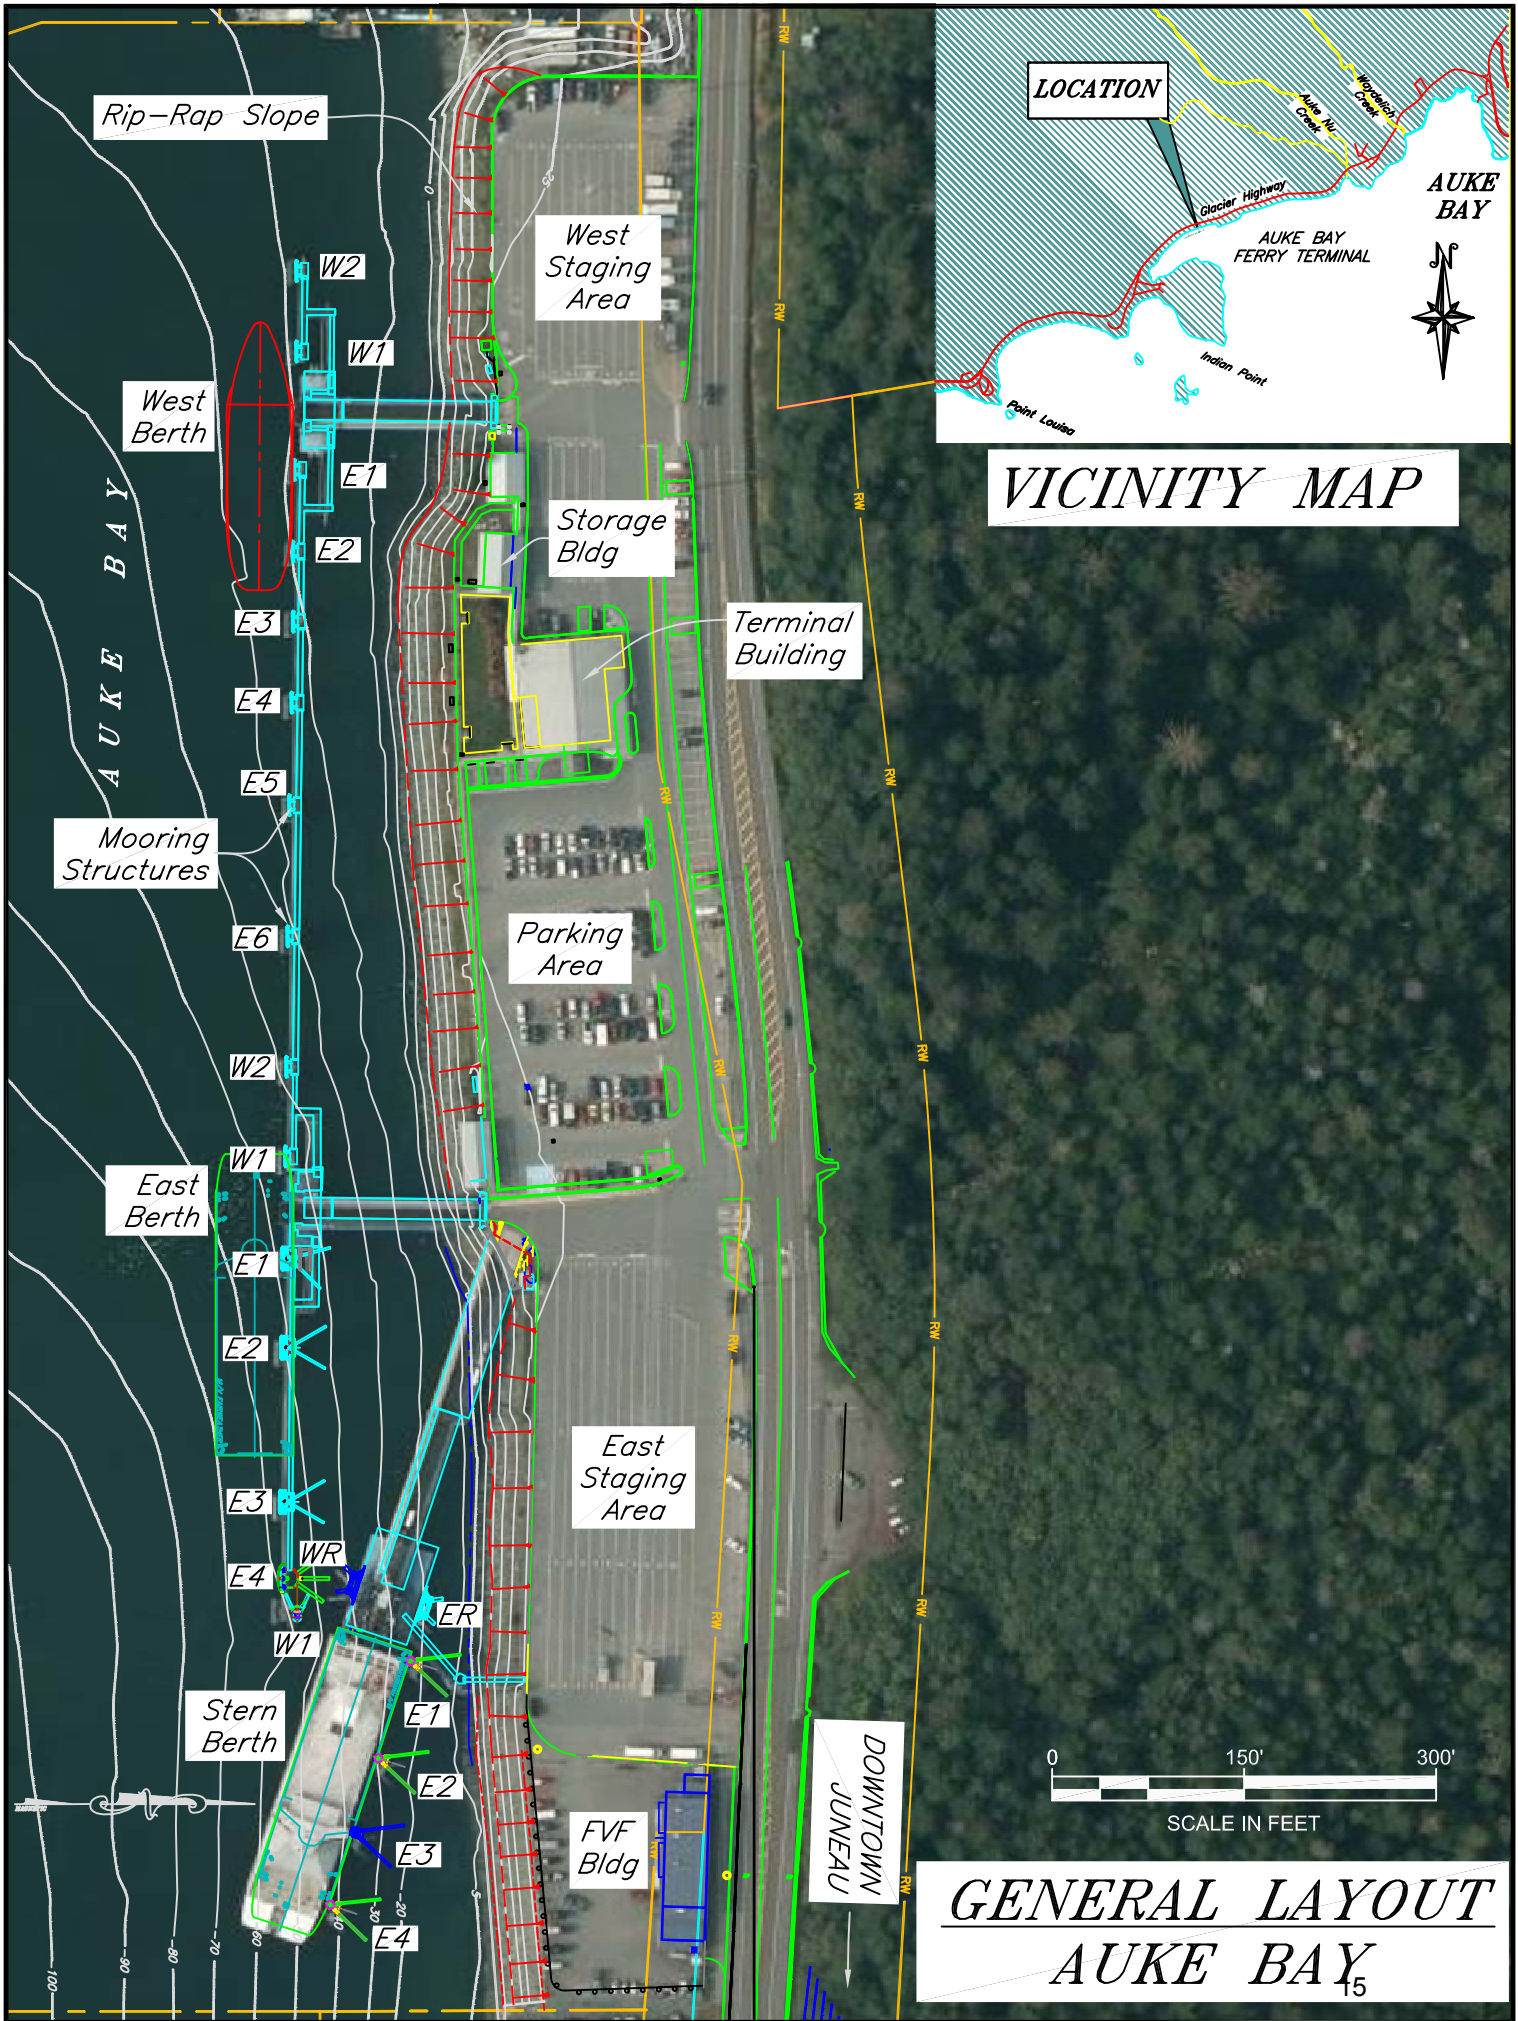
Auke Bay East Berth is a side-loading facility consisting of a transfer bridge, steel support float, six steel pile dolphins and catwalks/gangways for line-handling access. This facility was constructed in 1982 to handle mainline vessels.
