GENERAL LAYOUT
BELLINGHAM

Bellingham Ferry Terminal

Terminal Description: Bellingham Ferry Terminal, built in 1989, is the southern terminus for the Alaska Marine Highway System (AMHS). Bellingham is a stern-loading facility consisting of a steel transfer bridge, supported by a steel framed lift tower and counterweight system at the seaward end, with two stern dolphins and five breasting dolphins connected by timber catwalks. The terminal building differs from AMHS owned facilities in that it is a multiple use facility. The terminal building lies on a concrete dock supported by steel pipe piles. The dock extends around the northern, eastern, and western faces of the terminal building. The staging area has separate long and short term parking areas. Bellingham’s past 10 years of total passenger and vehicle traffic are shown below.

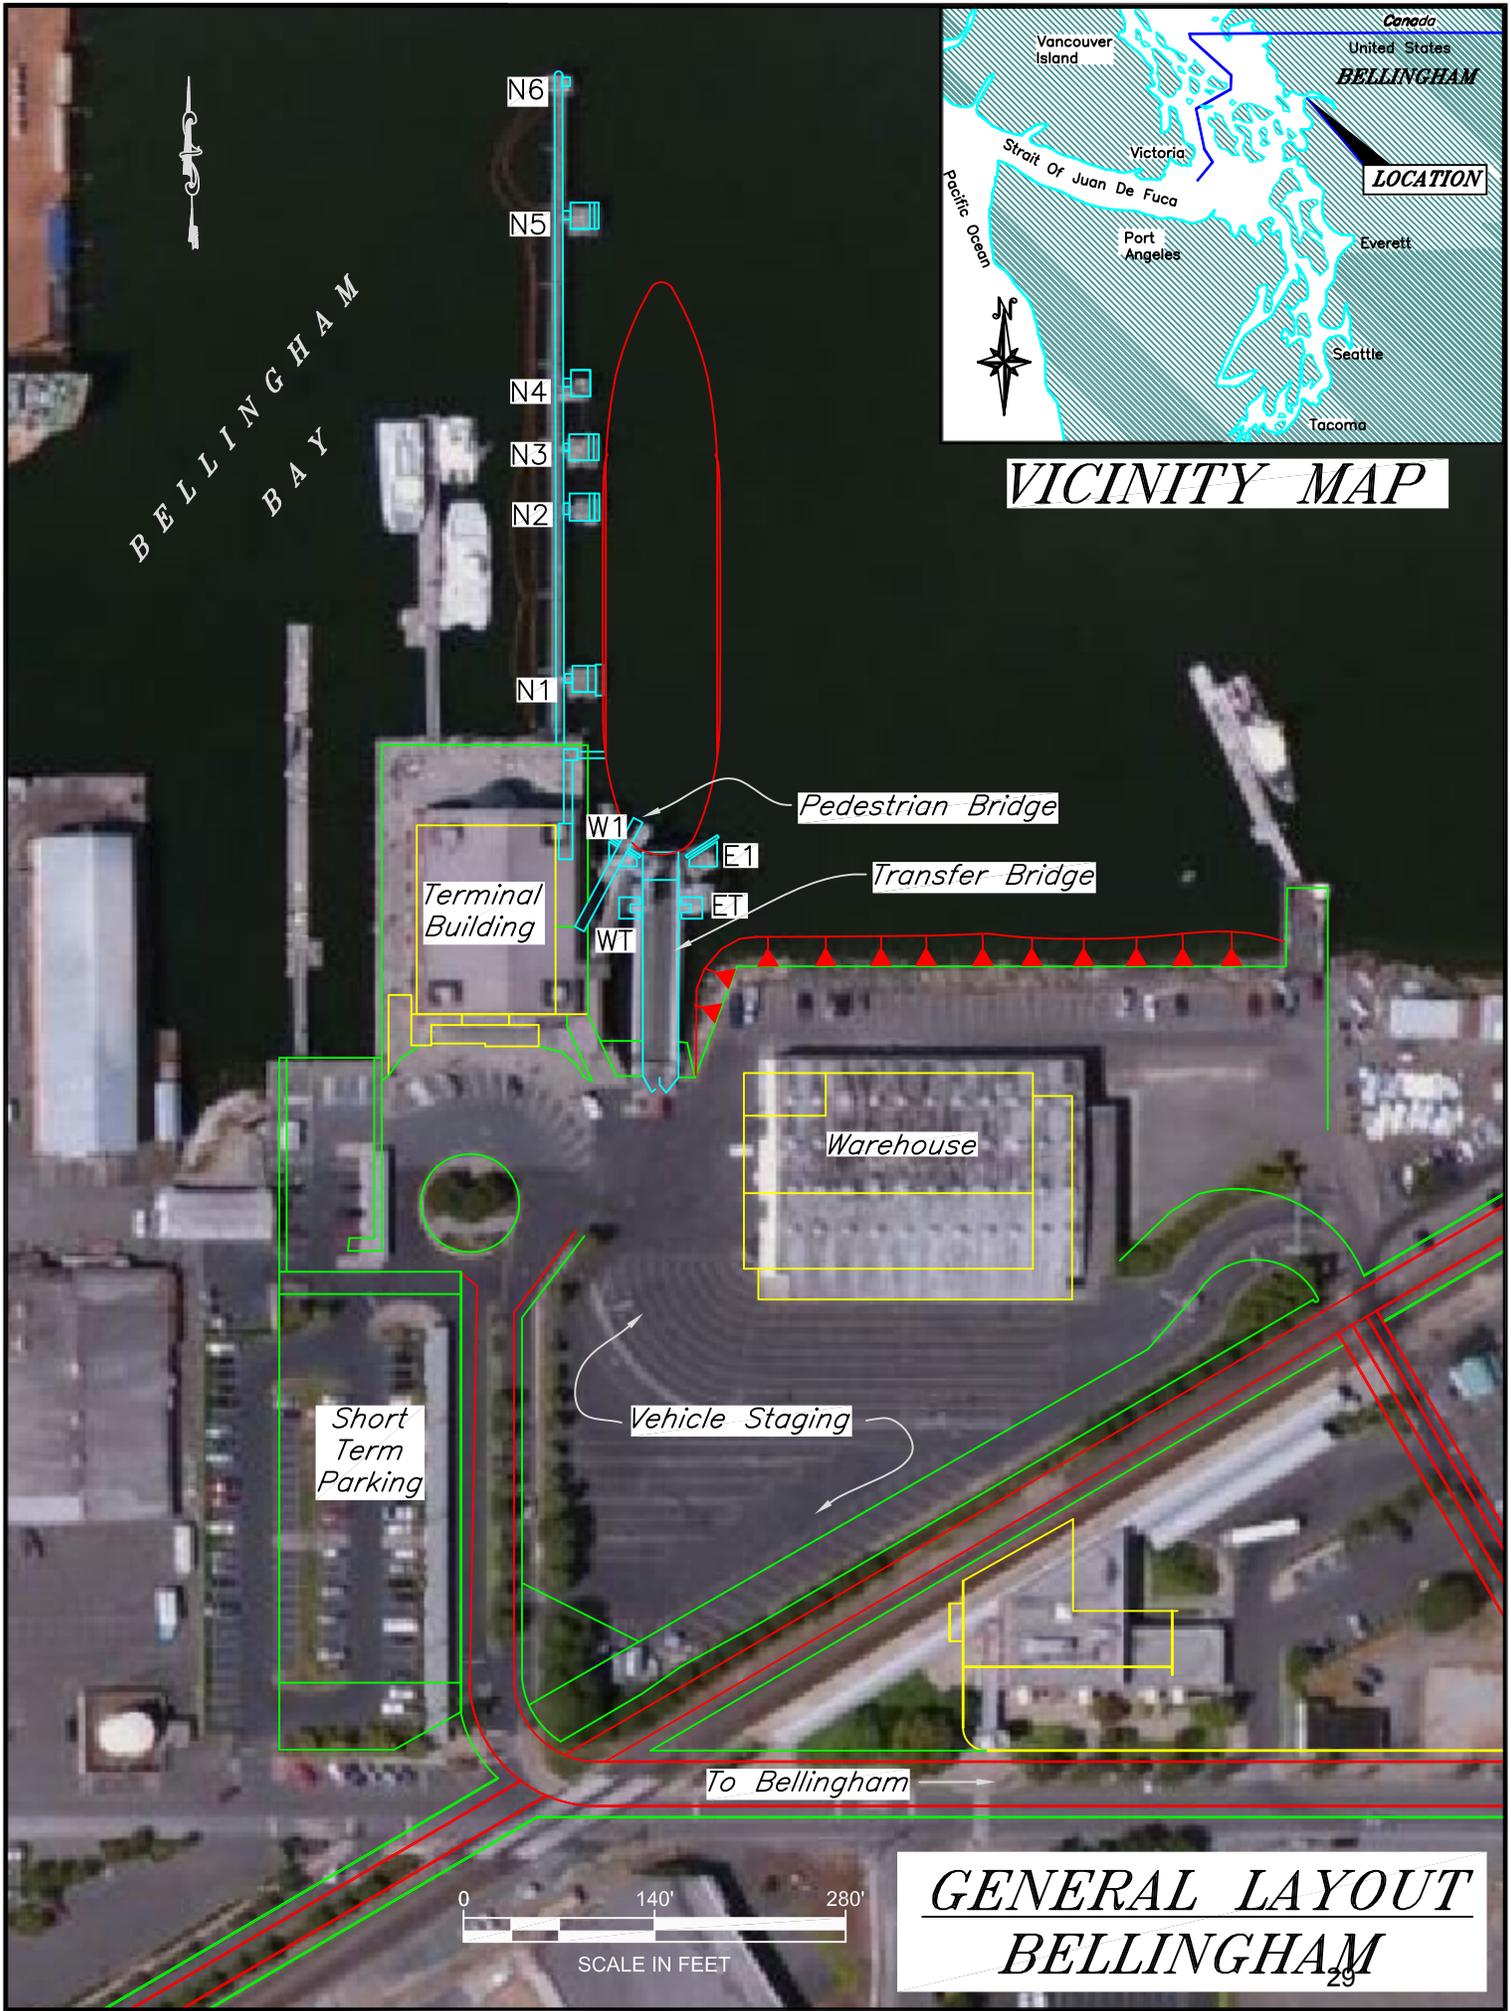
BELLINGHAM
BAY

N6
N5
N4
N3
N2
N1

Terminal Building

Pedestrian Bridge

Transfer Bridge

Warehouse

Short Term Parking

Vehicle Staging

2. The terrazzo floor has cracked between the roof truss supports. The microcracks are small and don't present a tripping hazard.
3. The northern-most mooring structure (N6) and approximately sixty feet of access catwalk were damaged in 1992 by an AMHS vessel collision. The vessel was approaching the facility during high winds. The vessel stern was blown against the northwest corner of this dolphin, which has no fender protection. The Port replaced the damaged mooring structure, navigation light, windsock, and catwalk in 1994. AMHS vessel masters have requested that this structure be replaced with a wraparound turning dolphin similar to those located at the ends of the mooring structures in Ketchikan to aid vessel landing during high wind conditions. With the potential cost of this upgrade approaching one million dollars, this project has not been placed on the Port's priority list. The state will need to coordinate funding of this project with the Port of Bellingham. This dolphin has a red nav light and windsock mounted on the cap.

In 1997, AMHS added a new dolphin (N2) with a steel fender system. This dolphin was added to accommodate the M/V Kennicott. The new dolphin is a galvanized steel cap structure supporting a steel suspended fender system. The fender face is an ultra-high-molecular-weight (UHMW) black plastic. Cylindrical rubber bumpers installed between the fender system and dolphin provides vessel energy absorption. CP measurement in 2017 for dolphin N2 was below -0.8V, which indicate that the steel is unprotected from corrosion.
Several of the timbers are broken on the fender panels of dolphins N1 & N3. The energy-absorbing units of these fender dolphins are "buckling column" rubber units. These have very good energy capacity but require a large initial force to cause buckling. Most broken timbers are located in the corners of the panels where the vessel sponson contacts a single timber when berthing obliquely. It is very likely the timbers fail because the fender units are stiff and the large initial reaction causes failure of the timber prior to buckling of the rubber unit. Recommend an analysis of the fender assembly by marine engineering to ensure compatibility among the timbers, wales, rubber elements and back-up structure. If the timbers are the limiting element, a possible solution is substituting the damaged timbers with stronger members such as steel beams faced with UHMW.

5. The horizontal fender chains, mounted on the sides of the caps and fenders of dolphins N1, N3 & N5 are corroding. U-bolt chain connections to the fender and caps are undersized and corroding.
