# Chenega Dock

**Owner:** North Pacific Rim Housing Authority  
**Contact Person:** Pete Kompkoff, 907-573-5132

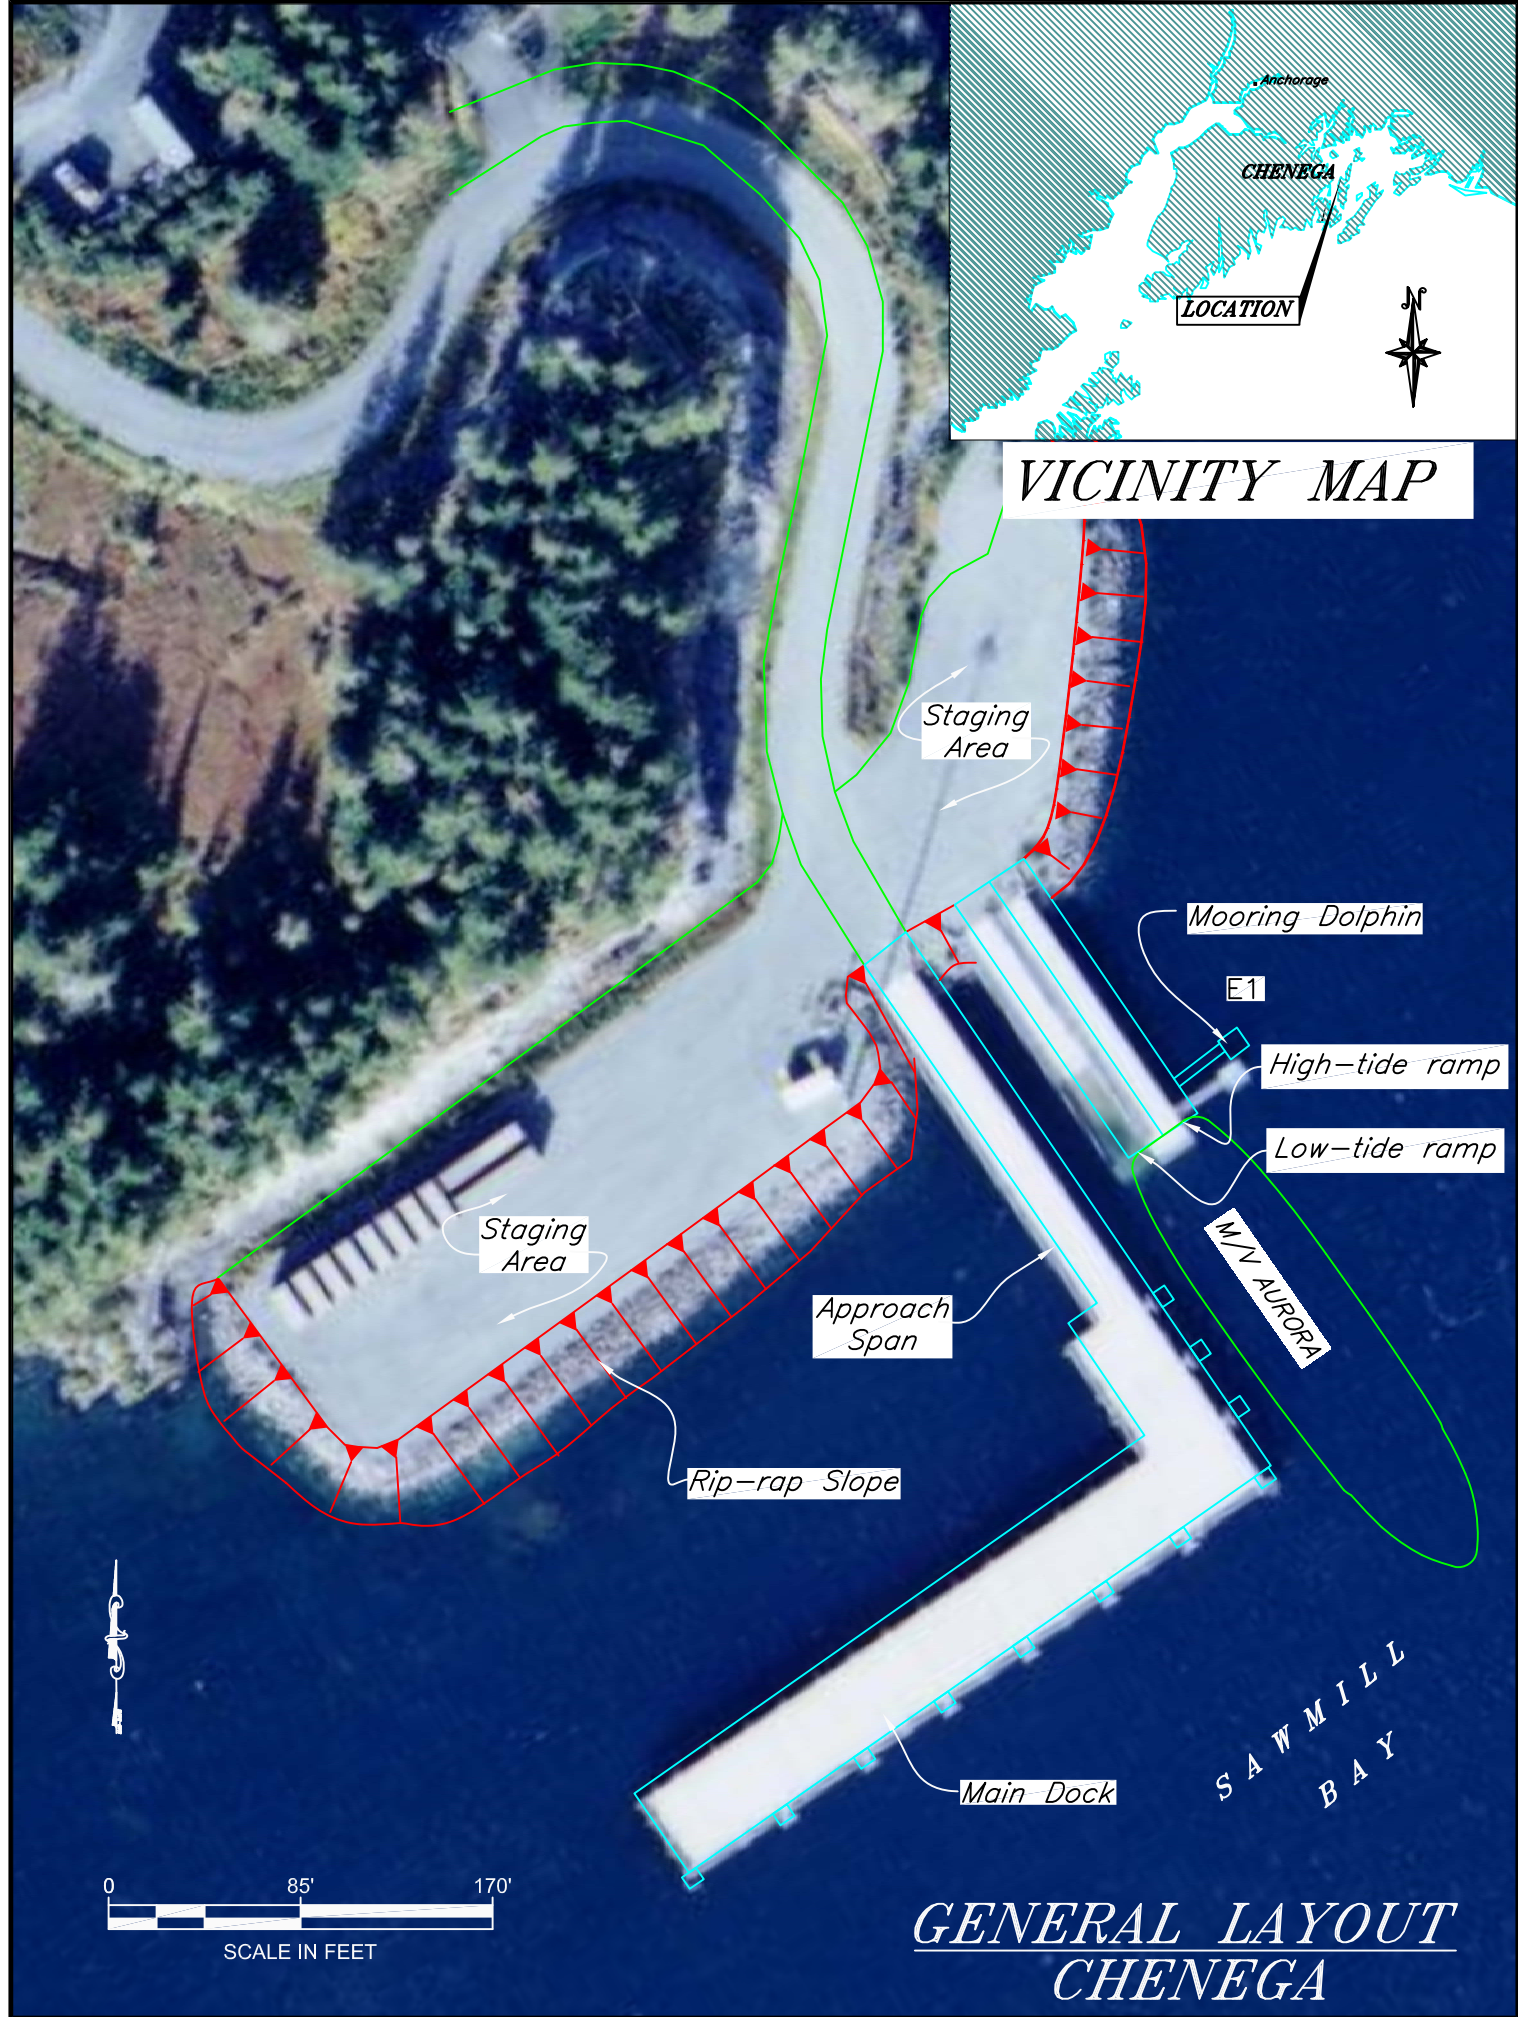
*GENERAL LAYOUT  
CHENEQA*

**Terminal Description:** The Chenega dock and tidal ramps were originally constructed in 1995 to provide a terminal for the BARTLETT. The State of Alaska transferred ownership to the North Pacific Rim Housing Authority (NPRHA) in October, 1998. The Chenega facility consists of an approach, dock and two tidal ramps constructed of prestressed concrete panels welded to bridge beams supported by steel pipe piles socketed to the underlying bedrock. The M/V Tustumena has used the east face of this dock for moorage, while the M/V AURORA uses the tidal ramps located along the north face of the dock for stern loading. The past 10 years of total passenger and vehicle traffic at Chenega is shown below.
