***GENERAL LAYOUT
SELDOVIA***

Seldovia City Dock

Terminal Description: Seldovia City Dock is a multi-purpose dock owned and operated by the City of Seldovia. The City & AMHS have an agreement for docking use. The dock is supported on steel pipe piling and has a steel and concrete superstructure with a steel wale, timber faced fender system. Vehicle access is via Dock Street and across a steel approach structure. There is a designated AMHS vehicle staging area (on City owned property), but no terminal building or other upland ferry terminal related facilities. This staging area does not appear to be utilized by ferry traffic. The dock and approach area has a fueling station, fuel storage facilities and serves as a freight wharf. The past 10 years of total passenger and vehicle traffic at Seldovia is shown below. The M/V Tustumena was out of service most of 2013, causing a steep dropoff in traffic at the terminal. The global pandemic caused the decline in 2020.

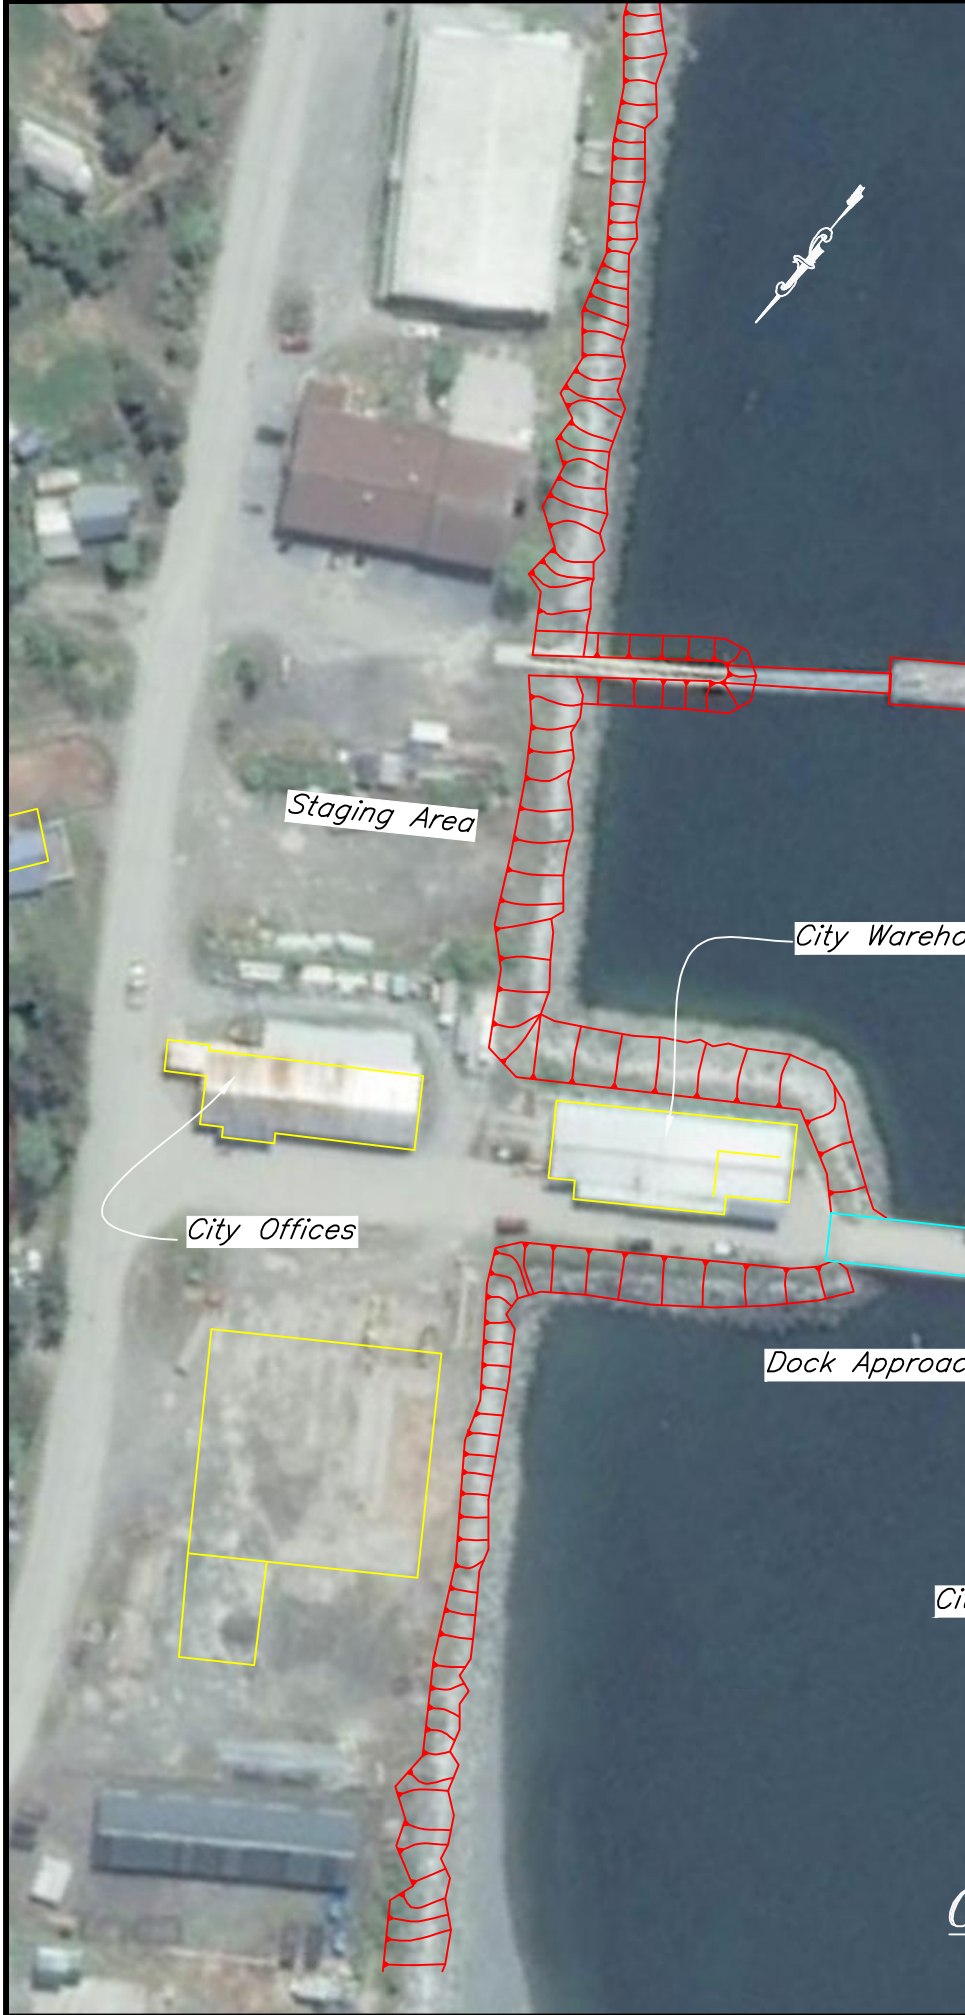
Staging Area

City Warehouse

Fuel Building

Float

City Offices

Dock Approach

City Dock
