RE: FIRE TRAINING PIT CAP INSTITUTIONAL CONTROLS REV1, FAIRBANKS
INTERNATIONAL AIRPORT, FAIRBANKS, ALASKA

Shannon & Wilson, Inc. is pleased to submit this Fairbanks International Airport (FAI) Fire Training Pit (FTP) Cap Institutional Controls letter as an addendum to the *Fairbanks International Airport Fire Training Pit Corrective Action Work Plan REV02 (Work Plan)*, submitted on September 12, 2019. The revised Work Plan was conditionally approved by your letter dated September 24, 2019. This addendum is intended to add context to and expand upon Section 4.5.6, FTP Cap Institutional Controls, of our Work Plan. The FAI FTP is an active, Department of Environmental Conservation (DEC) listed contaminated site (File Number 100.38.070, Hazard ID 1071). This document has been revised in response to DEC comments, and supersedes the version submitted on February 21, 2020. A response to comments matrix is enclosed.

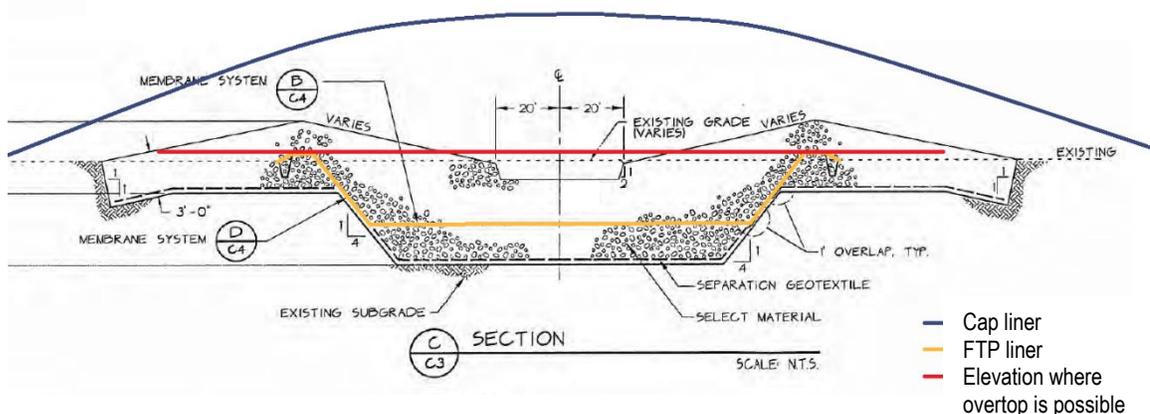
Exhibit 1: FTP Schematic

Exhibit 1 presents a generalized cross-section of the FTP, showing the newly installed cap liner (blue line) with respect to the existing FTP liner (orange line). During the corrective action effort, Shannon & Wilson's contractor uncovered the existing FTP liner at several depths within the compacted soil berms prior to beginning cap construction. The lowest FTP liner elevation within the berms was 430.7 feet above sea level and is considered a

conservative estimate of where groundwater could potentially overtop the FTP liner. This elevation is shown using a red line in Exhibits 1, 2 and 4.

Note: Schematic is exaggerated vertically, not to scale.

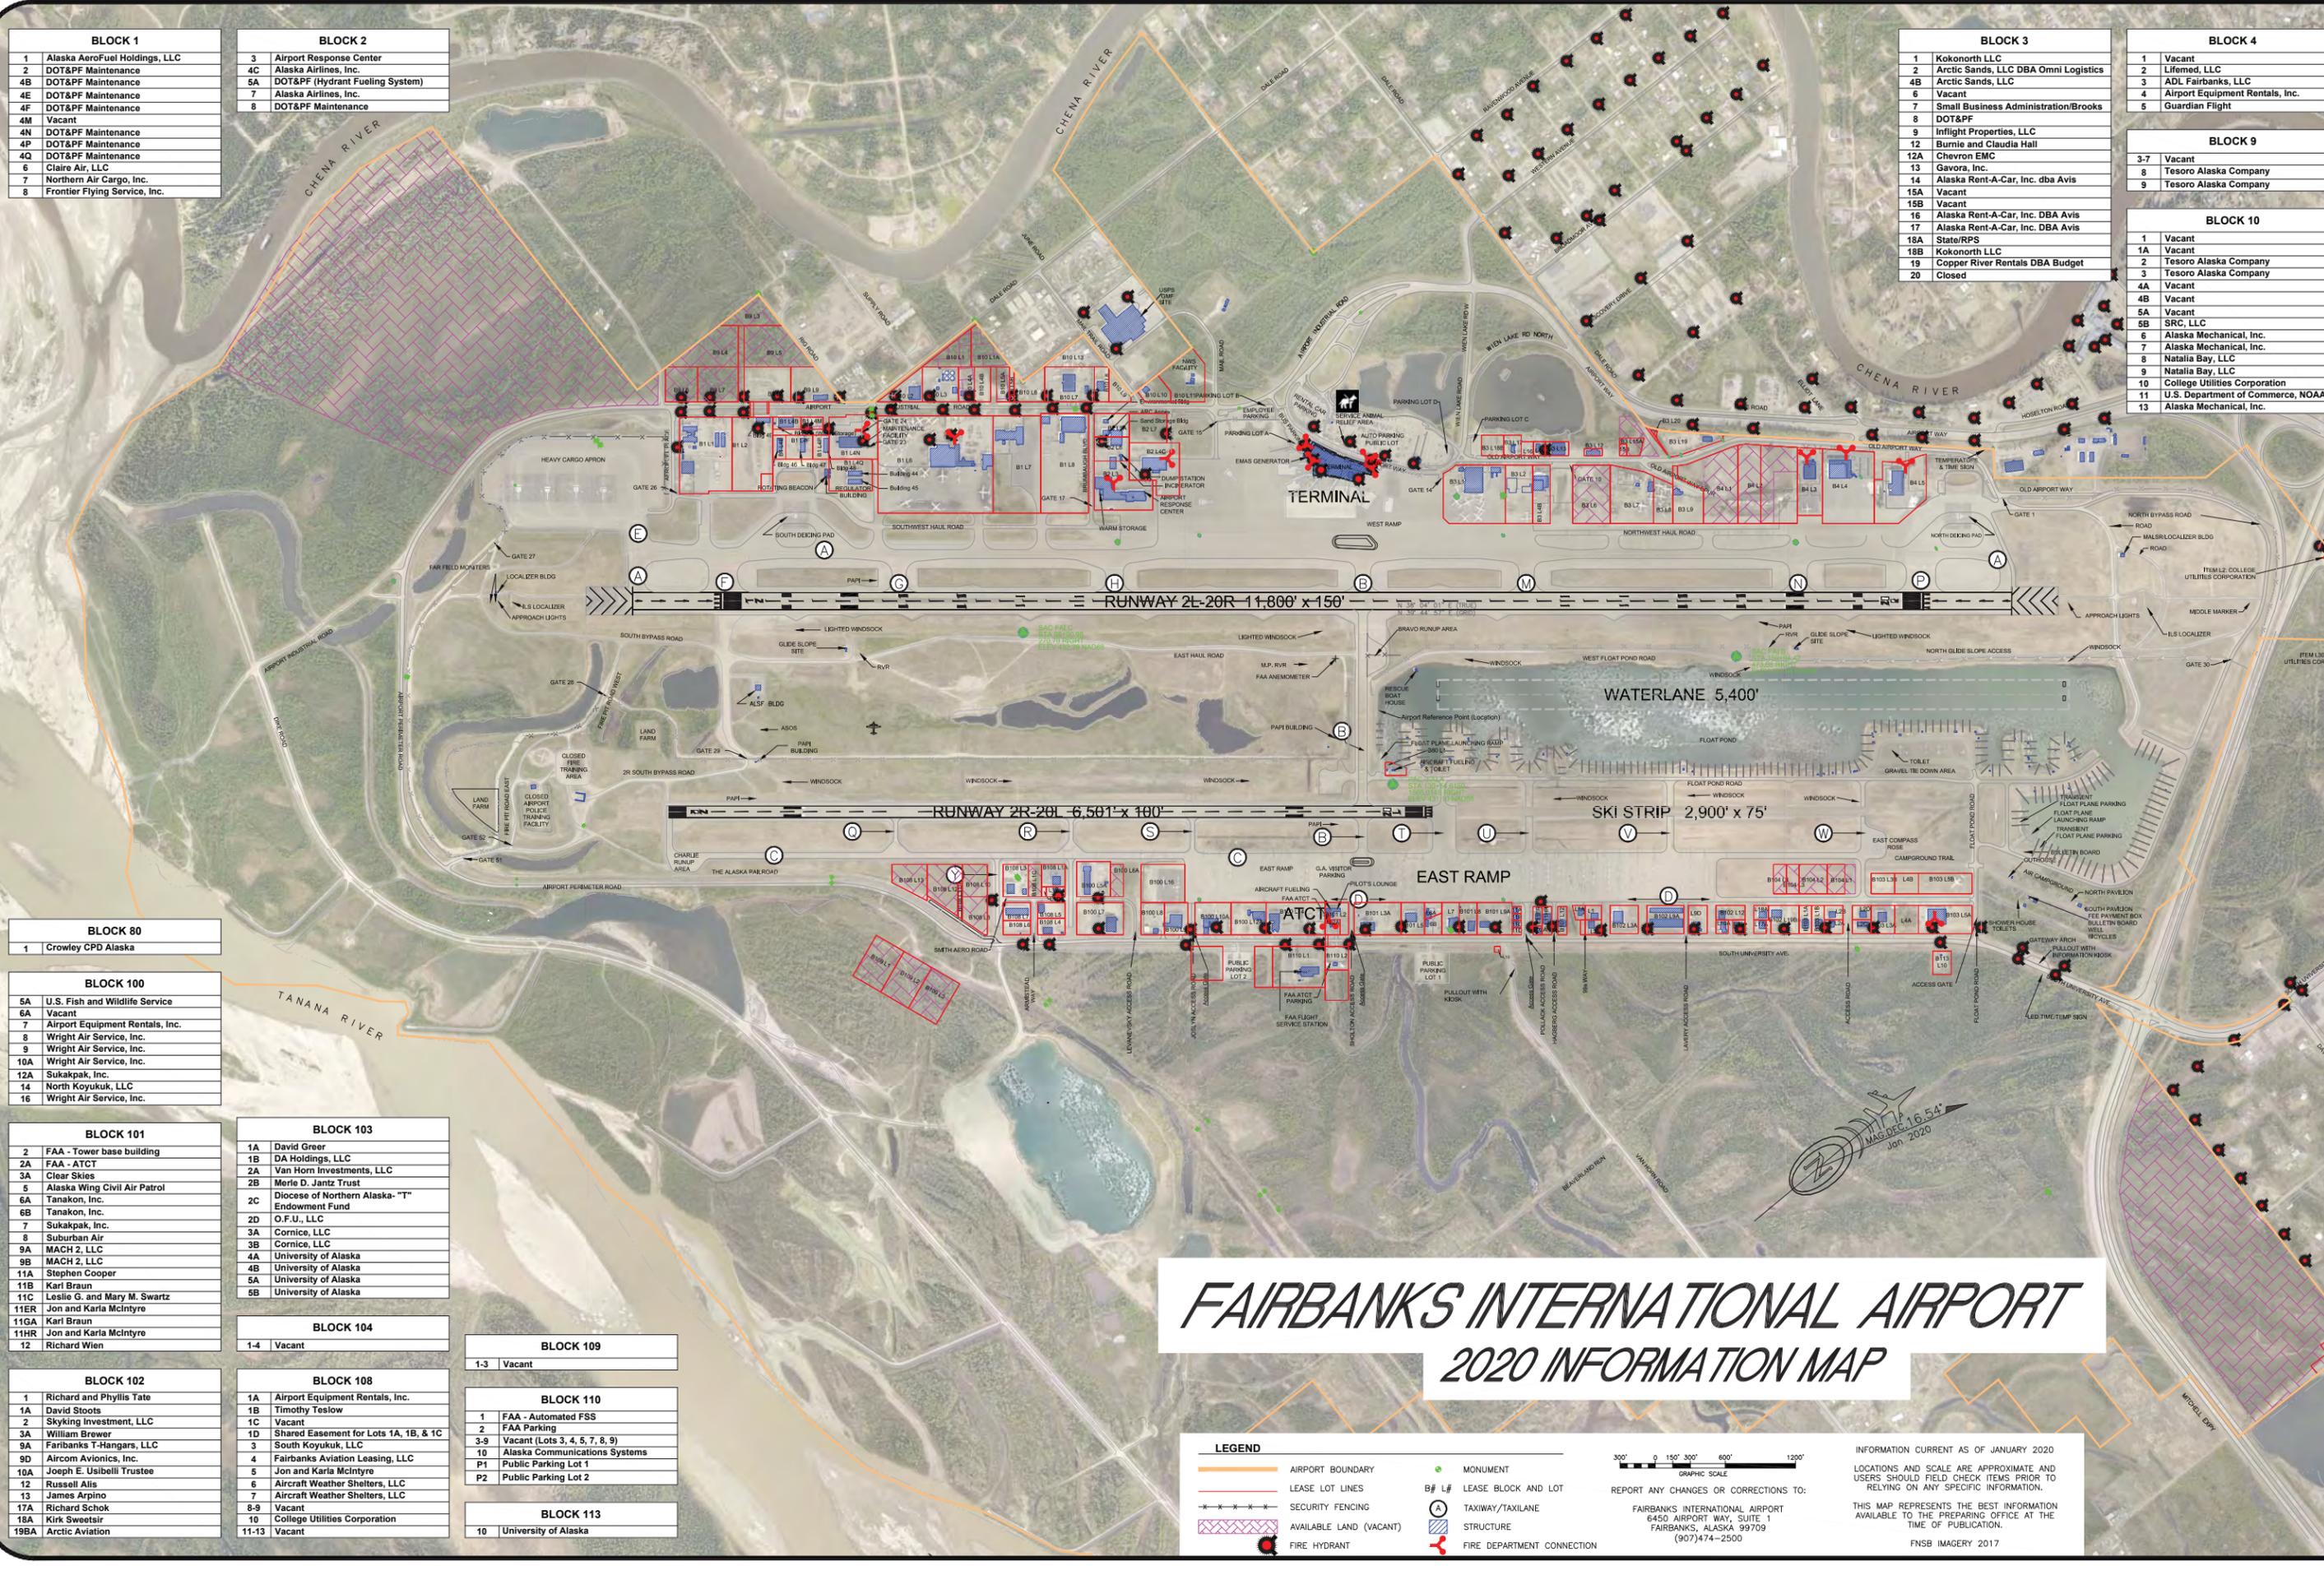
The FAI has noted the former FTP on the internal FAI Information Map to inform FAI staff the area is closed, and to prohibit excavation, drilling, or other soil-disturbing activities within the cap boundaries. The Information Map is maintained by FAI Engineering in

AutoCAD and is universally available in pdf format for reference by FAI staff. A copy of the map is appended.

INFORMATION CURRENT AS OF JANUARY 2020
LOCATIONS AND SCALE ARE APPROXIMATE AND
USERS SHOULD FIELD CHECK ITEMS PRIOR TO
RELYING ON ANY SPECIFIC INFORMATION.
THIS MAP REPRESENTS THE BEST INFORMATION
AVAILABLE TO THE PREPARING OFFICE AT THE
TIME OF PUBLICATION.
FNSB IMAGERY 2017
