FIELD INSPECTION RATING GUIDE FOR EXISTING GUARDRAIL

EXISTING GUARDRAIL FIELD INSPECTION GRADING

GUARDRAIL FIELD
INSPECTION
RATING GUIDE

This guide is for use by DOT&PF Design,
Construction, and/or Maintenance in planning
or prioritizing repair and replacement of
existing guardrail through field observation/
inspection.

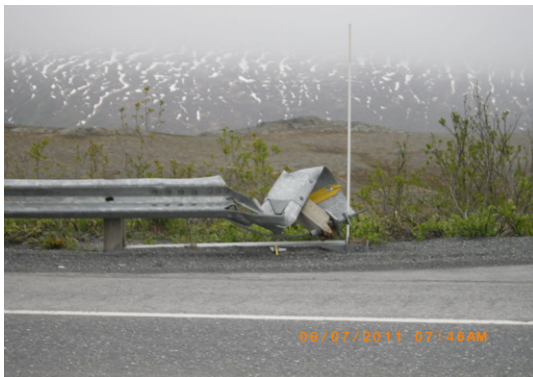
(F) PRIORITY
Replace

GRADE F
Unacceptable

Existing guardrail condition is poor, significantly damaged, or deteriorated towards its end of life.

Guardrail considered unable to absorb another vehicular impact and is a safety concern. A second impact results in unacceptable safety performance including barrier penetration and/or vehicle roll over.

Document unacceptable elements as a priority for consideration of replacement by all projects.

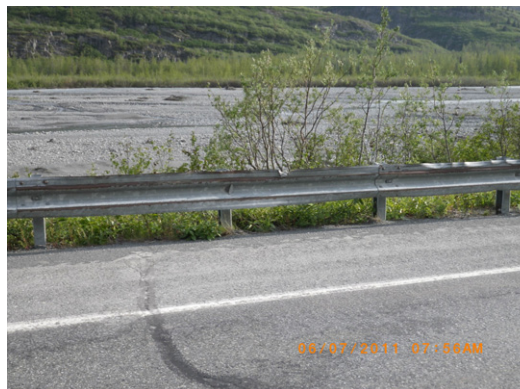
(D) DAMAGED
Repair

GRADE D
Damaged but functional

Existing guardrail condition is fair overall. Meets height standards. Isolated locations of damage, but no moderate or severe damage.

Guardrail considered functional - able to absorb additional vehicle impacts with acceptable safety performance.

Document damaged elements for repair, maintenance, or replacement under rehabilitation projects.

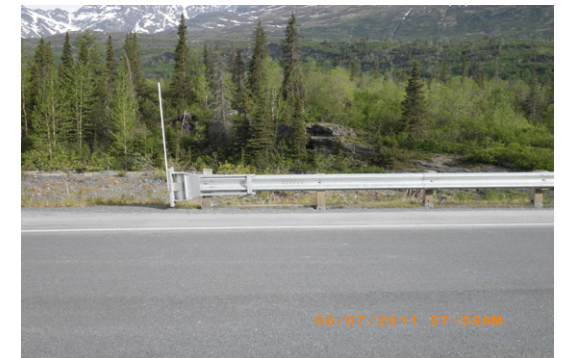
(A) ACCEPTABLE
Remain in place

GRADE A-B-C
New or Acceptable

Existing guardrail shows little or no damage.

Condition is excellent to fair with minimal damage. Posts and rail appear to be in good working condition.

Documented inventory or field inspection ratings are not required. No repairs identified.

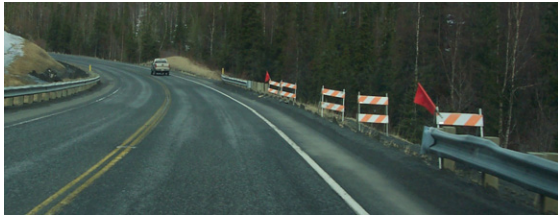
F-MISS-RAIL

Missing Guardrail

- Replace as soon as crews are available
- Consider temporary barrier, crash cushions for extended periods (> 10 days during Construction)

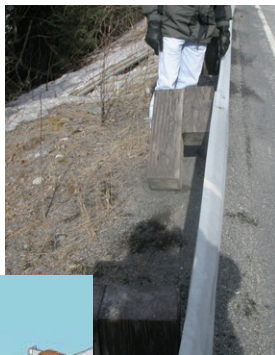
F- MISS-POST

Missing / Broken Posts

- 1 or more posts missing, cracked across the grain, broken, rotted or with metal tears, disconnected from ground level.
- Includes end posts on guardrail terminals

*Exception:
Std Plan G-29
with 3 CRT
posts each side

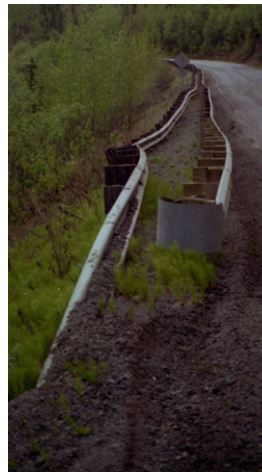
F-HGT Existing Guardrail Height (in-service):

Too low or Too high

Over a 25' length of guardrail (between any 4 standard posts) top pavement to top rail:

Top of W-Beam guardrail less than 26 - 1/2" when spliced at post only (2017 and earlier installations.)

* Top of W-Beam or W31 rail higher than 32"

* 28" required after raising pavement 29" (+3", -1")

(2011 AASHTO RDG pg. 5-17, Std Plan G-04)

* Top of W31 guardrail less than 30" when spliced between posts. (2018 and later installations)

(Std Plan G-05)

*Height required when changing pavement elevation

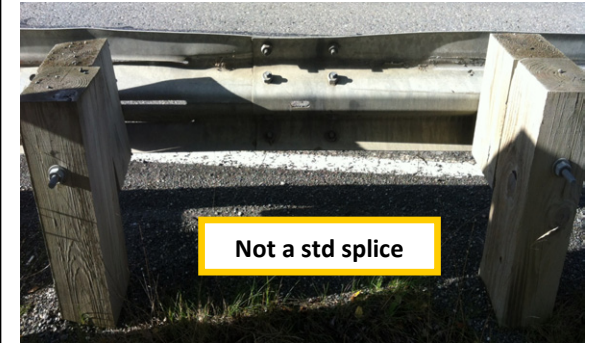
F-IMPR-SPLC

Improper Splice

- Splice not consistently located at posts for older 29" guardrail. (≤29" Height)
- Allowed at 3' midspan only for 31" guardrail per Std Plan G-05 as of 2018 forward, Not < 3' off adjacent post

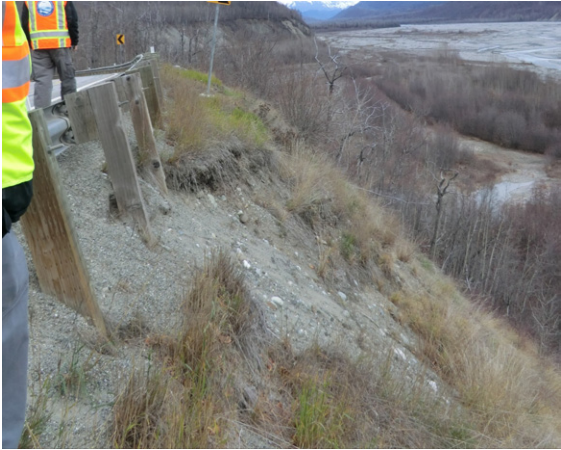
F-EMBD

Loss of post
embedment

More than one post too
exposed due to erosion
(6'-7' of post exposed)
See Std Plan G-10

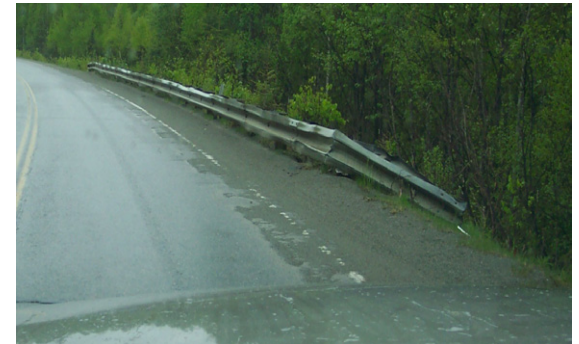
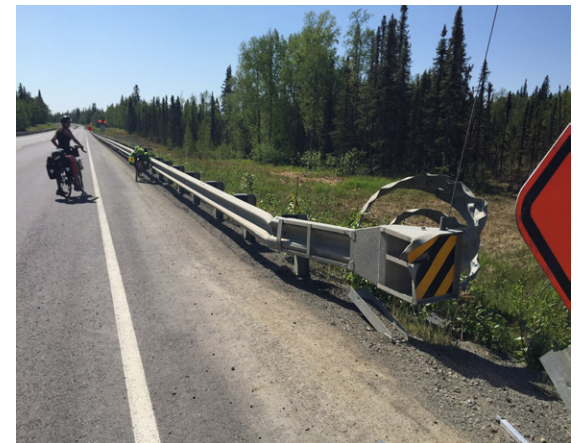
FT-HIT-TERM

“Activated” or Kinked Energy
Absorbing Terminal
or Crash Cushion

Impacted terminal no longer functional.

Repair or replace during routine maintenance and
during work zone activity.

More than one post sheared or cracked.

Damage to foundations that disallows repair.

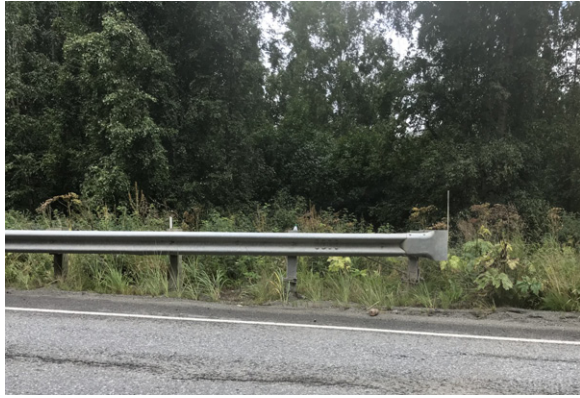
FT-HGHT

Over length of terminal (37.5' to 50')

Terminal Height too low or too high:

Top of NCHRP 350 or BCT terminal is less than 26 - 1/2" or > 30"

Top of MASH terminal is < 30" or higher than 32"

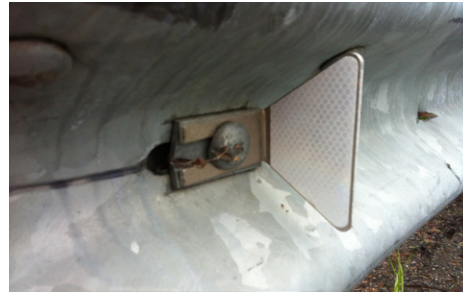
FT-REFL

No web reflectors within 50' end terminal.
Post top reflectors OK

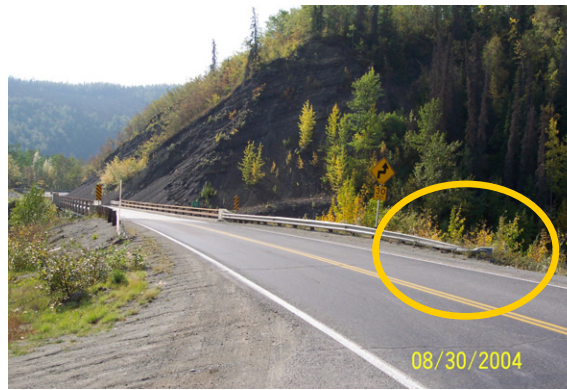
FT-TX-TWST

"Texas Twist"

"Texas twist" is a turned down guardrail end bolted to ground level

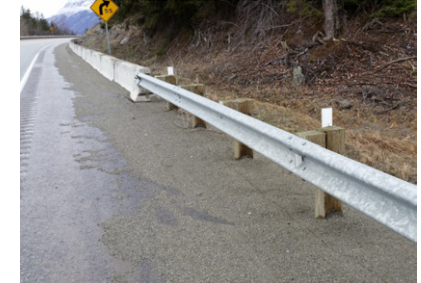
FT-NO-TRANS

No stiffened transition

Guardrail transition not stiffened with increasing post density prior to rigid guardrail barrier/wall/ bridge connection

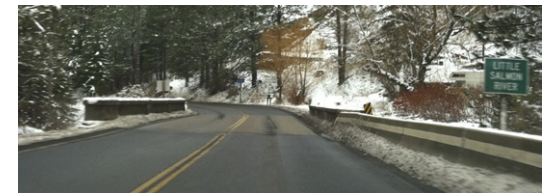
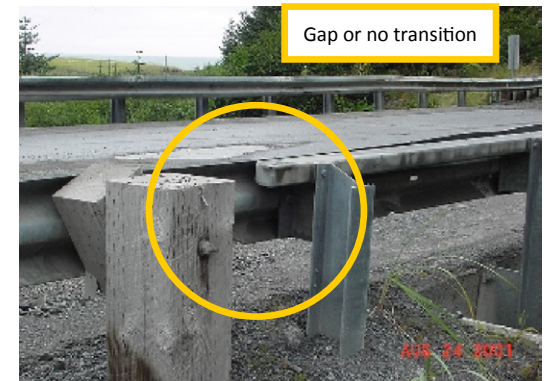
FT-NO-BRIDG

No bridge connection

Guardrail transition not attached to bridge guardrail with a transition piece – there may be a gap between w-beam rail and bridge rail, with no connection.

May be older bridges – preexisting designs at the time.
New standards may require opposing direction treatment.

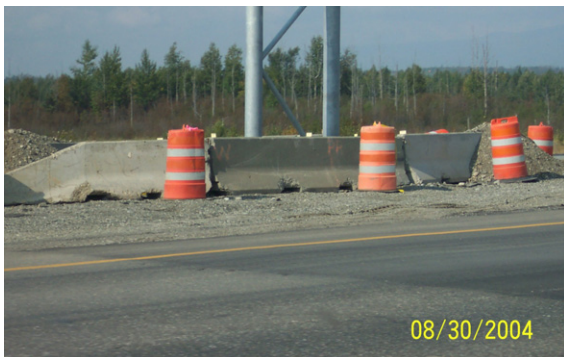
FT-SLPD-END

Sloped concrete ends at 35 MPH+

Do not use for speeds of 35 MPH or higher within the clear zone

Only for temporary or low speed use of 30 MPH or less. (2011 AASHTO RDG 9.2.2)

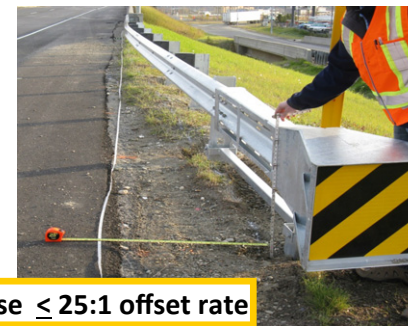
FT-TERM-OFFST

End Terminal offset too far

See G-20

2' offset maximum (almost 3' shown) For a 50' terminal.

Use $\leq 25:1$ offset rate

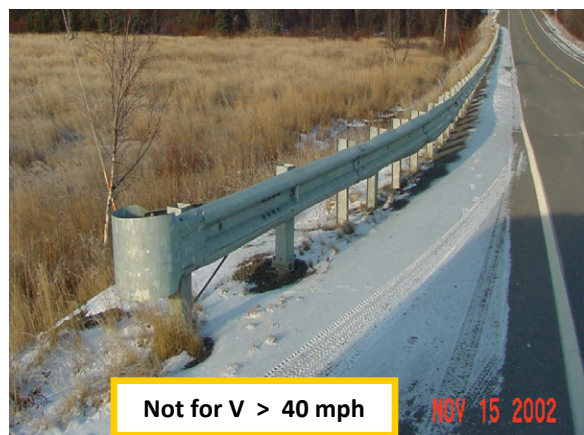
FT-BCT

BCT Terminals

See Regional End Terminal Replacement Guide for replacement of Breakaway Cable Terminals (BCT's), MASH requirements.

BCT's are not acceptable on 45 MPH or greater roadways or NHS (National Highway System) Routes

BCT's have no extruding head, no horizontal guardrail and no ground strut slotted

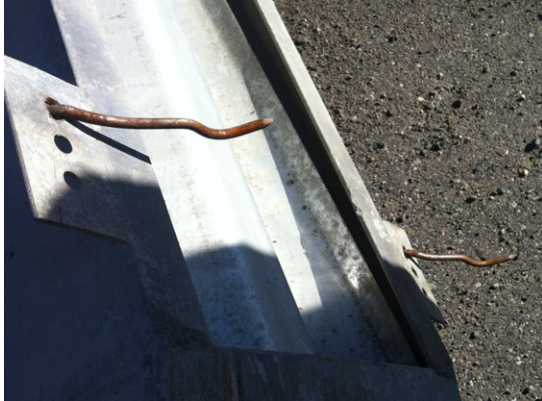
FT-LAG

Lag Screws

Missing or failed lag screws in wood post, extruding terminals Non-galvanized bolting of terminal leads to rusting, poor fit. Improper use of nails. Use manufacturer required connections.

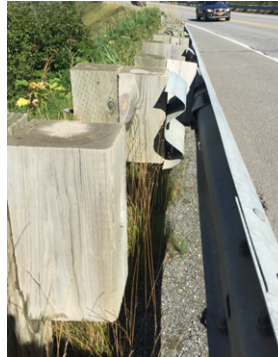
D-POST-SEP

Posts separated from rail

- 2 or more posts with block out attached with a post/rail separation less than 3".
- 1 or more posts with a post/rail separation which exceeds 3".

- If the block out is not firmly attached to the post, use the missing blockout guidelines.
- Damage should also be evaluated against post/rail deflection guidelines.

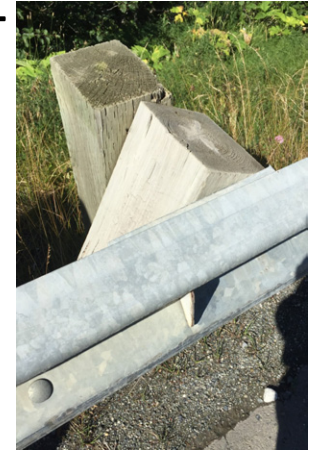
D-TWST-BLKT

Twisted blockouts

Note: Repairs of twisted blockout are relatively quick and inexpensive

(Missing galvanized 8d toe-nails may be the cause of rotation in the case of wood posts and wood blockouts)

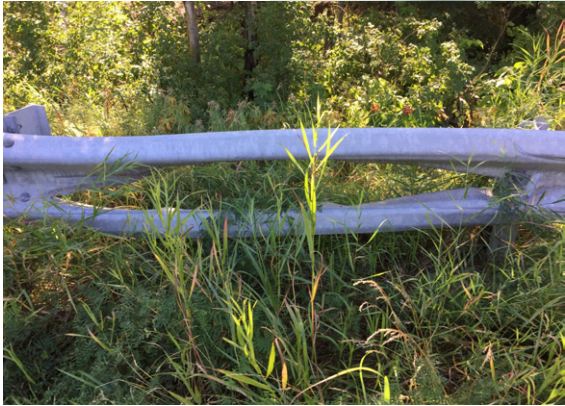
D-HORIZ-TEAR

Horizontal Tear

Horizontal (longitudinal) tears greater than 12" long or greater than 0.5" wide

Note: for horizontal tears less than 12" in length or less than 0.5" in height, use the non manufactured holes guidelines

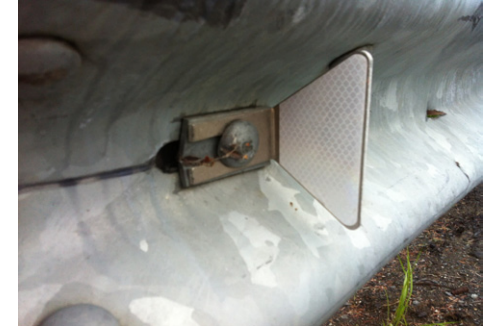
Web reflectors location poor

- No longer installed on posts.
- For guardrail repair or replacement, only install between posts,
- Post –top reflectors ok, on top of steel bridge posts as well.

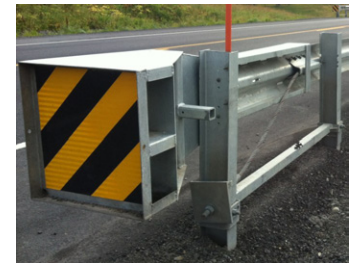
DT-STRUT

Stub Height or "Floating Strut"

Undercarriage snagging concern

Bottom of strut should be flush with ground or pavement.

Problem when steel soil sleeve tubes, post base stubs have steel height which exceeds 4" up from ground level.

"Floating Strut" crossbar between 1st and 2nd posts, should be ≤4" from top of strut to adjacent gravel or paved road surface (not used on BCT's.)

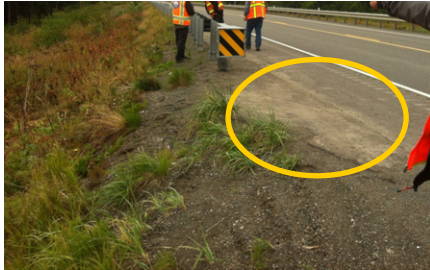
DT-FLARE

Parallel
Terminal
Widening

Improper flare pad or approach
cross slope (proper flare shown).

See Std
Plan G-20

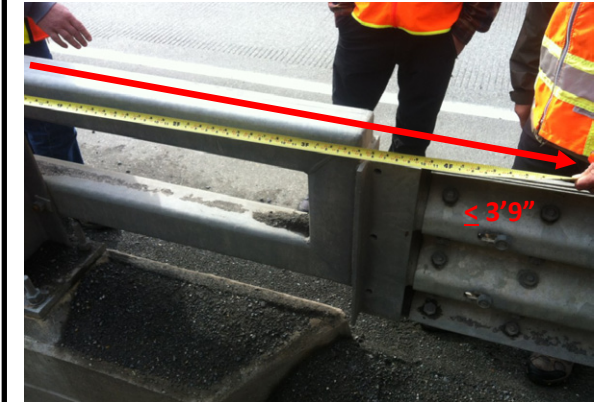
DT-BRDGEGAP

Poor bridge connection

3'9" maximum between last bridge guardrail
post and thrie beam transition post.

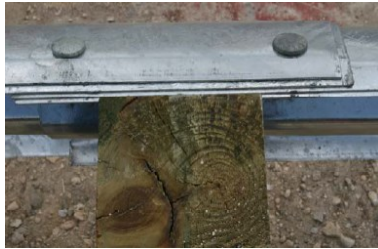
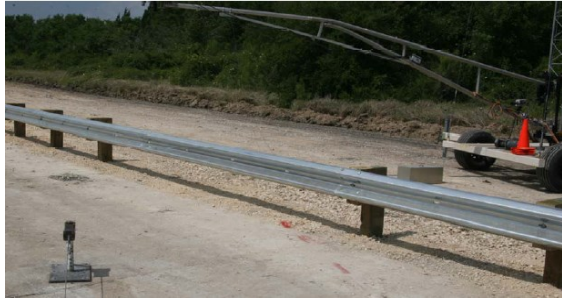
(350)

(2018 and prior)

Was Std Plan G-28

25' max span

≤ 3 posts for 27
3/4" w-beam,
with splice on
posts

Nested guardrail

2 wood blockouts
per CRT Post

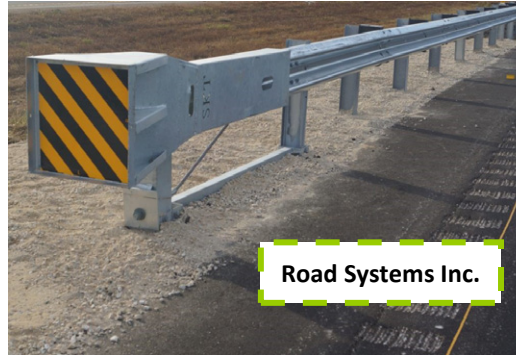
MSKT

(MASH-16)

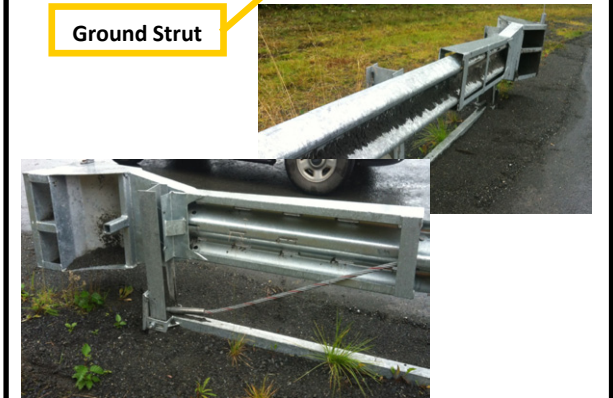
SKT

Slotted Rail

Extruding head
Cable anchor
Ground strut –
BETWEEN posts 1 and 2
Object marker panel flush
with extruding head
“2 square” front of head
Square handle backside

3/4" bolt at hinged post #2 on
downstream side of the post

5/8" bolt at hinged post #1 on
upstream side of the post

Ground Strut

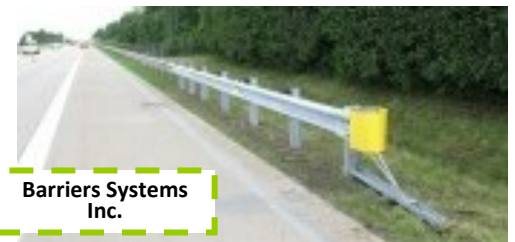
X-TENSION

(350)

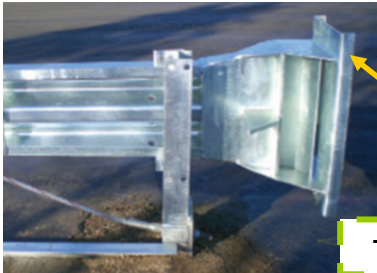
ET-PLUS

(350)

Extruding head
Cable anchor
Ground strut BEHIND
posts 1 and 2.
Object marker panel
taller than extruding
head.
"1 square" front of head
Triangular handle backside

Angle Strut

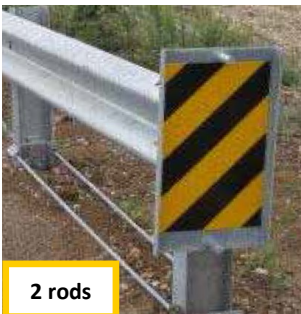
Sliding panels
Slider assembly post 3
Cable anchor posts 2-3
Ground strut rods – 2
sided
Painted shear bolts to
blackouts
No steel soil sleeve tubes

2 rods

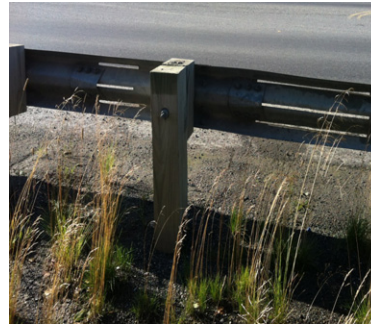
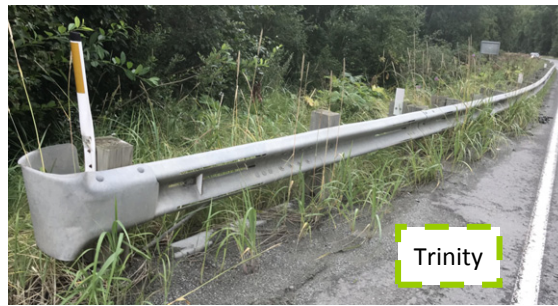
(Slotted Guardrail Terminal) (350)

Cable Anchor
Slotted guardrail
Ground Strut
Looks like BCT
But with slots,
ground strut

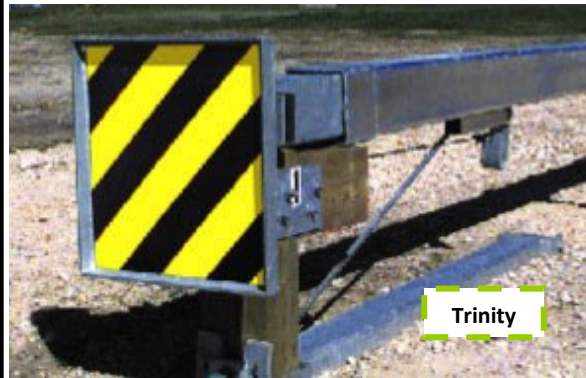
WY-BET

(Box beam)

(350)

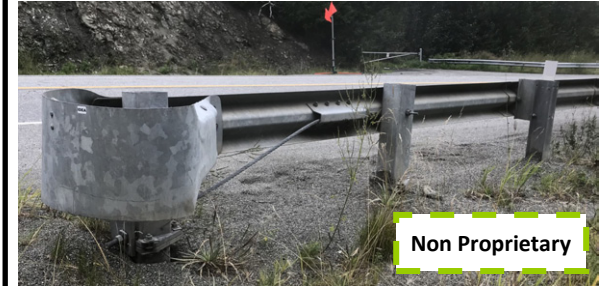
(Breakaway cable terminal)

Cable anchor
No ground
strut
No object
marker panel

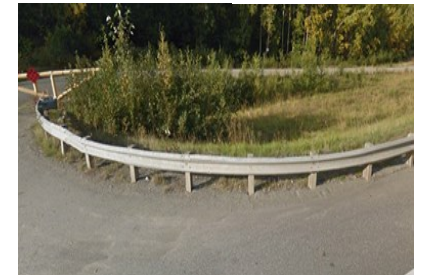
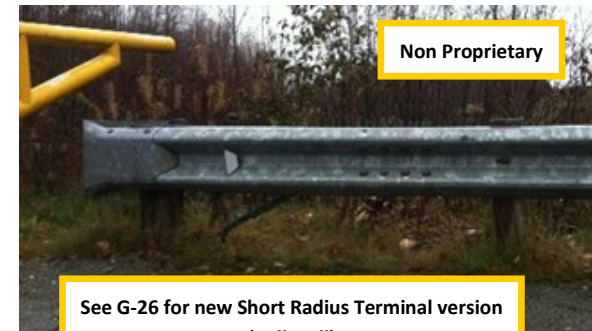
Not for V > 40 mph or main highways

CRT (existing) Was Std Plan G-25

Features:
Cable anchor
No strut
Round pipe
can on end
post
Wood
breakaway
posts in
radius.
22" TYP HT

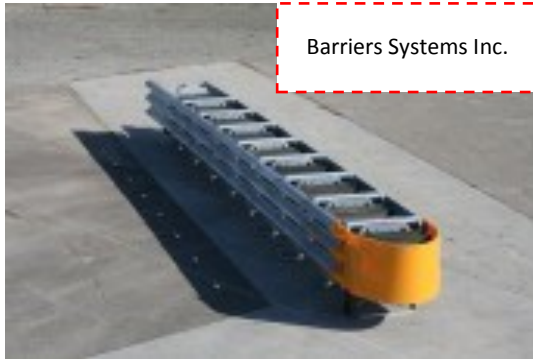
TAU II - R

(350)

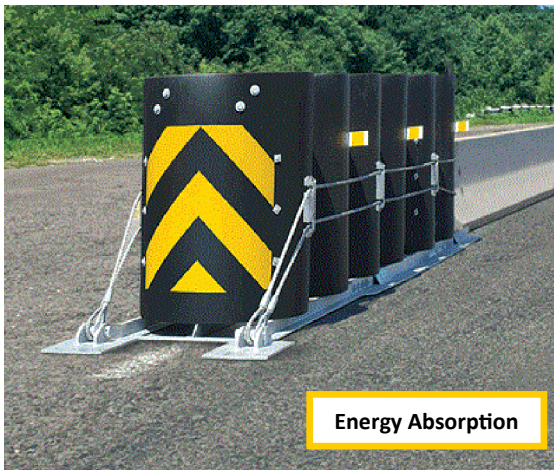
REACT

(350)

Energy Absorption

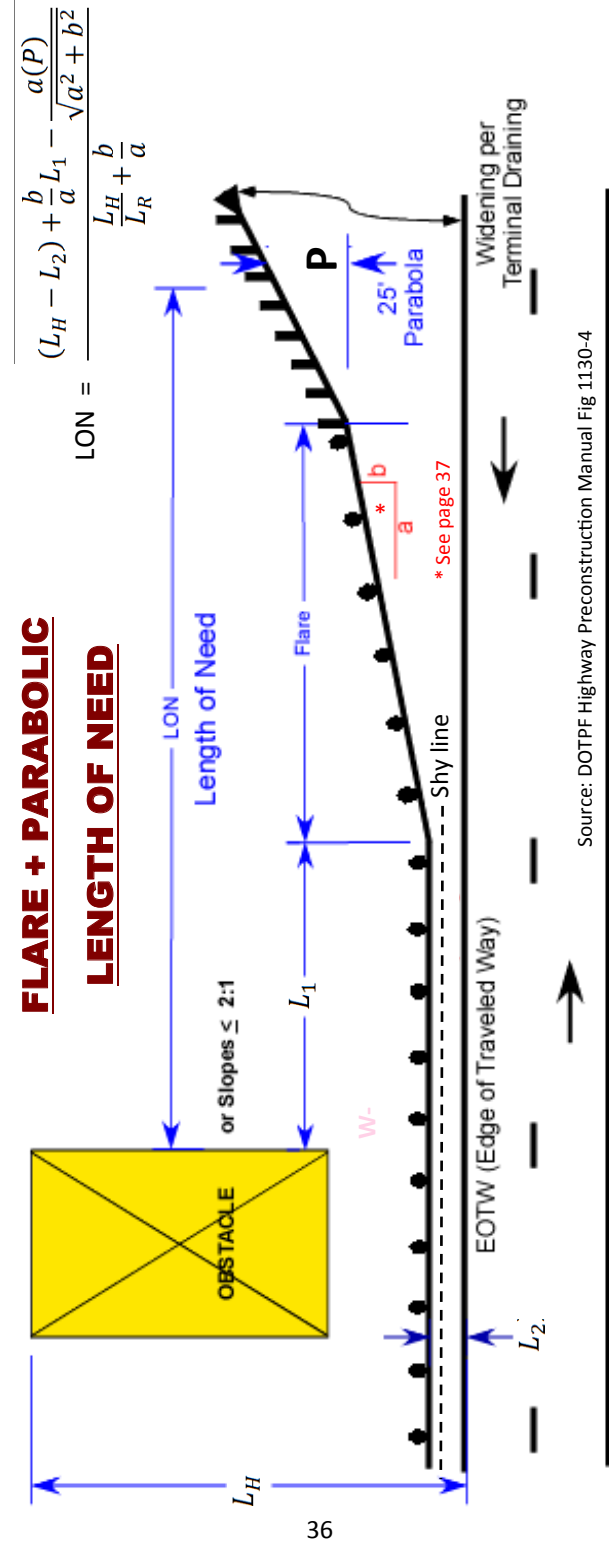
FLARE + PARABOLIC

LENGTH OF NEED
