Alaska Department of Transportation and Public Facilities Central Region

NHS STORM DRAIN INSPECTION REPAIR RECOMMENDATIONS PROJECT NO. 0A31055 / Z591280000

Dimond Boulevard from Jewel Lake Road to Old Seward Highway
Muldoon Road from Boundary Avenue to Northern Lights Boulevard
Debarr Road from Bragaw Street to Muldoon Road
Downtown: 5th and 6th Avenue from Gambell Street to Orca Street and
Ingra Street from 6th Avenue to 9th Avenue

May 20th, 2019

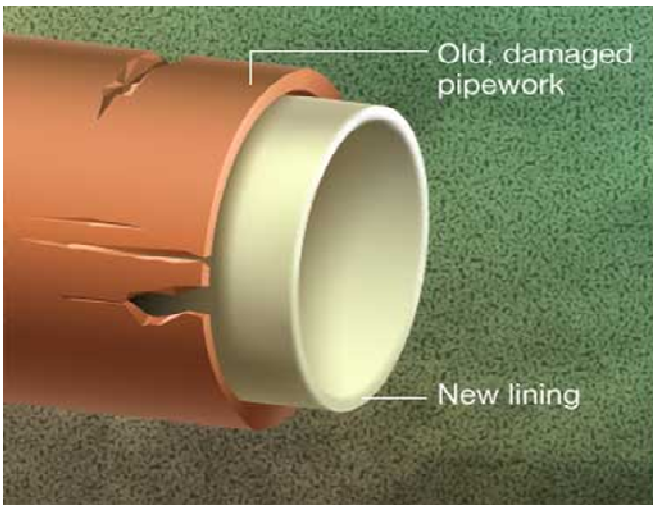
Cured in Place Liner

The CIPP process uses a flexible nonwoven or woven material liner and thermosetting epoxy resin to form a durable pipe within the old pipe. The liner is inserted through an existing manhole and may be inverted or winched into place. The resin impregnated lining is cured by circulating hot water, or with ultraviolet light. The CIPP lining will fit tightly against the host pipe, will follow the invert grade of the existing pipe and will conform to irregularities in the host pipe wall. The process is often accomplished in a 24-hour period for a typical segment from one manhole to the next.

The cured in place lining method is an economical and feasible trenchless solution for upgrading storm drain pipes. The benefits of CIPP include minimal impact to pipe capacity, installation without excavation, and competitive costs. It is a proven technology. In Alaska, there are contractors and equipment available locally to complete this work. A CIPP liner is estimated to have a minimum 50-year life. It was developed in 1974 and is the most popular pipe rehabilitation method in use in the world today. Hundreds of miles of CIPP liner are installed each year.

On this project, a CIPP liner would be designed for either the “partially deteriorated” or “fully deteriorated” condition. In most cases, the wall thickness of a new liner is thicker (and more expensive) for the fully deteriorated design condition. When designed for the fully deteriorated condition, a CIPP liner has the structural capacity to replace the deteriorated host pipe that is around it. The engineers who are responsible for the pipe rehabilitation design would decide which condition is applicable. In most cases the fully deteriorated condition is applied when metal host pipes are corroded or have metal loss occurring in the invert.

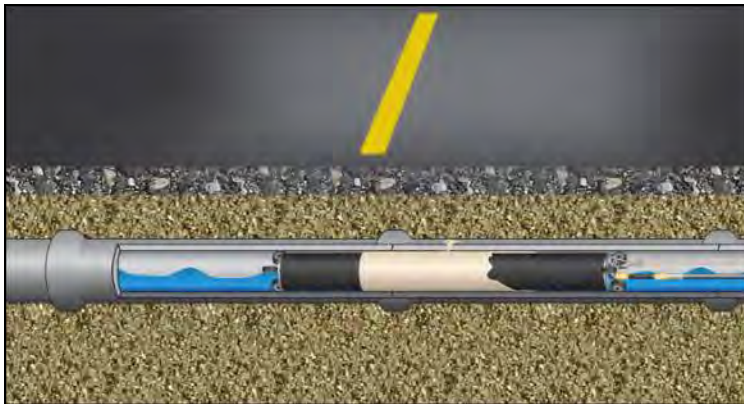
Trenchless point repair (courtesy of Pipe Patch).

A trenchless point repair is described as a short section of CIPP liner that is installed inside of a host pipe to repair a single defect. No digging is required; the work can be accomplished from the manholes. The repair consists of a resin impregnated fabric tube (usually 2 feet to 8 feet long) that is positioned over the defective area and pressed against the host pipe with an inflatable bladder and then cured until hard. Some systems use hot water to cure the resin. Most trenchless point repair systems cure in ambient temperatures. Trenchless point repairs are very beneficial for repairing a single defect in a host pipe that is in overall good condition.
