Engineer Design Report

Brevig Mission Airport Lighting and Resurfacing

Project No. NFAPT00500

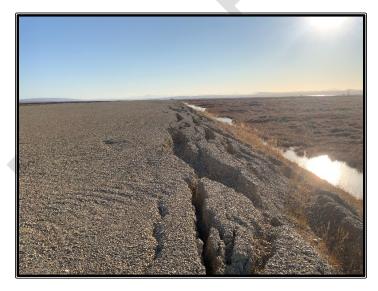
Figure 1: RW 11-29 RSA degradation present during October 14, 2020 Site Visit (View southeast)

Periodic regrading over the years has redistributed the runway, taxiway, apron, and access road surface course causing depressions and loss of surfacing material. Significant erosion and toe rotation are also present at the embankment shoulders reducing the safety area below the required dimensions (See **Figure 1**). This erosion has encroached on the threshold markers and lighting and is beginning to impact the runway lighting. The associated damage is primarily caused by thaw induced differential settlement of ice-rich subgrades underlying the airport embankments. The airfield lighting system has also outlived its useful life and requires rehabilitation and replacement.

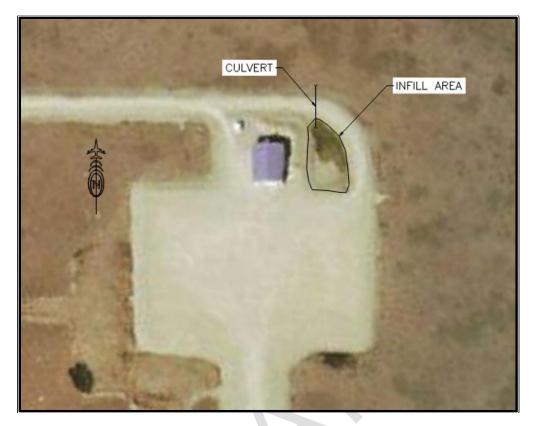
Figure 6: Infield Area Plan View

There is a single existing culvert located on the airport access road at approximate station 1124+00, adjacent to the SREB building pad see **Figure 6**. This culvert was installed in 1997 to convey drainage from the infield area across the access road. The culvert inlet and outlet were both underwater during the June 9, 2021 site visit (see **Figure 7** and **Figure 8**). This project will fill the infield area, crush the culvert ends, and abandon the structure in place.

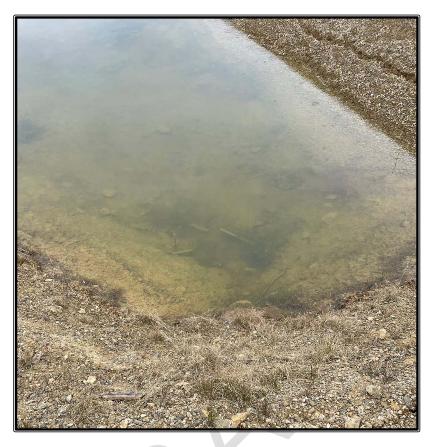
Figure 7: Infield Access Road Area – Culvert Inlet

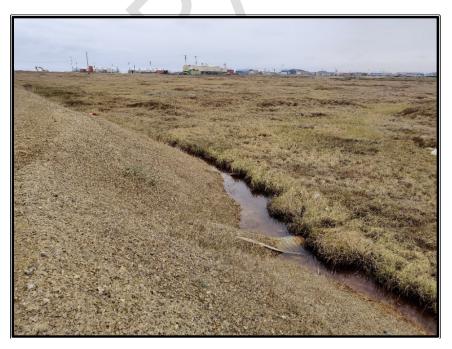
Figure 8: Infield Access Road - Culvert Outlet

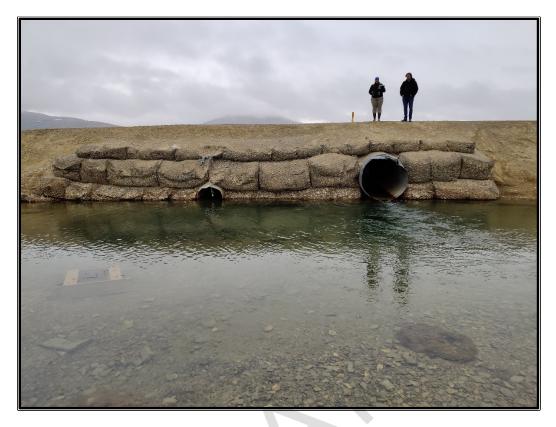
Figure 10: Shelman Creek Crossing – Clarence Road

Potential impacts to existing drainage structures along haul route were examined. The proposed haul route is approximately 1.5-miles as shown in **Figure 9**. Existing structures along the haul route include five culverts along Clarence Road and two culverts on New Haul Road. The Clarence Road culverts consist of three 24" corrugated metal pipes (CMP) cross culverts. Two culverts convey flow across Shelman Creek (60" CMP and 36" CMP). This crossing includes a gabion headwall to support the embankment, see **Figure 10**. At the time of the site visit, the 36" CMP was completely blocked. Improvements to the Haul Route Drainage structures are outside of the scope of this project. However, it is recommended the contractor provides rig mats to support additional truck loading across the culverts during construction.

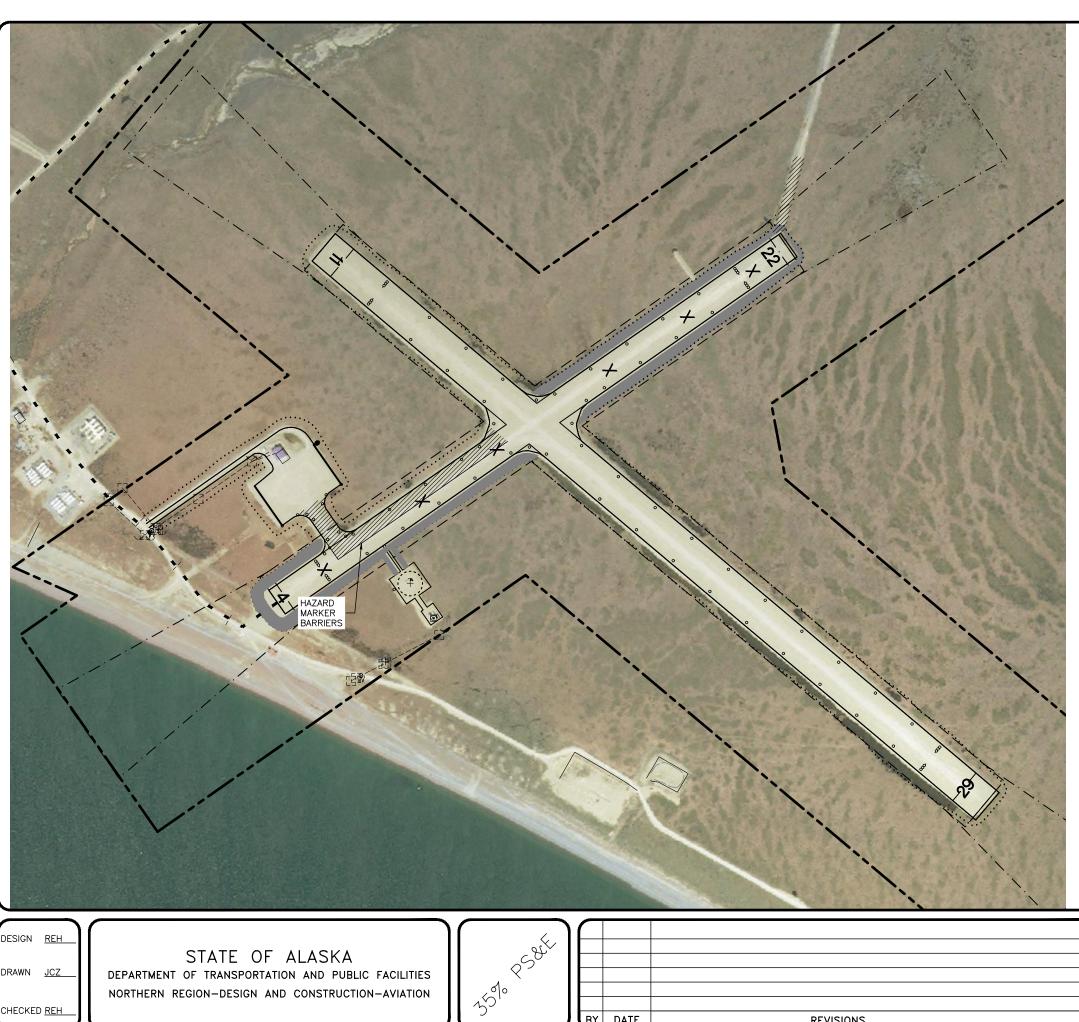
- C. DEMOLITION OF OLD HAUL ROUTE FROM NORTH END OF RW 04-22 2. MAINTAIN A 35' TAXIWAY FROM RW 11-29 TO THE APRON 3. RW 11-29 IS TO REMAIN OPERABLE DURING THIS PHASE

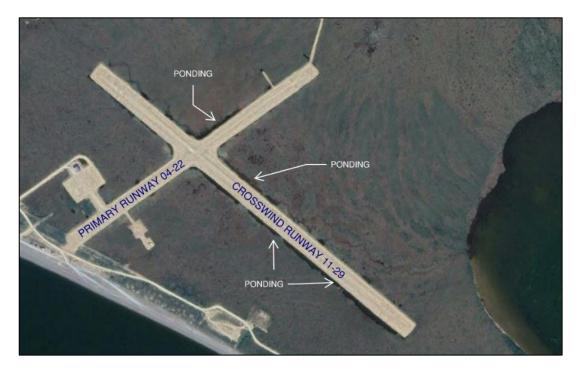
Figure 1-1: Brevig Mission Airport

The airfield consists of two gravel-surfaced, perpendicular runways, a taxiway, an apron, and an access road. The primary runway (RW), designated 04-22, is 75-feet wide and 2,110-feet long. The crosswind runway, RW 11-29, is 100-feet wide and 2990-feet long. Brevig Mission airport is shown in Figure 1-1.
