# GENERAL LAYOUT TENAKEE

# Tenakee Ferry Terminal

**Terminal Description:** The Tenakee Springs city dock was constructed in 1978 to provide passenger and light freight service to Tenakee Springs. The dock facility is a 40' x 52' main dock section with a 12' x 240' approach span to shore and consists of concrete panels supported by steel pipe piles. Three, steel pile mooring dolphins with timber fenders are used by AMHS for port side mooring. By City ordinance, *Transfer of vehicles at Tenakee Springs is limited to motorcycles, all terrain vehicles and other small motorized vehicles under 10'-0" in length and under the maximum weight limit of 1000 pounds.* The City Dock also supports a fuel and freight operations, a small city storage building and a jib crane that is located on the southeast corner of the dock. The AMHS ferry terminal is accessed from the City Dock by a pile supported steel platform structure and steel gangway. This platform structure was widened by ADOT in 2011.

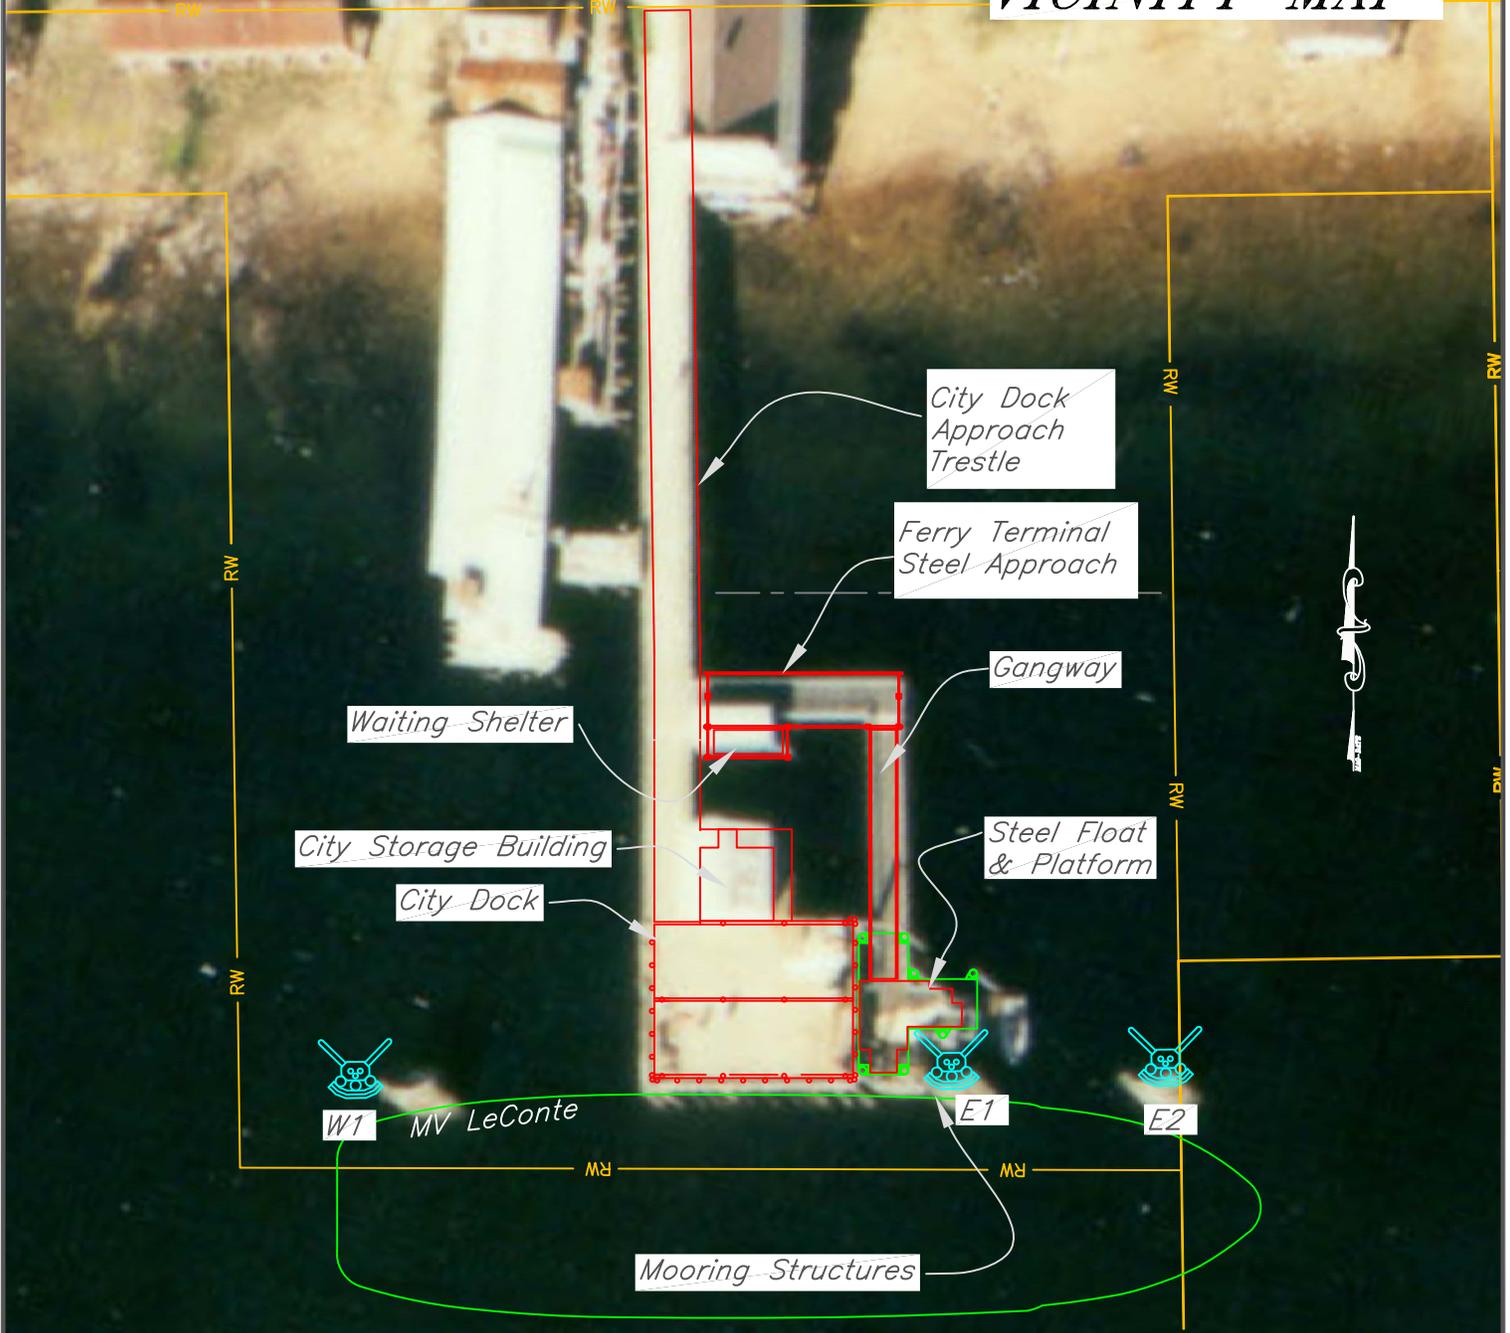
T E N A K E E I N L E T

The passenger transfer facility was built in 1984 to service LeConte class vessels. An open steel grate approach extends to the east, perpendicular to the City Dock. At the end of the approach is a gangway down to a floating platform supported by a custom steel pontoon. A counter weighted, pull-down apron connected to the platform provides access to the ferry side deck. An 8' x 20' waiting shelter was constructed at the juncture of the City Dock and the ferry terminal approach. The past 10 years of total passenger and vehicle traffic at Tenakee is shown below.

City Dock & Approach - #1451	
Type:	40'x 52' concrete panel dock with 12' x 240' approach span
Year Built:	1985
Support:	Vertical & Battered Steel Piles
Steel Coating:	Galvanizing
Fender System:	Timber Pin Piles bolted to steel wale with rubber (donut) energy absorbing units
Anodes:	No
Lighting:	Two lights mounted on fuel shed.
Condition:	Poor
Notes:	
Load Posting Sign:	Single Axle 4 Tons

<b>Platform Pontoon</b>	
Type:	715 s.f. steel barge
Year Built:	1984
Ballasted:	Yes
Ramp lift:	counterweight
Anodes:	Yes
Condition:	Fair

<b>Dolphins</b>							
Dolphins	Dolphin Piles	Fender Support	Fender Face	Anodes	Built	Cond.	Notes
W1	2B, 1V	4H	Sitka Spruce	No	1977	Fair	
E1	2B, 1V	4H	Sitka Spruce	No	1977	Fair	
E2	2B, 1V	4H	Sitka Spruce	No	1977	Fair	
EG	4V	-	-	No	1984	Fair	
ER	7V	-	-	No	1984	Fair

V = Vertical steel pipe piling      B = Battered steel pipe piling      H = Vertical steel h-piling  
ER = East gangway support float restraint piles      EG = East gangway support piles
