GENERAL LAYOUT
HOMER

Homer City Dock

Terminal Description: Homer is a modern U-shaped concrete dock, built around the original timber city dock in 2001. It is owned and maintained by the City of Homer. The facility consists of terminal building and uplands staging area, east and west approach trestles connected to the main dock, two breasting dolphins and one mooring dolphin with one access catwalk. Vehicle and passenger transfer takes place on the city dock. The Coast Guard (USCG) uses the north end of the dock as a berth for their buoy tender. The presence of nearby Homer Harbor traffic has produced docking conflicts in the past. The State provided a portion of construction funding, has priority use and does not pay a docking fee per the MOA with the City.

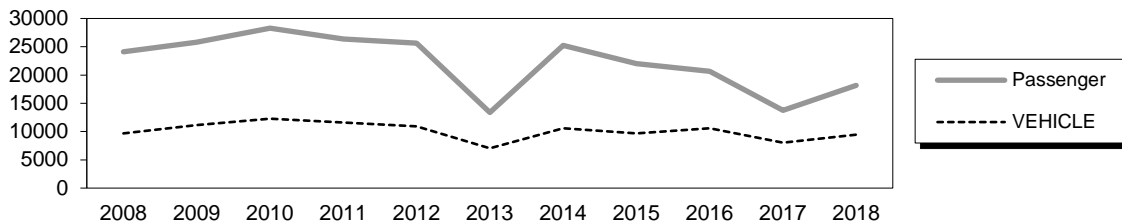
The past 10 years of total passenger and vehicle traffic at Homer is shown below. The M/V Tustumena was out of service most of 2013, causing a steep dropoff in traffic at the terminal.
