GENERAL LAYOUT
TATITLEK 155

Tatitlek Dock

Terminal Description: The Tatitlek facility is a multipurpose dock structure that was originally constructed in 1995 to accommodate the M/V BARTLETT. The Tatitlek facility consists of a staging area, an approach, a dock and two tidal ramps constructed of concrete panels welded supported by steel beams and piles. AMHS has an MOA for use of the dock for ferry operations. Ownership of the facility was transferred to the North Pacific Rim Housing Authority (NPRHA) in 1999.

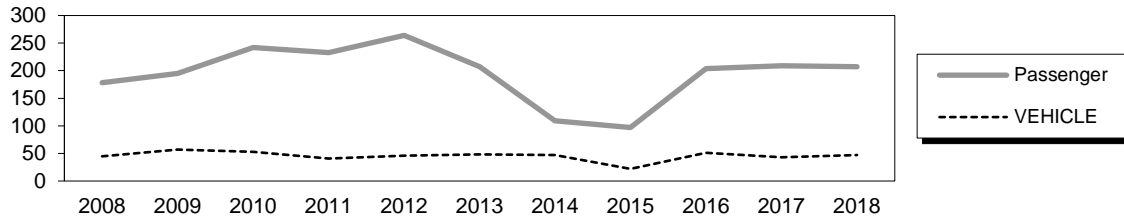
The past 10 years of total passenger and vehicle traffic at Tatitlek is shown below.
