STATE OF ALASKA  
Department of Transportation  
and Public Facilities

2018  
Alaska Marine Highway System  
**SHORE FACILITIES CONDITION  
SURVEY REPORT**

Prepared by  
Southcoast Region  
Marine Engineering Section

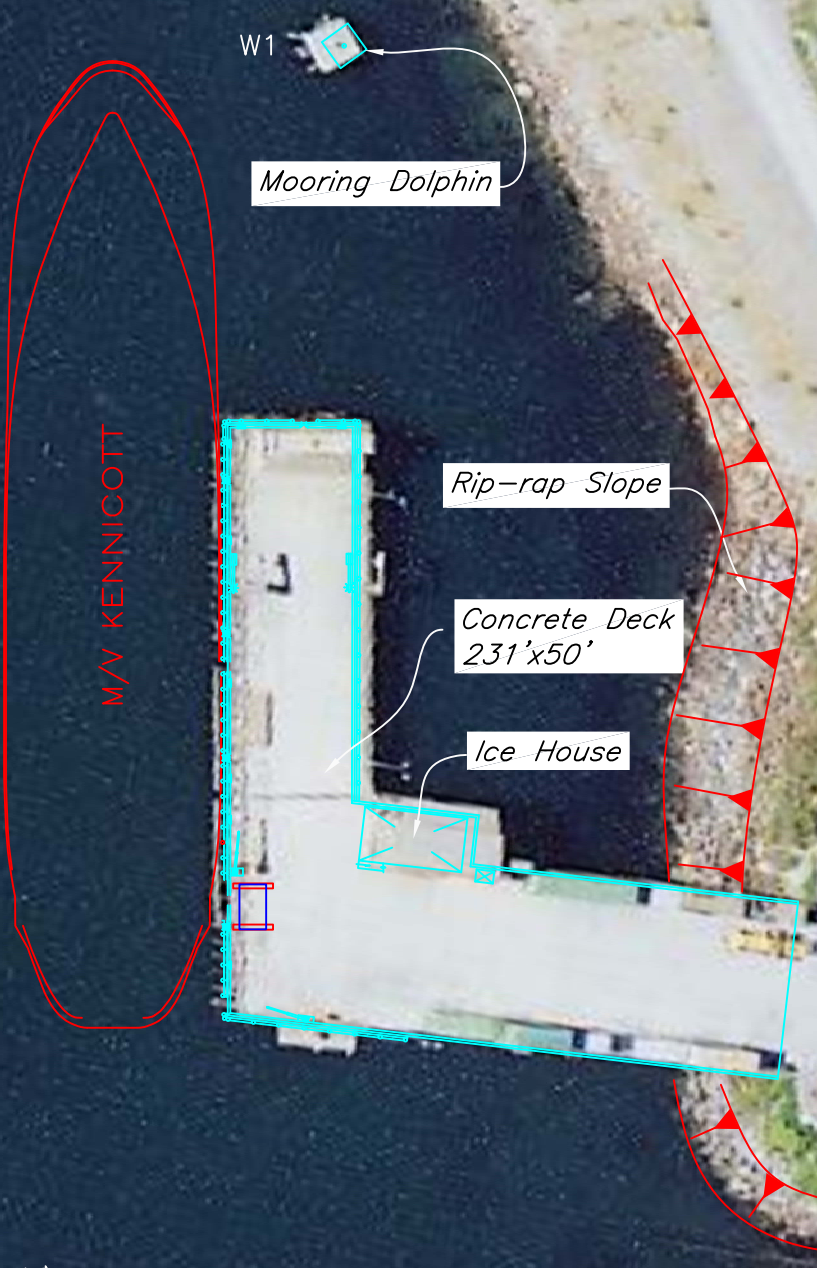
*GENERAL LAYOUT*  
*YAKUTAT*<sub>125</sub>

**Terminal Description:** The M/V KENNICOTT calls in Yakutat during its cross-gulf trips. The dock is L-shape in plan with a face 237 feet long by 50 feet wide and an approach 70 feet wide by 169 feet long. The dock is constructed of precast concrete deck panels atop cast-in-place concrete caps and steel support piles. Two mooring dolphins are located at each end of the dock and lie off-line from the dock face. The facility is a multi-purpose dock and could be in use by other vessels when the ferry arrives. AMHS is not in control of the operation or maintenance of this facility. The past 10 years of total passenger and vehicle traffic at Yakutat is shown below. The KENNICOTT began its service in 1998.

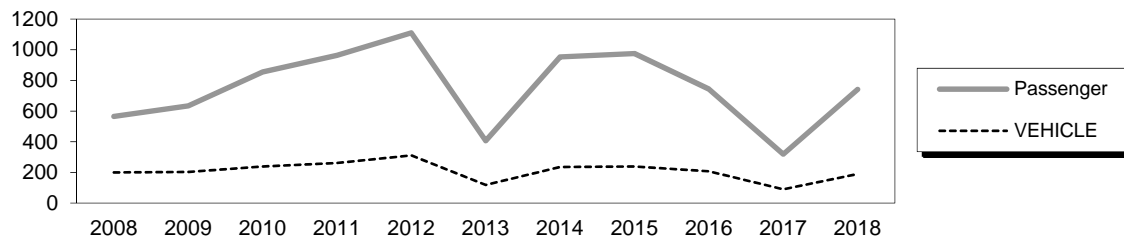
**Terminal Description:** The M/V Tustumena docks at the Aleutians East Borough facility in King Cove on its east/west passage through the Aleutian Chain. The King Cove facility consists of a sheet pile cell structure with a face approximately 125' long, and 4 steel pile mooring dolphins (two on each side of the dock) connected to the dock by steel catwalks. Access to the dock is via an embankment and paved roadway. There is a breach in the embankment at about its midpoint to permit juvenile fish migration. A steel girder/concrete deck bridge spans the breach; open sheet pile cells protect the abutments. The facility is a multi-purpose facility and could be in use by other vessels when the ferry arrives. AMHS is not in control of operation or maintenance of this facility. The past 10 years of total passenger and vehicle traffic at King Cove is shown below. The M/V Tustumena was out of service most of 2013, causing a steep dropoff in traffic at the terminal.

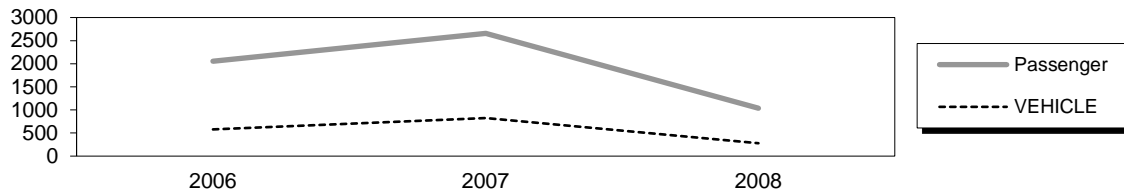
**Terminal Description:** South Mitkof is a new side-loading facility constructed in 2006 consisting of a modular ticketing office, secure (fenced) staging area, 900-foot long steel approach, steel transfer bridge, steel support float and five steel pile mooring dolphins. The IFA northern route has not been operational since 2008. South Mitkof's total passenger and vehicle traffic between 2006 and 2008 is shown below.
