AUKE BAY FERRY TERMINAL

GENERAL LAYOUT
AUKE BAY

Auke Bay West Berth

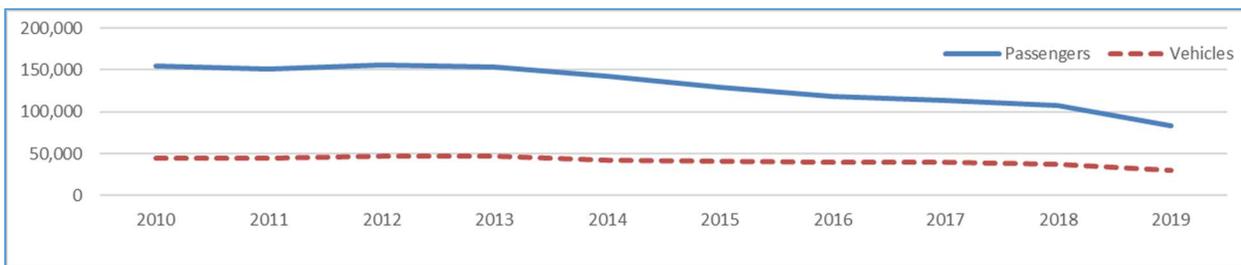
Auke Bay’s past 10 years of total passenger and vehicle traffic for all three berths (West, East, and Stern) is shown below. This data is reported each year in the Alaska Marine Highway System’s Annual Traffic Volume Report: <https://dot.alaska.gov/amhs/reports.shtml>.

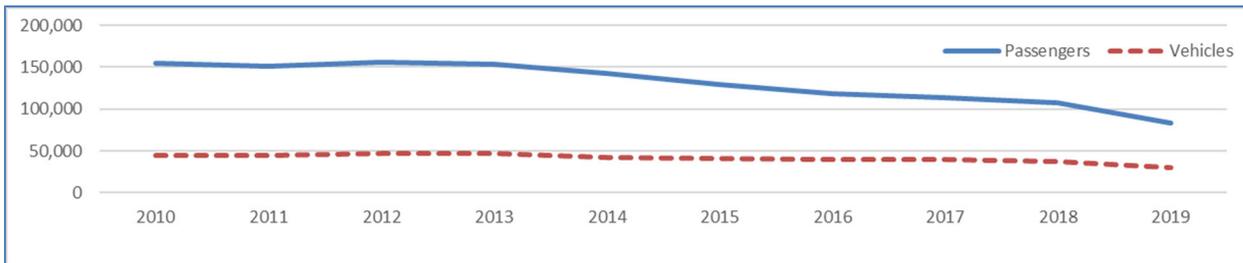
Auke Bay’s past 10 years of total passenger and vehicle traffic for all three berths (West, East, and Stern) is shown below. This data is reported each year in the Alaska Marine Highway System’s Annual Traffic Volume Report: <https://dot.alaska.gov/amhs/reports.shtml>.
