WRANGELL AIRPORT

Alaska Airport Pavement Inspection Report

Published September 2014

2014 Pavement Inspection Results

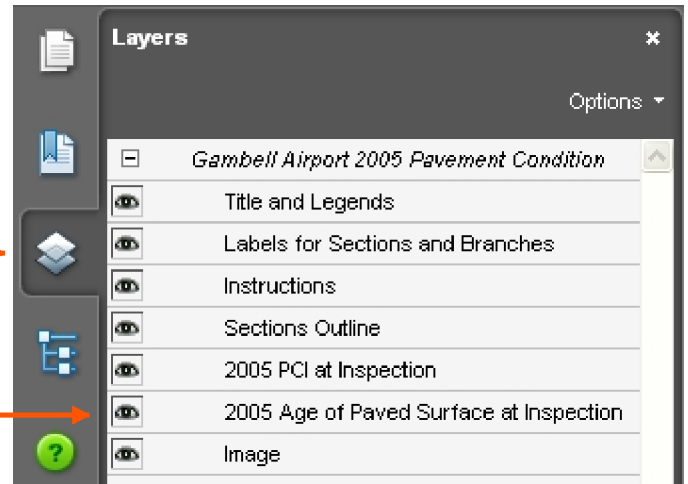
- The map contains layers, and must be opened with Adobe Reader version 8 or later.

- Click on Adobe's Layer Tab to View Layer Controls
- Click in a layer's box to turn it on/off

- The "eye" symbol shows that the layer is visible.
- These layers draw from the bottom up, which means that a layer higher in the list might block out the information on a lower layer. Turn off the higher layer to see the information on a visible lower layer.

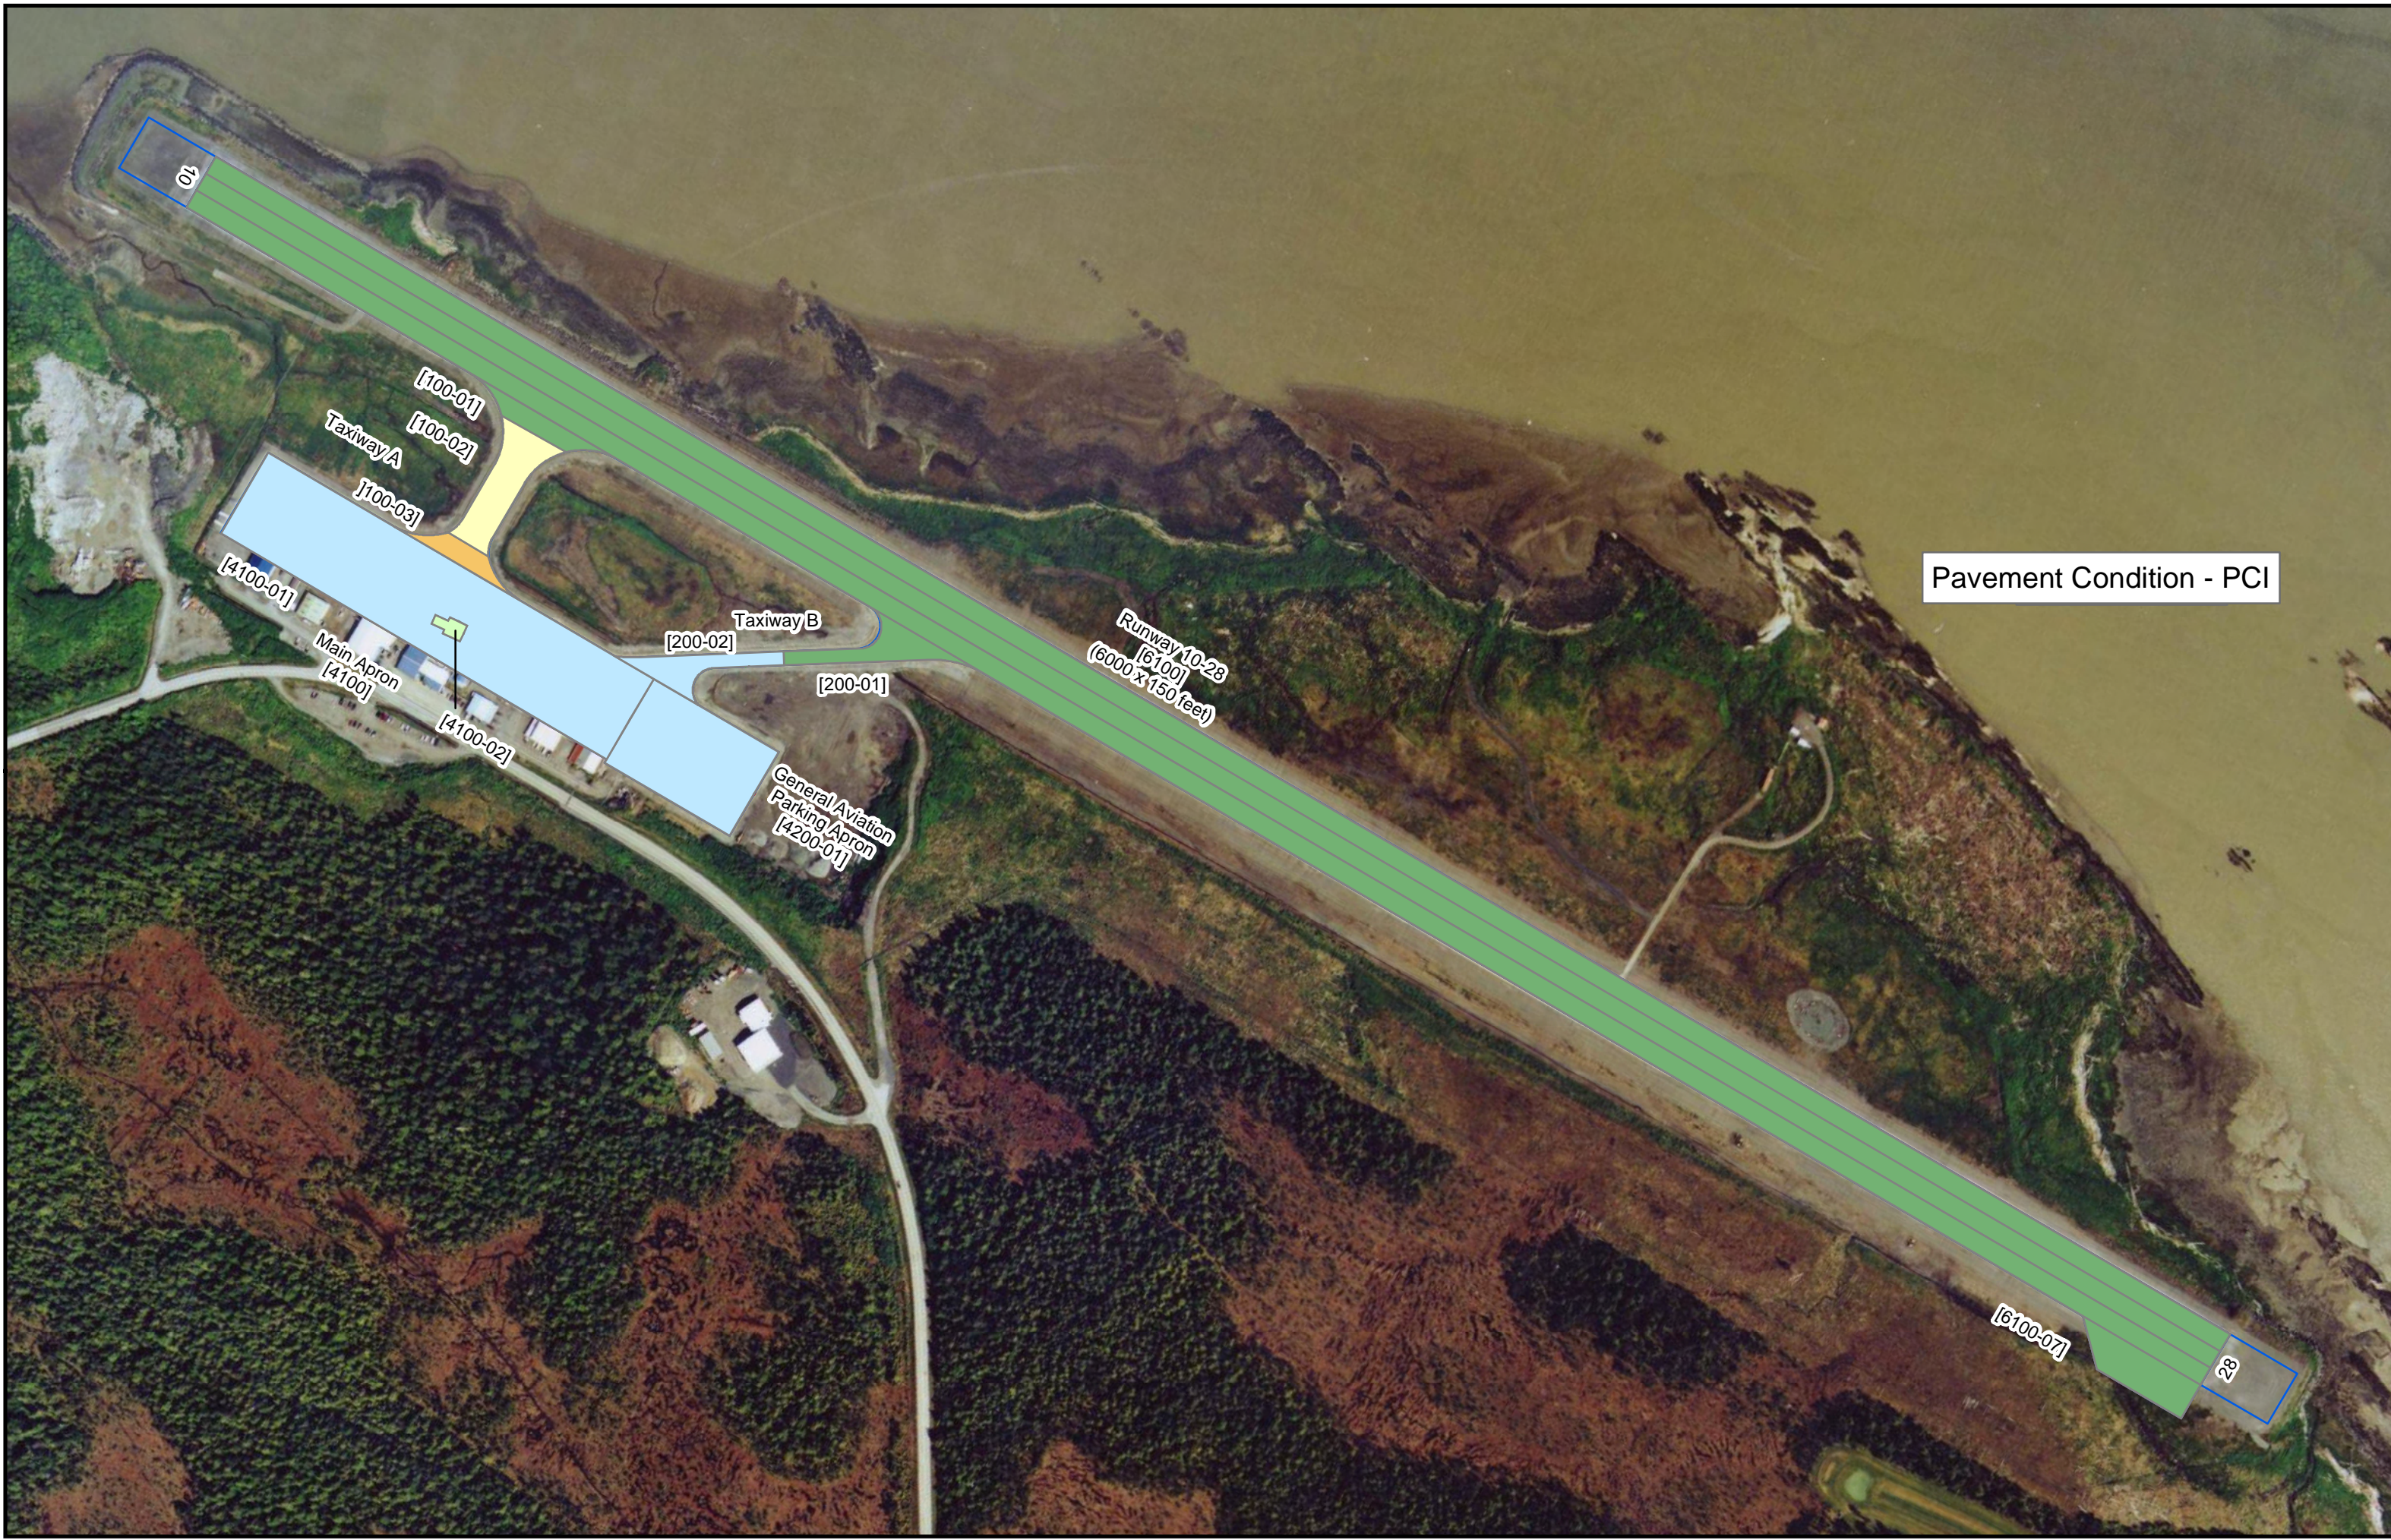
Pavement Condition - PCI

Pavement Condition Index (PCI)

Target PCI Range for Runways: 70 to 100
Target PCI Range for Taxiways and Aprons: 60 to 100

PCI Values	General Pavement Recommendations
85 - 100	Do Nothing or Preventative Maintenance
70 - 84	Preventative Maintenance
60 - 69	Corrective Maintenance
55 - 59	Rehabilitate
40 - 54	Rehabilitate
25 - 39	Reconstruct
10 - 24	Reconstruct
0 - 9	Reconstruct

[] Branch-Section Identifier

Aerial Image: June 2003, Aero-Metric, Inc.
