Fairbanks International Airport

# Winter Storm Efficiency Study: Airport Landside and Airside Snow Removal Study

Alaska International Airport System

RICONDO

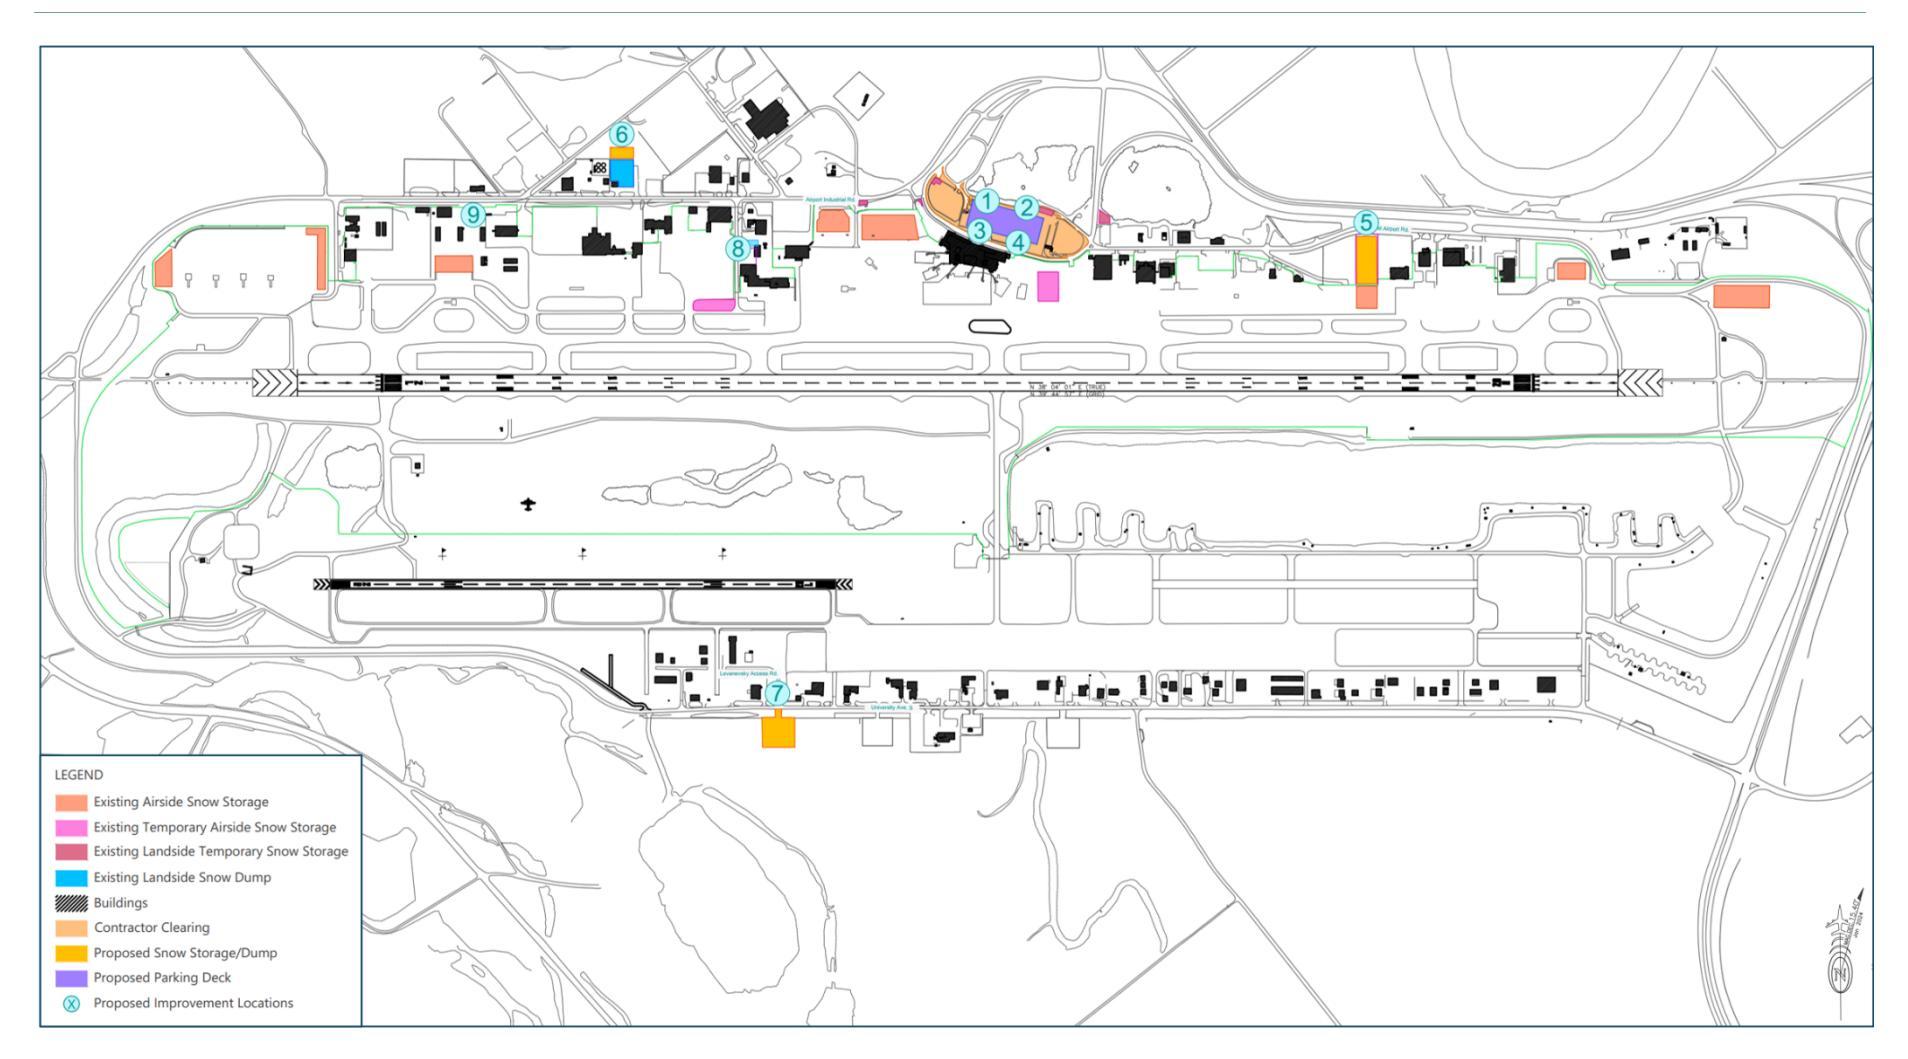
#### EXHIBIT 1: LOCATIONS OF PROPOSED RECOMMENDED IMPROVEMENTS

The proposed Terminal area landside improvements range from minimal effort and cost to major infrastructure development and investment to help better address the Airport's Terminal area snow and ice removal concerns. The recommendations are,

The Airport's snow storage capacity improvements provide a series of options which, depending on the improvement selected, may void the need to implement another recommended improvement. The Study's snow storage improvement recommendations are,

Finally, two operational improvements were identified to help improve maintenance vehicle access and response time to the airfield during winter storm events. The Study recommends,

While FAI has a robust and refined snow removal and storage plan for addressing winter weather on its landside and airside facilities, the Study has identified several recommendations for consideration including facility and operational improvements to help improve snow removal and ice control at the Airport. These include a series of progressive Terminal area landside improvements, landside and airside snow storage and snow dump capacity enhancements, and a proposed realignment of the SIDA fence to improve operational efficiency and response times to winter weather events. **Exhibit 16** identifies the location of all the recommended improvements listed below.

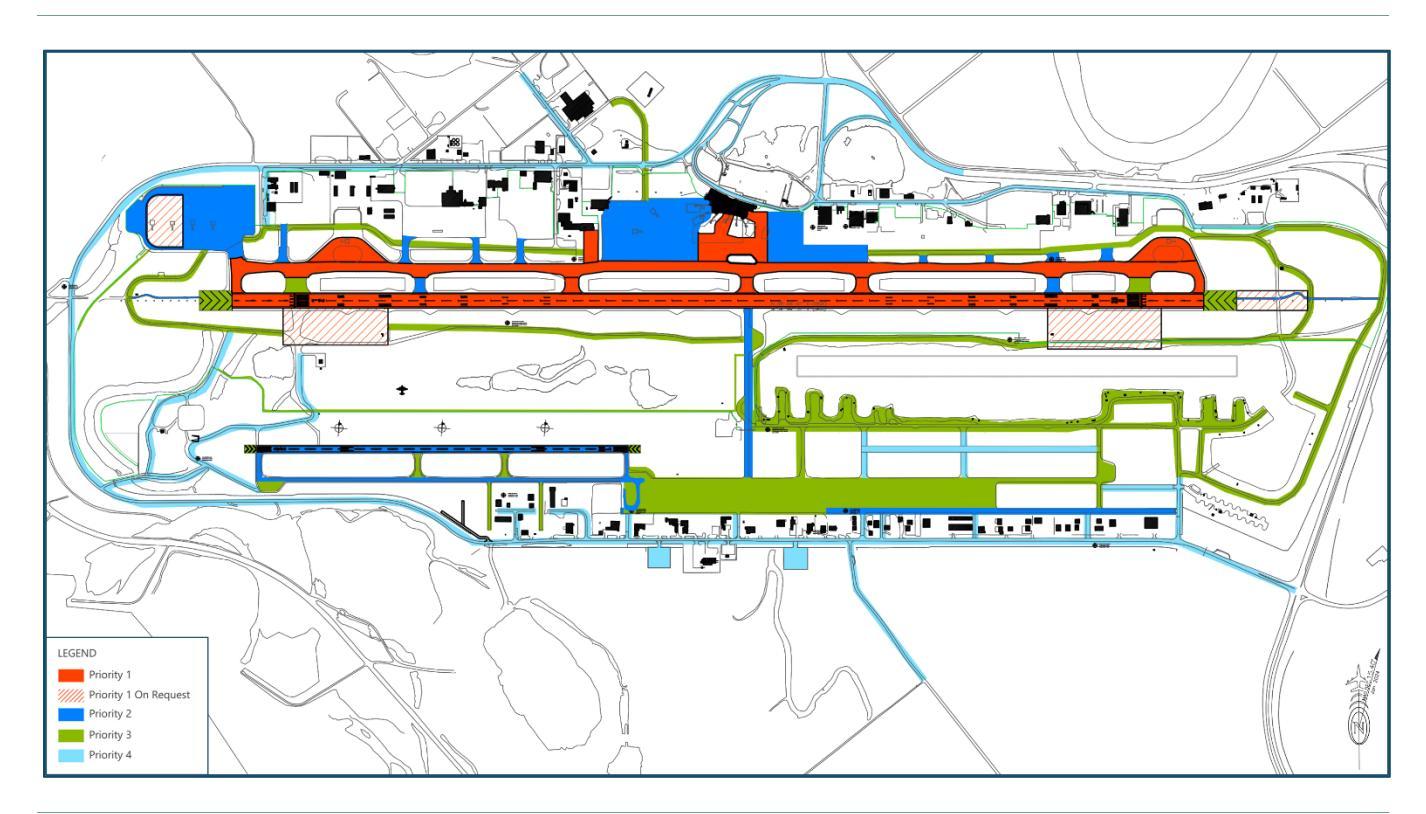
#### EXHIBIT 2: AIRSIDE AND LANDSIDE SNOW REMOVAL PRIORITIES

The Airport has established a plan to prioritize the clearing of the airside and landside facilities which they are responsible for during a snow event. **Exhibit 2** illustrates the areas the Airport is responsible for clearing and the order of priority in which they are cleared. Generally, Priorities 1 through 3 focus on airside facilities while Priority 4 is mainly focused on landside facilities, with some exceptions. The Priority 1 areas include the main runway; Taxiways A, B, H, and M; the terminal ramp (gates 1, 2, and 3); the cargo apron; the Aircraft Rescue and Fire Fighting (ARFF) ramp; and the north and south deicing ramps. These areas total about 6,000,000 square feet. Instrument Landing System (ILS) critical areas are considered Priority 1 as well, on request from the Federal Aviation Administration (FAA) – specifically the glide slope areas and the areas in front of the north and south localizers.

On the landside, the Airport is responsible for clearing the majority of the Priority 4 areas illustrated in Exhibit 2 during a snow event. These areas include the southern portion of Airport Way, the terminal area roadways (Old Airport Road, Wien Lake Road, Road N), Airport Industrial Road, Mail Road, Mail Trail, Aerofuel Place, Airport Perimeter Road, and University Avenue South to the intersection with Route 3.

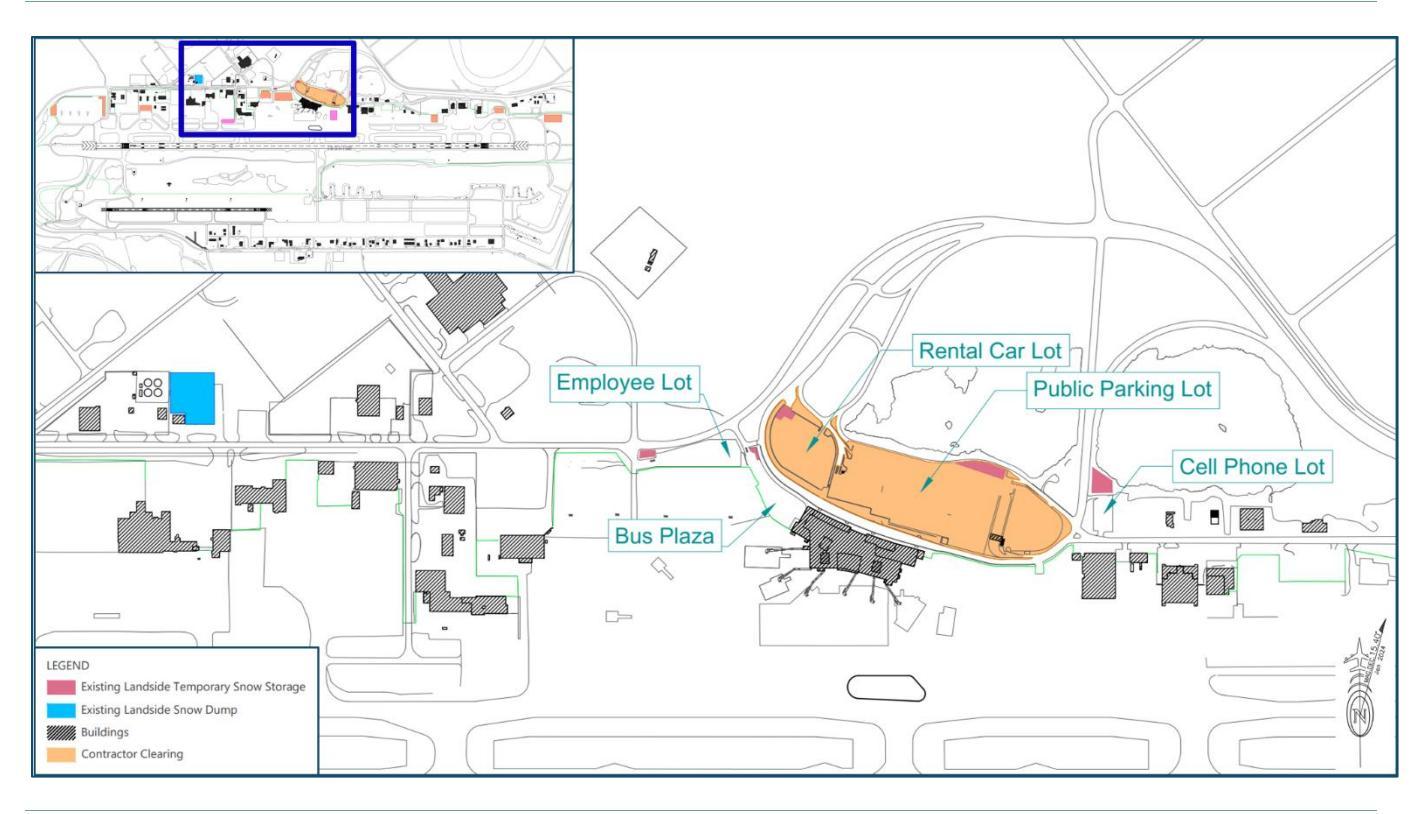
#### EXHIBIT 3: LANDSIDE SNOW STORAGE AND SNOW DUMP LOCATIONS

The Landside Snow Dump, located along Airport Industrial Road, immediately north of the Airport's old fuel farm as shown in **Exhibit 3**, is used to store snow from the landside facilities. This site is approximately 47,000 sq. ft. and the Airport is required to maintain access along the northern side of the site to an existing lift station. Snow from the Terminal area curbsides and roadways, and the Cell Phone Lot is cleared and moved to the Landside Snow Dump by the Airport. Snow from the Bus Plaza, Employee Lot, Rental Car, and Public Parking Lots is cleared by a contractor who is also responsible for moving snow from these lots to the Landside Snow Dump. During a snow event, the snow from each lot is initially stored in temporary piles within that lot, as illustrated in Exhibit 3, and later moved to the Landside Snow Dump. Similarly, during a snow event, lease holders on the Airport are responsible for clearing and storing snow within their lease limits. As snow accumulates on each lease site, it is the tenant's responsibility to move their snow piles to the Landside Snow Dump. Currently the Airport does not have a designated Snow Dump on the east side of the airport.

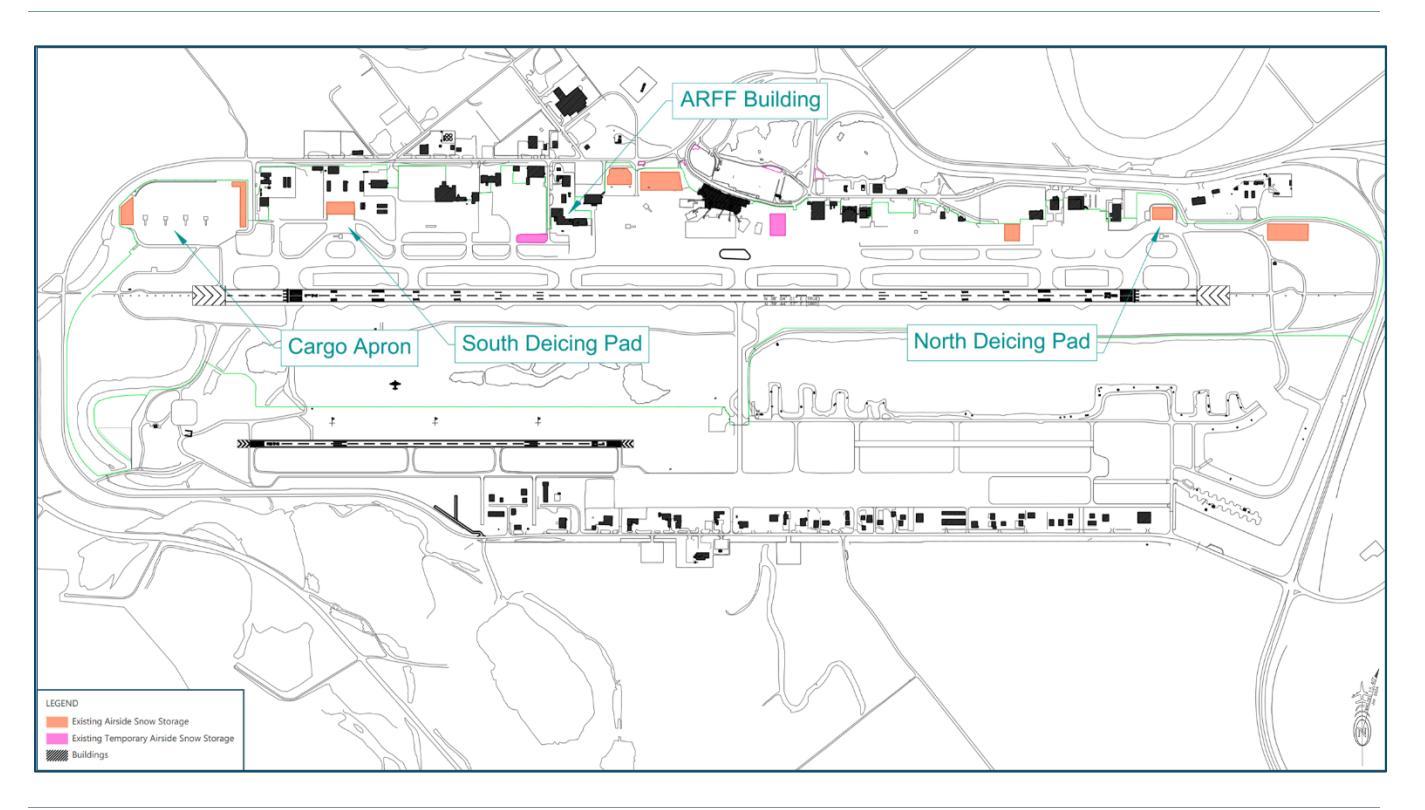
On the airside, much of the snow from the runways and taxiways can be blown into adjacent islands, while the snow cleared from many of the other areas for which the Airport is responsible for, such as the Terminal Area ramp, deicing pads, cargo apron and Airport facilities such as the Maintenance and ARFF Building is stored either in one of the Temporary Snow Storage sites or in one of the Airside Snow Storage Sites/Dumps as illustrated in **Exhibit 4**.

Following snow events and as the Temporary Snow Storage piles increase in size, the snow from these sites is moved to one of the nearby Airside Snow Storage Sites.

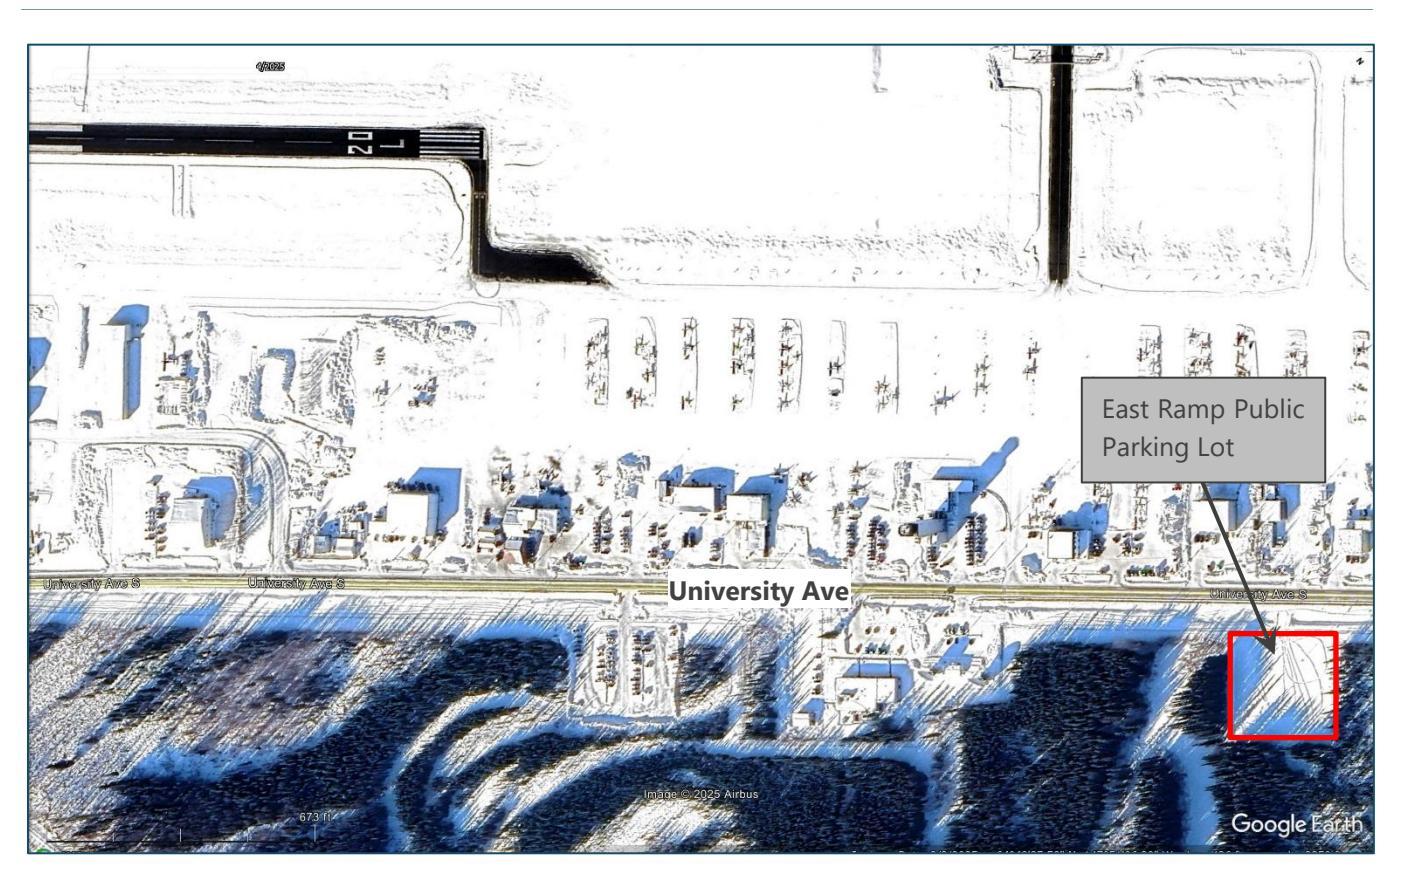
#### EXHIBIT 5: AERIAL IMAGERY OF PRIOR EAST AIRPORT SNOW DUMP SITE

On the landside, two separate needs for additional snow storage capacity exist. First, as noted earlier, there is no current landside Snow Dump located along the east side of the Airport. Prior to the 2024 – 2025 winter season, the East Ramp Public Parking Lot shown in **Exhibit 5** was designated as a Snow Dump location; in 2024, this site was identified for an alternative use. Second, the Airport has reported that the existing Landside Snow Dump, located along Airport Industrial Road, immediately north of the Airport's old fuel farm as shown earlier in Exhibit 2, occasionally experiences some capacity issues during heavy snow fall seasons. To alleviate this issue, the Airport must move snow previously dumped and pile it higher near the back of the site, effectively moving it at least twice. Additional landside snow dump storage could help resolve this problem.

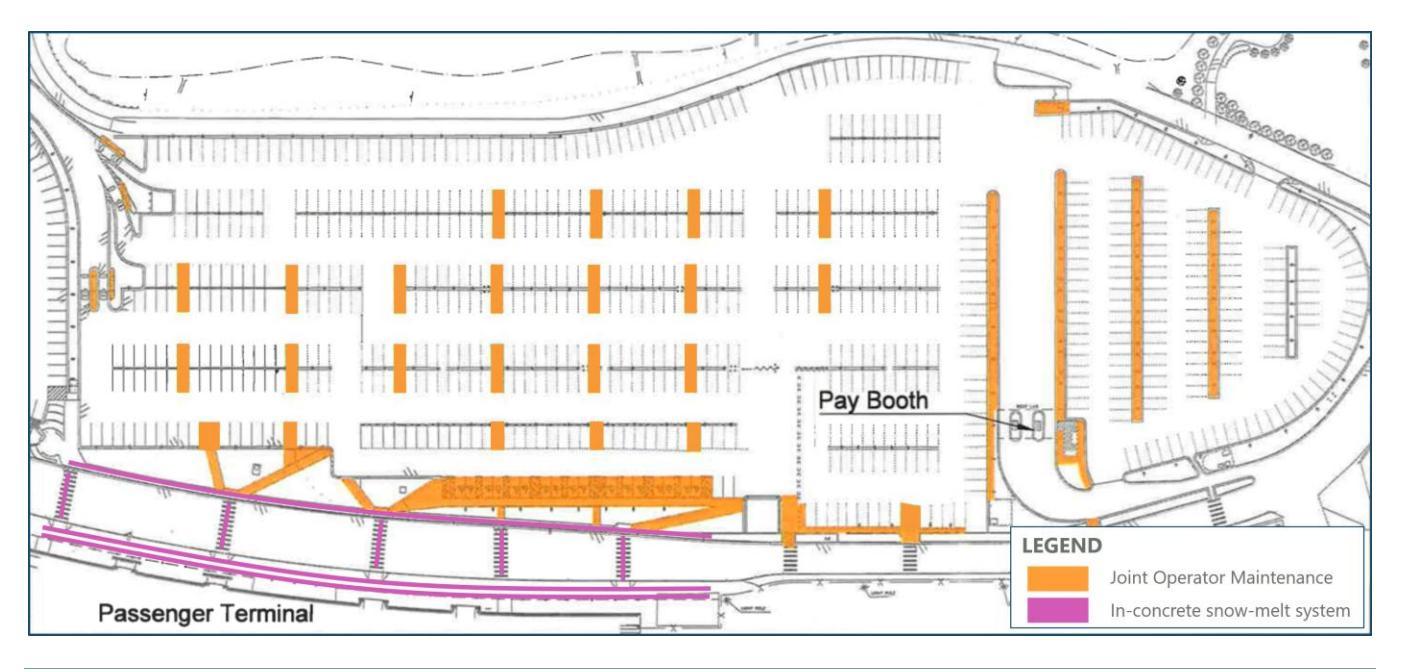
#### EXHIBIT 6: IN-CONCRETE/PAVEMENT SNOW MELT SYSTEM

To help alleviate the Airport's reliance on the use of manual labor to clear, treat and maintain the Airport Terminal Area sidewalks and walkways for snow removal and ice control, the Study **recommends that the Airport install a snow melt system along the Terminal's pedestrian curbside, the curbside pedestrian crosswalks and the sidewalk adjacent to the public parking lot.** Implementation of a snow melt network could be done incrementally over several years to help defer costs and minimize impacts to the Terminal curbsides and walkways. Installing a snow melting system would reduce the number of pedestrian slip and fall incidents, improving safety while reducing overall liabilities for the Airport. Additional study should be conducted to evaluate the appropriate snow melt technology for FAI. **Exhibit 6** identifies the proposed in-concrete/pavement snow melt network.

Adding an in-concrete/pavement snow melting system would:

- Provide a passive, proactive response to winter weather conditions instead of the reactive approach currently used to mitigate the impacts of snow and ice accumulation on most of the landside pedestrian surfaces,
- Help alleviate the issue of hiring and retaining staff, primarily entry level laborers, who are assigned to more manually intense landside snow removal tasks such as shoveling, snow blowing, and salting sidewalks and curbside pedestrian areas,
- Reduce the Airport's reliance on manual labor to maintain safe snow and ice-free walking surface for customers and employees,
- Reduce the use of salt, E-chip and other snow melt chemicals on these pedestrian surfaces, reducing the amount of material tracked into the terminal building and decreasing maintenance and efforts to keep indoor facilities clean, and reduce the corrosion associated with the use of salt for ice control

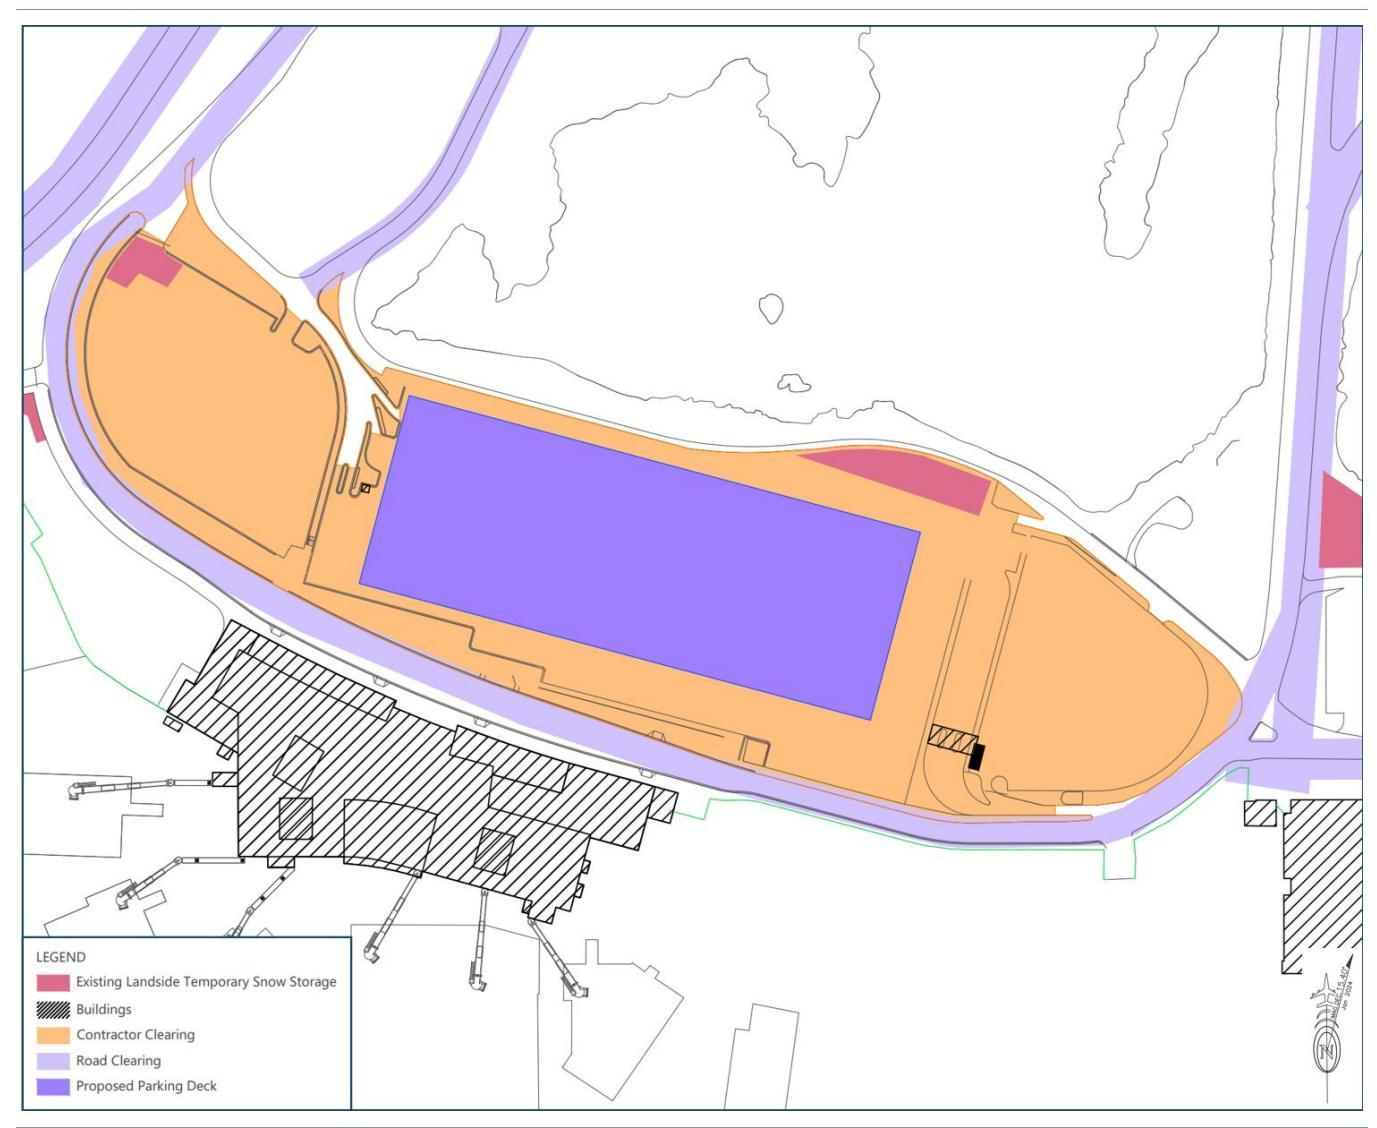
#### EXHIBIT 7: PROPOSED TERMINAL AREA PARKING STRUCTURE (MAXIMUM FOOTPRINT)

The proposed construction of a new public parking garage is consistent with one of the Public Parking expansion options provided in the 2020 *Fairbanks International Airport Terminal Gound Access Study* (TGAS). While the TGAS option was limited to 350 structured spaces, the concept presented in this document is only intended to illustrate the largest footprint practical with the constraints of the existing surface parking lot.

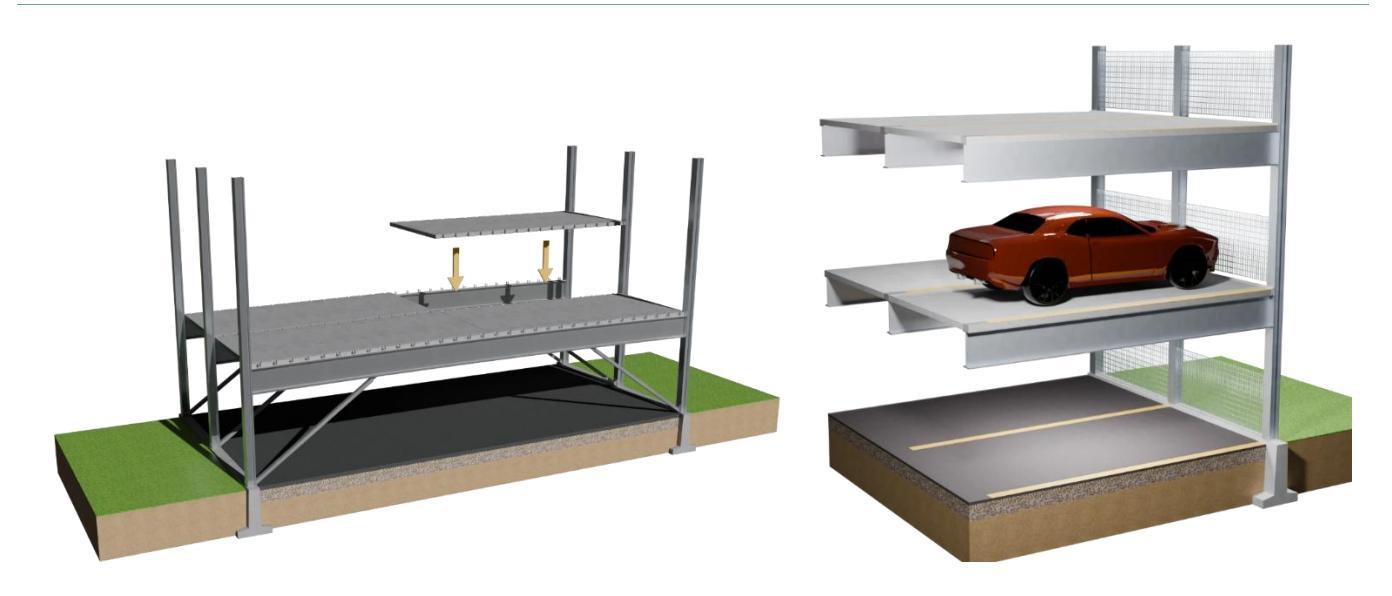
#### EXHIBIT 8: RENDERINGS ILLUSTRATING THE PREFABRICATED PARKING STRUCTURE

The prefabricated design and construction method uses a modular building system consisting of galvanized steel columns and beams, and precast floor slabs, stairs and foundations. The design builder claims that compared to traditional construction methods, using this prefabricated system results in reduced construction and operating

costs, and can be built on an accelerated schedule. **Exhibit 8** provides some renderings illustrating this prefabricated construction system. **Exhibit 9** provides an image inside of a completed parking structure using this system.

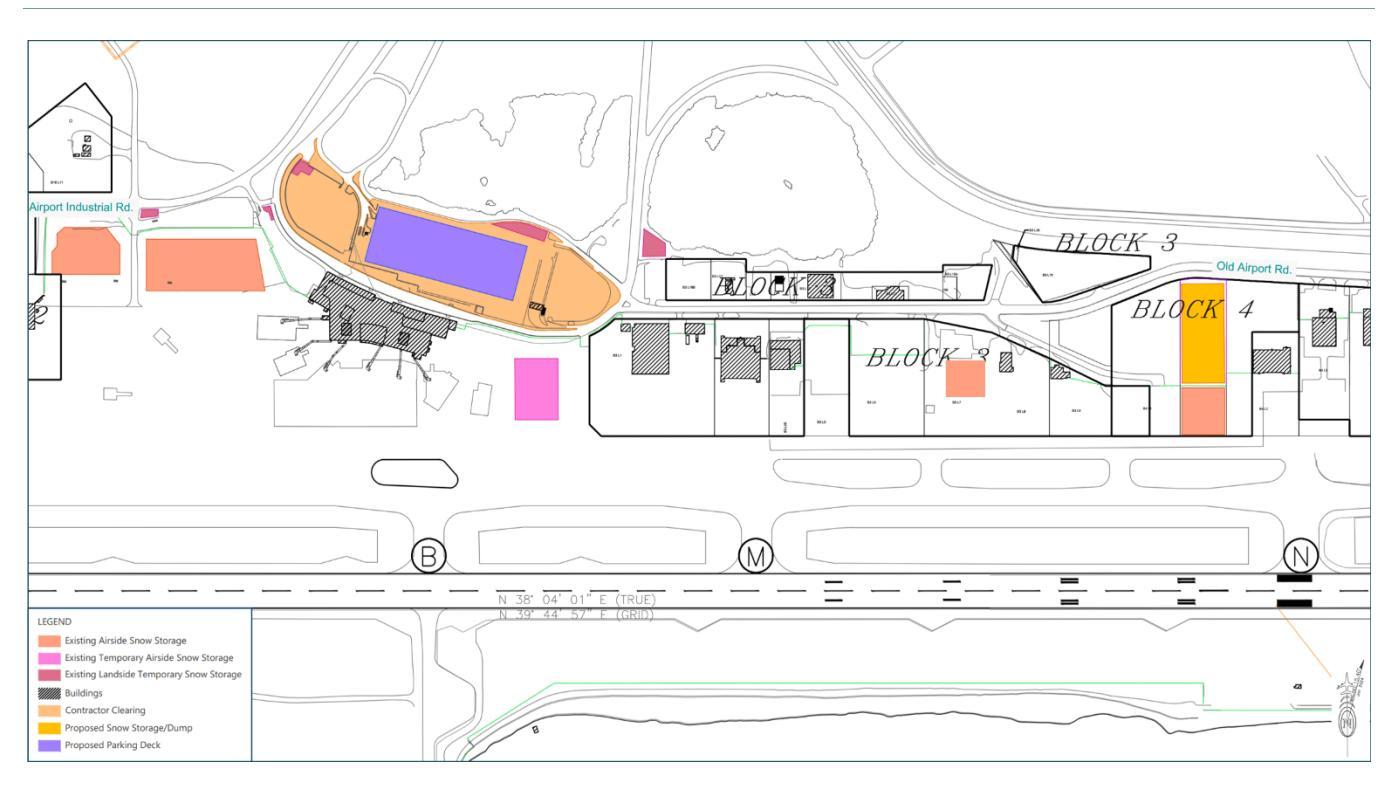
#### EXHIBIT 10: PROPOSED SNOW STORAGE - BLOCK 4 LOT 1

Currently the Airport uses the airside portion of lot the designated "Snow Storage" on the Fairbanks International Airport 2025 Information Map. This lot is located on the west side of the airfield between Lot B4 L1, and B4 L2. Currently Lot B4 L1 is vacant, and B4 L2 is leased to LifeMed Alaska, LLC. The western portion of this lot located outside of the SIDA fence is currently reserved for snow storage and is unused. **The Study recommends extending the SIDA fence to the west along the boundaries of this site, allowing the existing Airside Snow Storage site to be expanded by approximately 76,000 sq. ft. to a total of 117,500 sq. ft. as shown in Exhibit 10 This additional airside snow storage capacity would allow the Airfield Maintenance team the flexibility to move snow from the Temporary Snow Storage site located on the north side of the Terminal Ramp to this new expanded snow storage area. In addition, adding a SIDA gate to this newly expanded Airside Snow Storage site from Old Airport Road, this storage area could also provide the Airport Maintenance team with the flexibility to use this area as an alternate or overflow snow storage site for Landside snow if necessary. This would avoid a future need to expand the existing Landside Snow Dump site located north of the old fuel farm on the west side of Airport Industrial Road.**

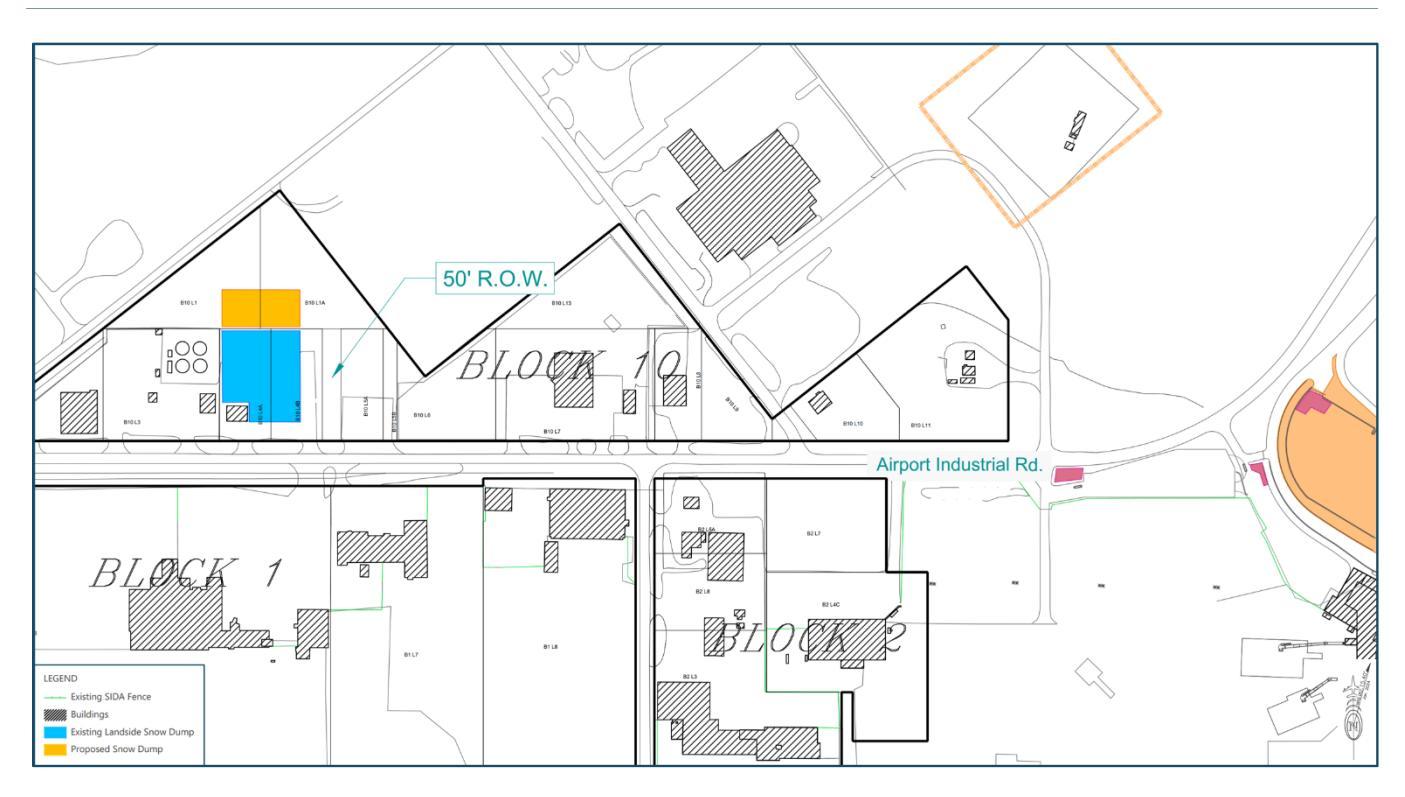
#### EXHIBIT 11: PROPOSED SNOW STORAGE - BLOCK 10 LOTS 1 & 1A

As noted in the previous section, the Airport's primary Landside Snow Dump is located south of the airport terminal along Airport Industrial Rd, north of the old fuel farm in Block 10, Lots 4A and 4B. Access to a lift station in the northwest corner of this site is provided along the northern perimeter of lot and must be maintained throughout the winter season. Snow Dump operations must avoid blocking this access. In the past, demand for snow storage in this site has required the snow to be moved and stacked higher in the back of the site to increase overall storage capacity. Should the Airside Snow Storage Site not be expanded as described in Recommendation #5, and the new SIDA gate not be included, it is anticipated that the existing Landside Snow Dump site would require some expansion in the future. **The Study recommends that Block 10 Lots 1 and 1A**, which are currently vacant be reserved for future expansion of the existing Snow Dump Site located along Airport Industrial Road. The Airport should avoid leasing these lots, if possible, to maintain the ability to expand the Landside Snow Dump if needed. Exhibit 11 provides an illustration of the proposed recommendation #6

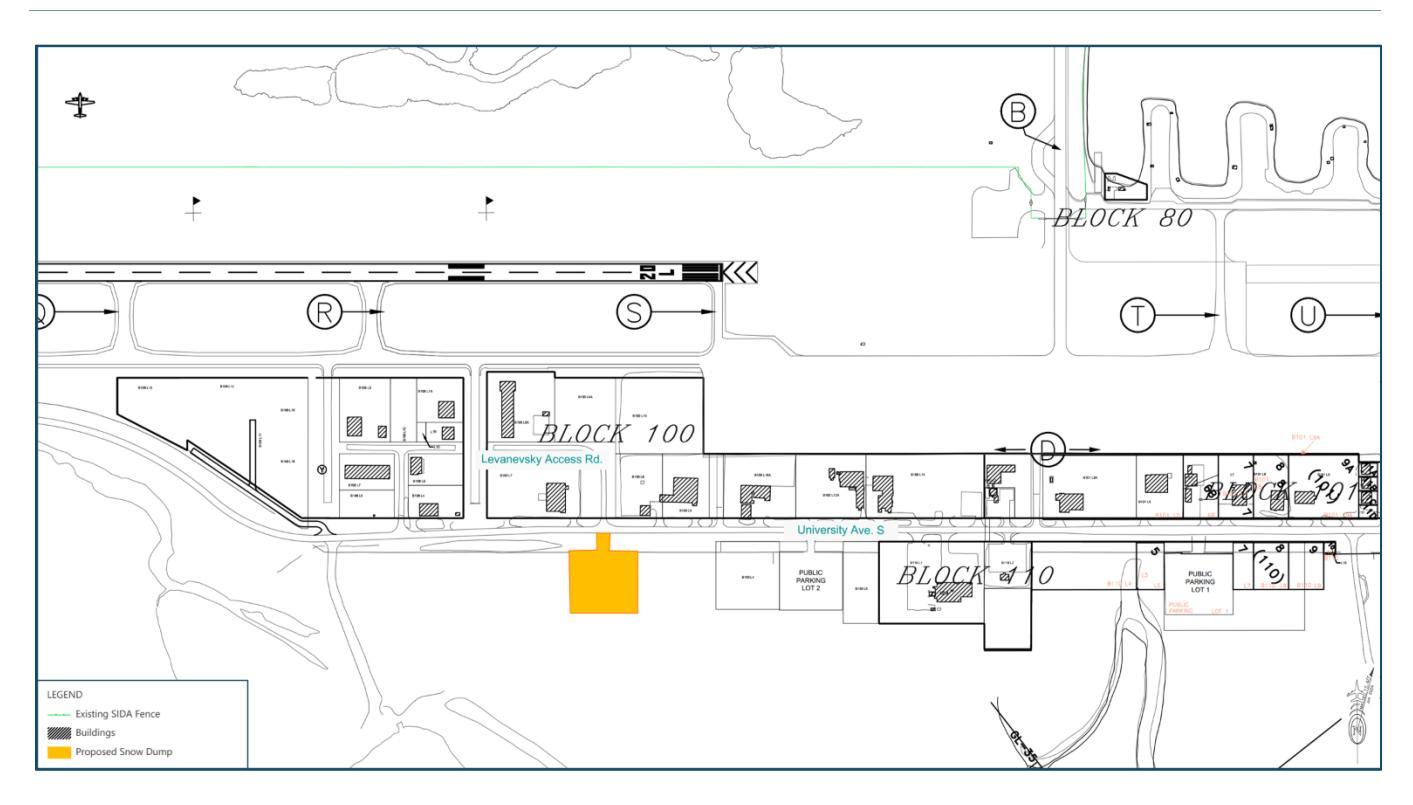
Following the closure of the Landside Snow Dump located in the East Ramp Public Parking lot in 2024, there are currently no designated snow dump locations on that side of the Airport. The Study has identified a potential location on the southeast side of the airport, shown in **Exhibit 12** for a new snow dump that the tenants can use to haul snow from their leased sites. The identified site is undeveloped and located on the East side of University Avenue, opposite Levanevsky Access Road. **The Study recommends that should the Airport choose to develop this location into a new Landside Snow Dump, the site should be developed to a similar size and layout as the existing East Ramp Public Parking Site located to the north along University Avenue.**

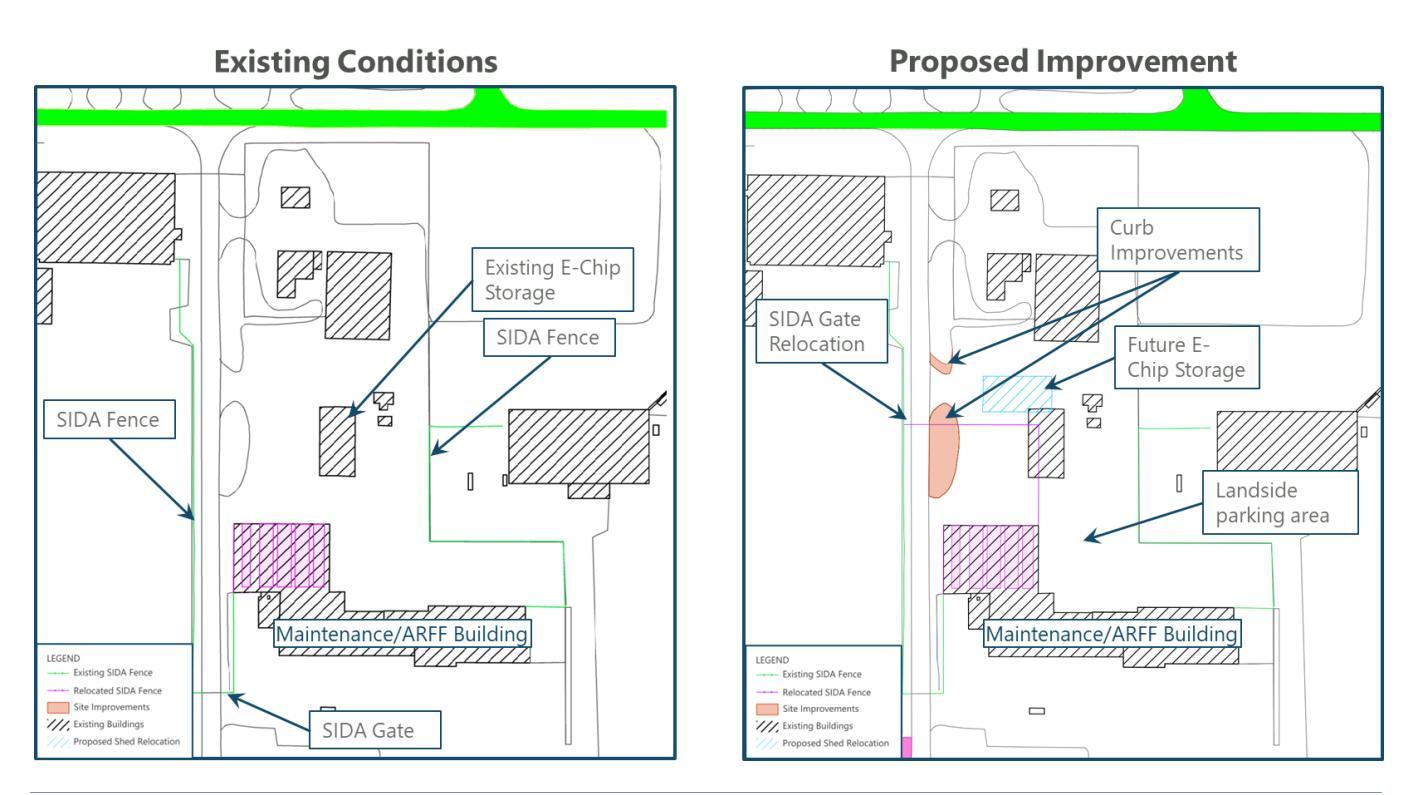
#### EXHIBIT 13: EXISTING AND PROPOSED SIDA FENCE RECONFIGURATION

The Study considered multiple options to reconfigure the SIDA fence to include the vehicle storage bays on the west side of the Maintenance Building within the Airport secure area while still providing landside access to the Airport's Badge and ID office located on the west side of the building. **Exhibit 13** shows the current SIDA fence

# configuration, and the proposed realignment. Multiple options were considered using a vehicle tracking analysis to account for the turn radii of the brooms.

By relocating the SIDA fence and gate as shown above, all the vehicles stored in the Maintenance Building would be within the secure area and would no longer be delayed accessing the airfield. Additionally, the relocated SIDA fence would still provide landside access to the west side of the Maintenance and ARFF Building for the Pass and ID Office as well as employee parking and deliveries.

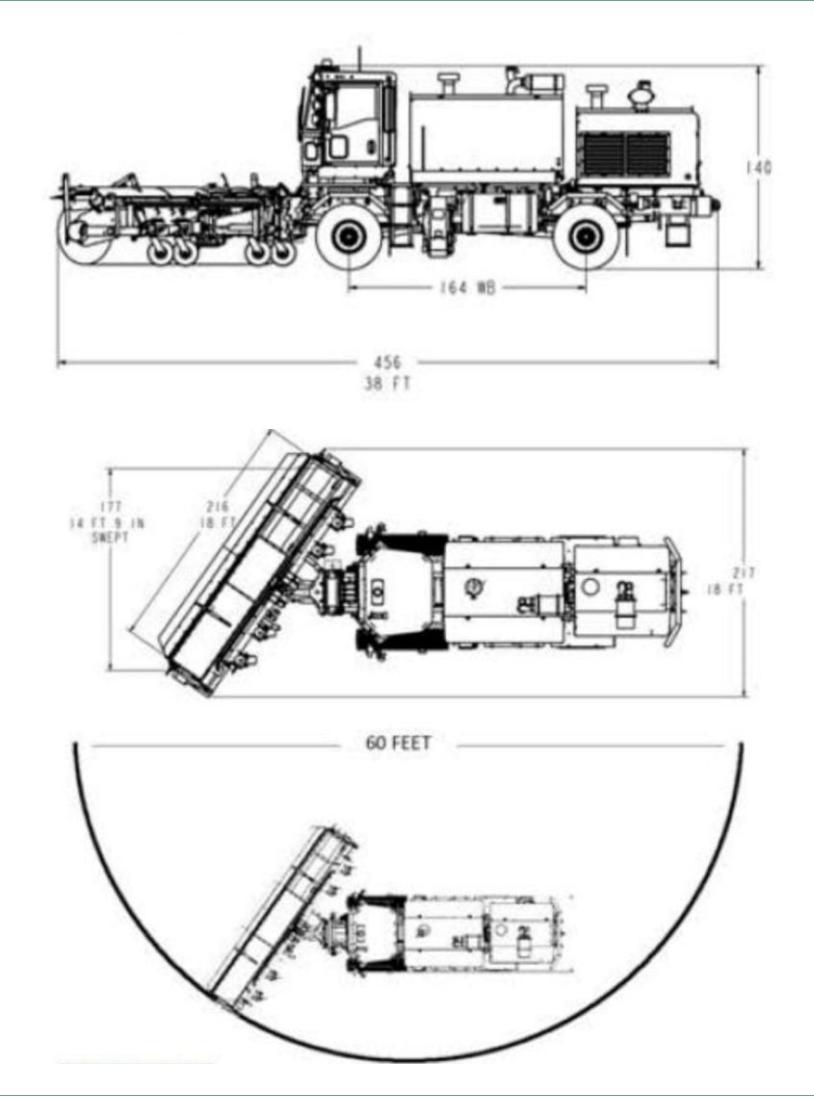
#### EXHIBIT 14: SWEPT PATH ANALYSIS DESIGN VEHICLE - MB3 BROOM TRUCK WITH 2-WHEEL STEERING

The proposed new SIDA fence line alignment was determined by evaluating the Broom Trucks' ability to maneuver in to and out of their assigned storage bays using a vehicle tracking software. To accurately evaluate a Broom Truck's ability to maneuver in and out of their storage bay, the MB3 Front Mount Broom Truck was selected as the design vehicle and vehicle specific information and specifications were used to identify the vehicle's key characteristics. For this analysis, the design vehicle was assumed to have only two-wheel steering with a maximum turn angle of 35 degrees, a wheelbase of 13 ft.-8 in., and an 18 ft. wide broom front mounted broom. The MB3 Broom Truck dimensions used in this analysis are provided in **Exhibit 14**.

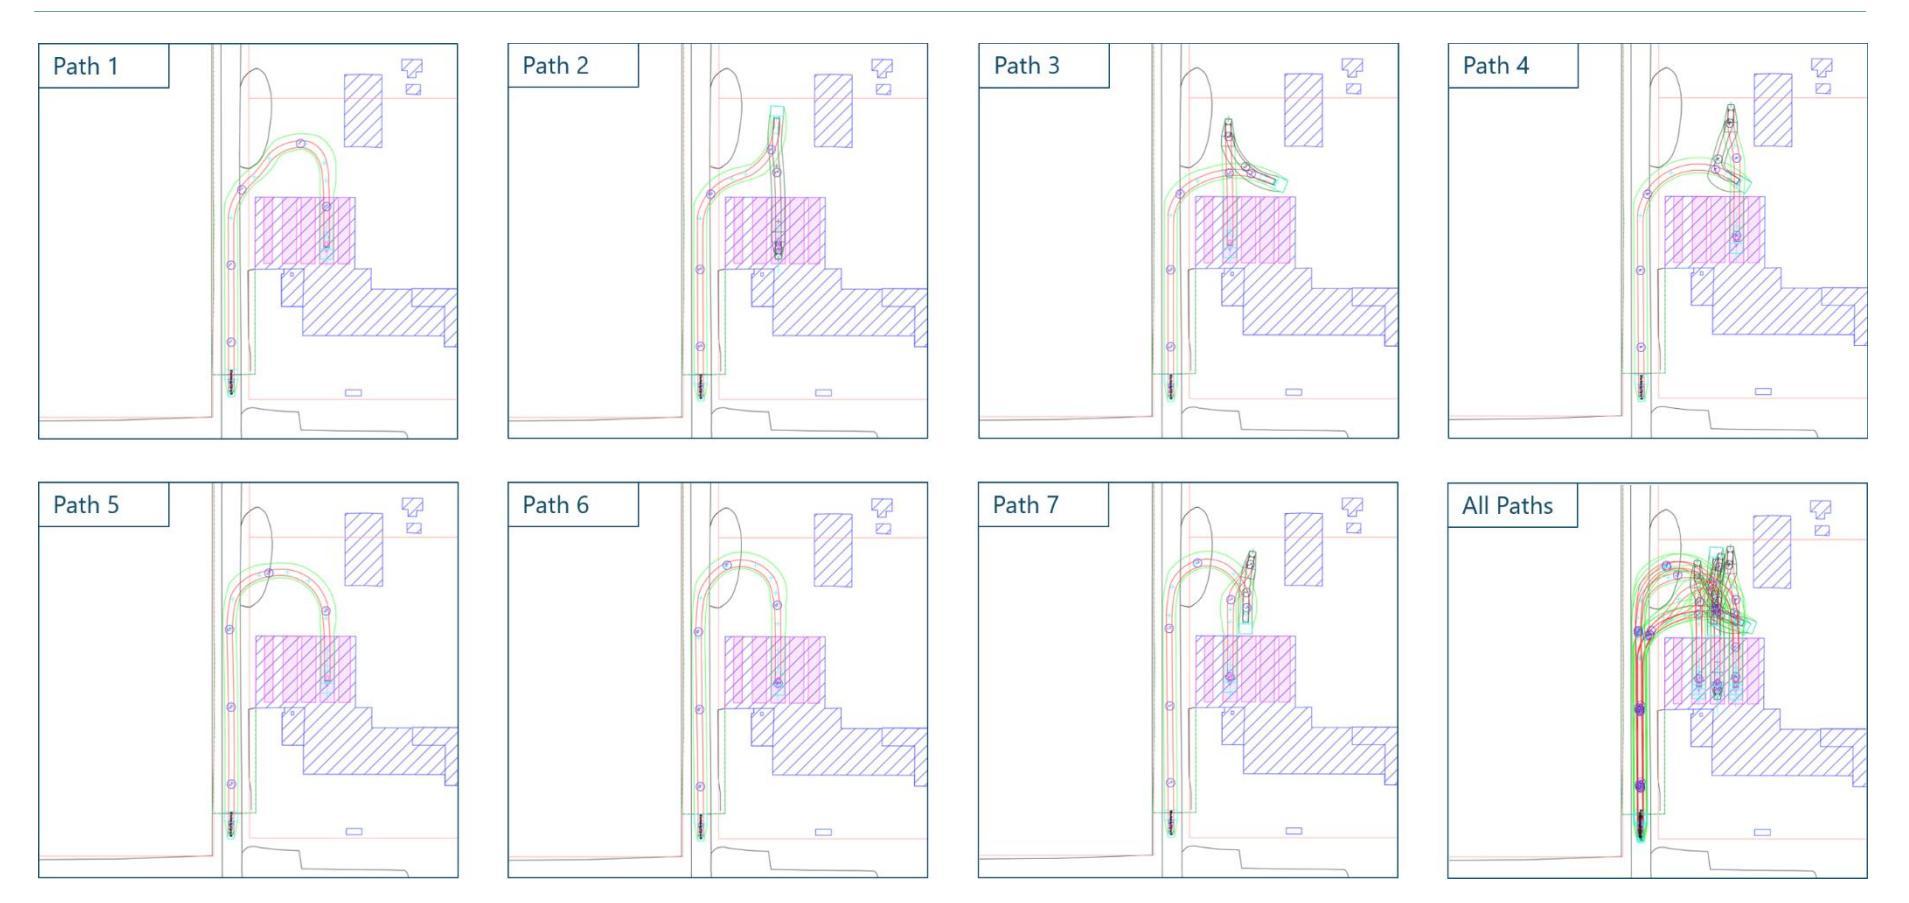
#### EXHIBIT 15: MB3 BROOM TRUCK SWEPT PATH ANALYSIS

Seven vehicle swept path analyses were conducted to determine if the design vehicle had sufficient space to maneuver the truck and broom into and out of the three storage bays in the Maintenance Building capable of accommodating them. The Broom Trucks drive into their storage bays, and back out of them. **Exhibit 15** shows that of the three storage bays the MB3 Broom Trucks are stored in, with the realignment of the SIDA fence, and the removal of the island, the MB3 Broom Trucks would be able to drive forward into the north and middle bays without backing up to realign the vehicle. To access the southern bay, the MB3 Broom Truck would need to back up and realign the vehicle to enter their storage bay. It is important to remember that the design vehicle selected was conservative as it was assumed to only have two-wheel (front axle) steering. Other Broom Trucks equipped with four-wheel (front and back axle) steering have a tighter turning radius and should be capable of driving directly into each of the storage bays without needing to back up and realign the vehicle.
