Fairbanks International Airport

# Winter Storm Efficiency Study: Airport Landside and Airside Snow Removal Study

Alaska International Airport System

RICONDO

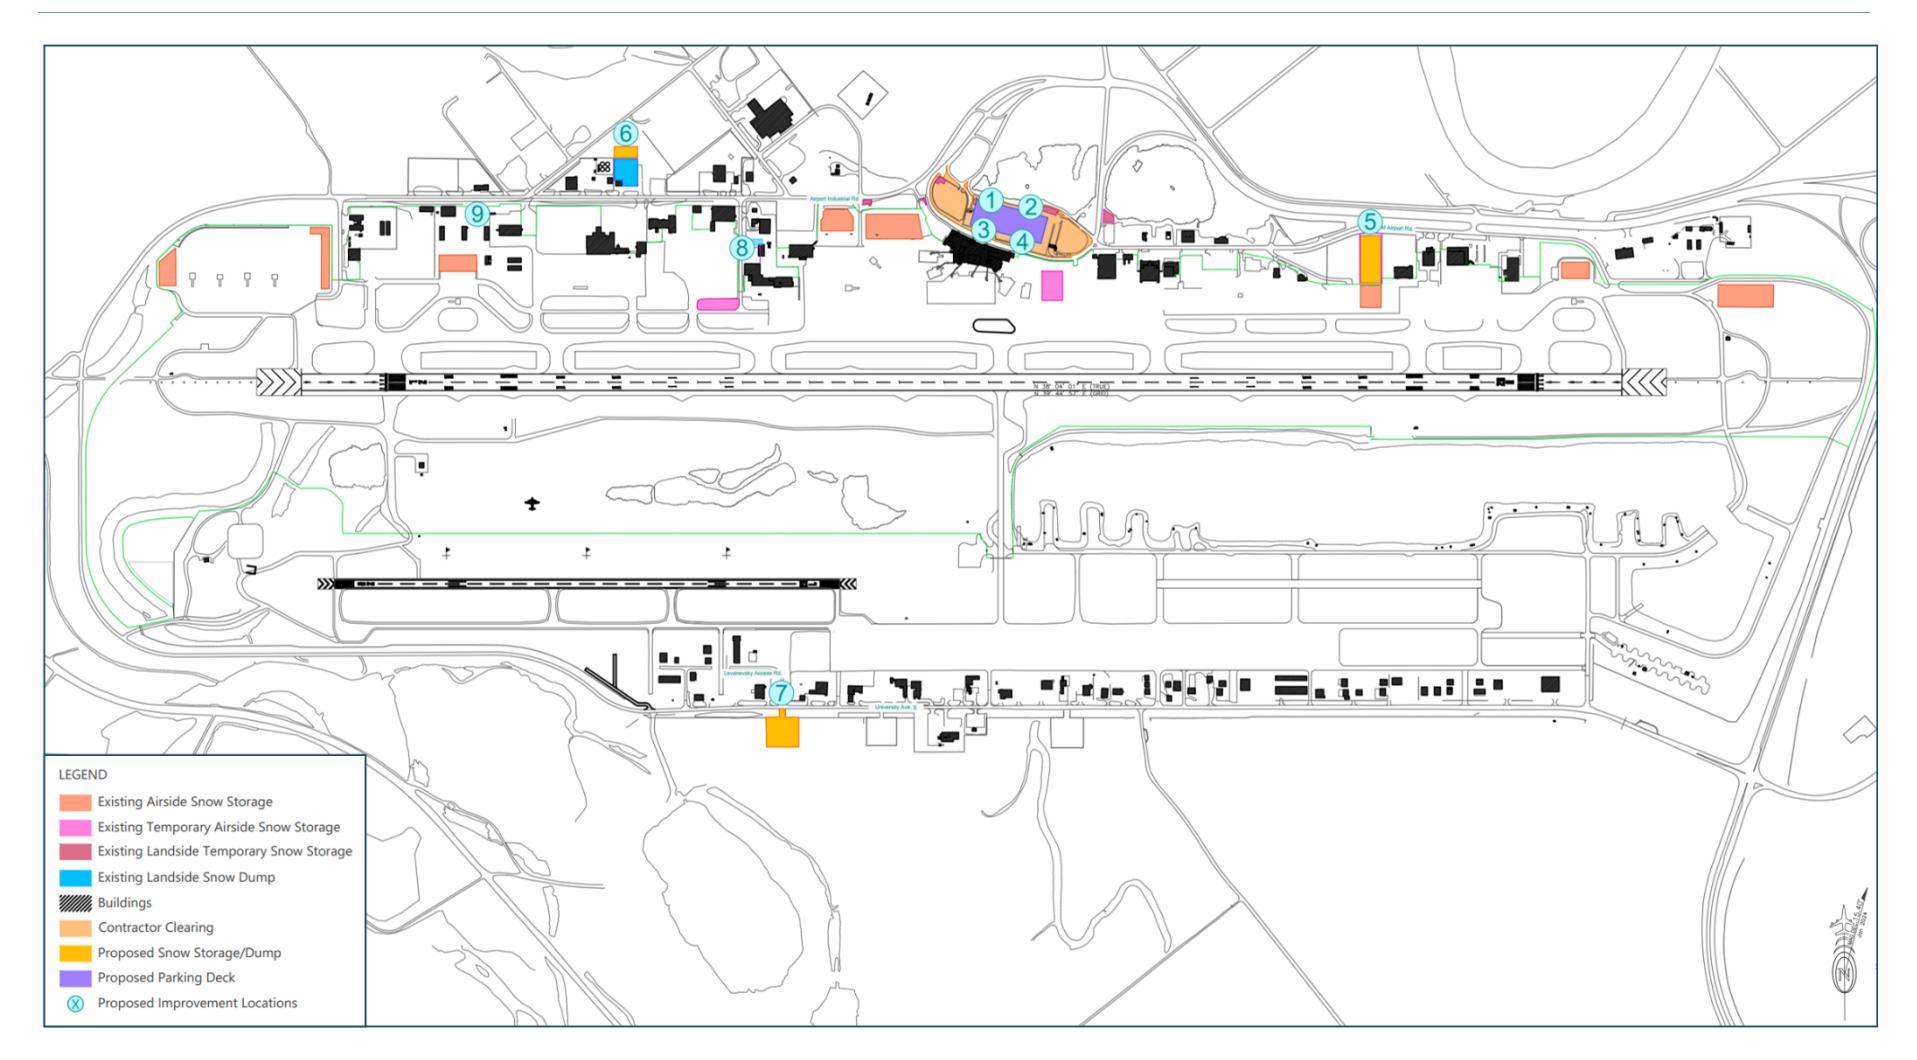
#### EXHIBIT 16: LOCATIONS OF PROPOSED RECOMMENDED IMPROVEMENTS

While FAI has a robust and refined snow removal and storage plan for addressing winter weather on its landside and airside facilities, the Study has identified several recommendations for consideration including facility and operational improvements to help improve snow removal and ice control at the Airport. These include a series of progressive Terminal area landside improvements, landside and airside snow storage and snow dump capacity enhancements, and a proposed realignment of the SIDA fence to improve operational efficiency and response times to winter weather events. **Exhibit 16** identifies the location of all the recommended improvements listed below.

The proposed Terminal area landside improvements range from minimal effort and cost to major infrastructure development and investment to help better address the Airports Terminal area snow and ice removal concerns. The recommendations are,

The Airport's snow storage capacity improvements provide a series of options which, depending on the improvement selected, may avoid the need to implement another recommended improvement. The Study's snow storage improvement recommendations are,
