ELECTROMAGNETIC INDUCTION MEASUREMENTS IN PERMAFROST TERRAIN FOR DETECTING GROUND ICE AND ICE-RICH SOILS

FINAL REPORT

Koji Kawasaki and Thomas E. Osterkamp Geophysical Institute University of Alaska Fairbanks, Alaska 99701

December 1984

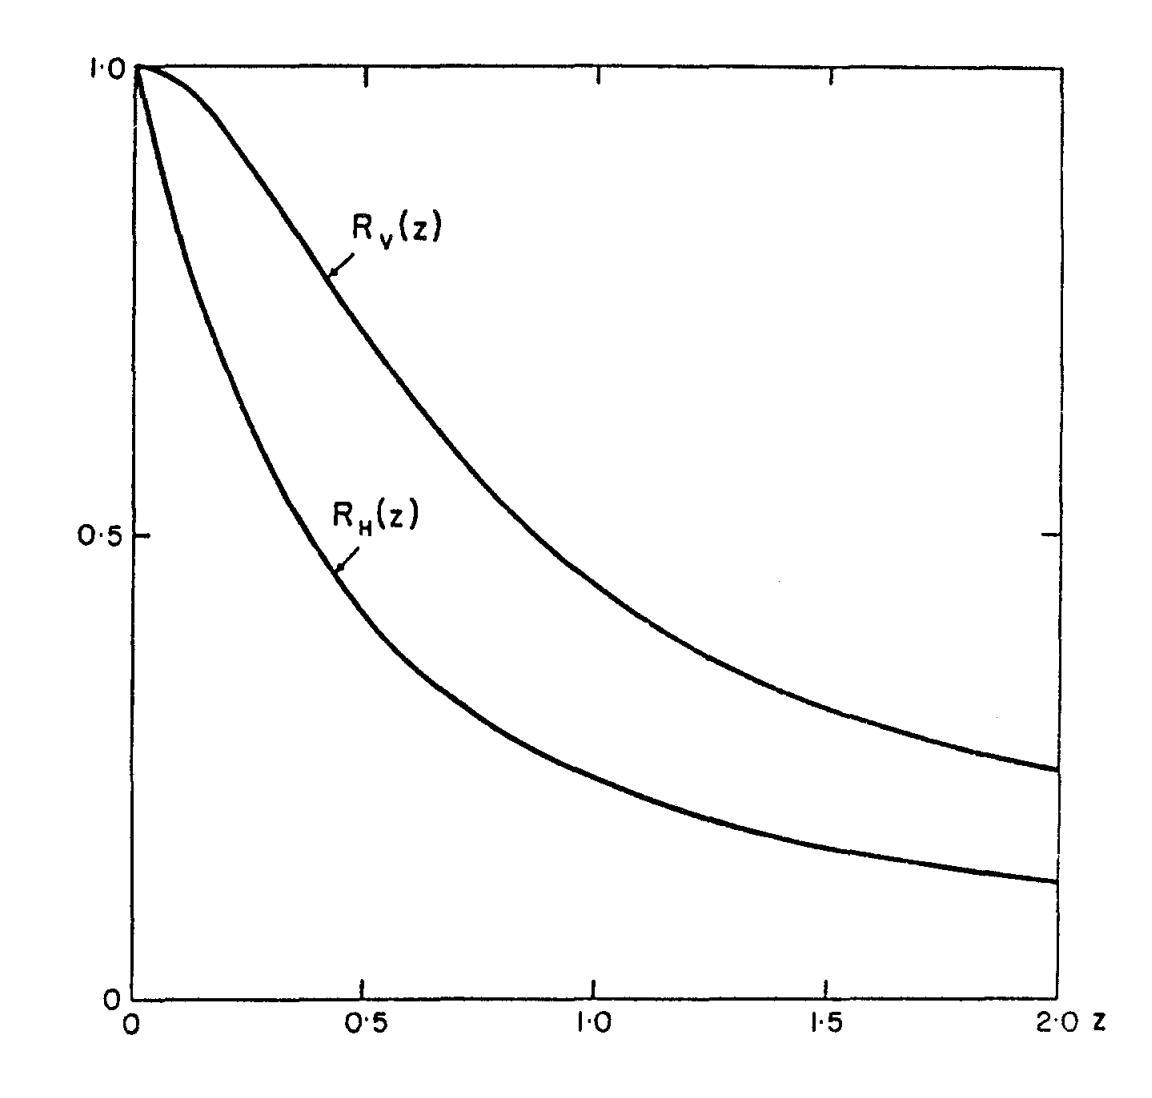
The curve labelled $R_{\gamma}(z)$ (= $1/(4z^2 + 1)^{1/2}$) in Figure 1 may be interpreted in the following way for a uniform earth: the response function at depth z will give the contribution to the measured conductivity from all material below that depth. Thus, at z = 0, the response function value is that for <u>all</u> the material below the instrument or $R_{\gamma}(z) = 1$, so that the apparent conductivity for a uniformly conductive earth is $\sigma_a = \sigma$ $R_{\gamma}(z) = \sigma$. The same interpretation may be made of $R_{\rm H}(z)$ (= $(4z^2 + 1)^{1/2} - 2z$).

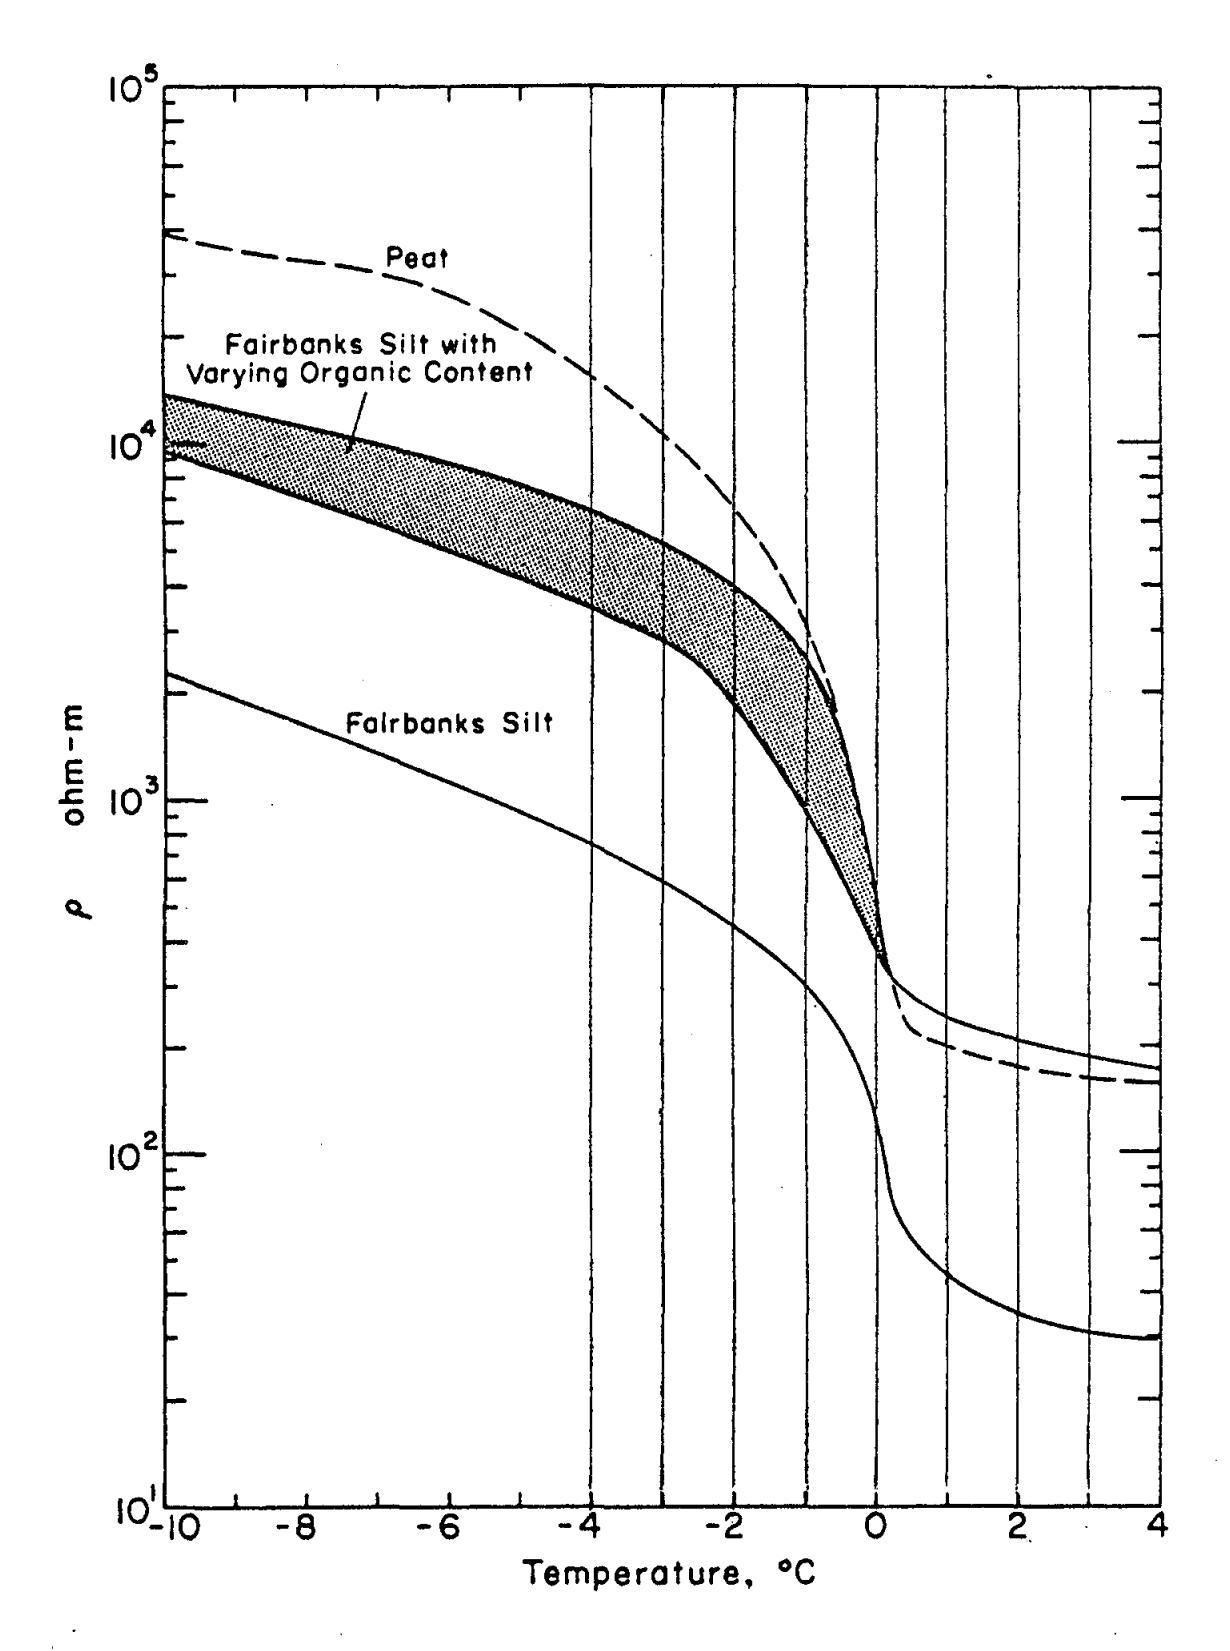
Figure 2. Resistivity of Fairbanks silt and other geotechnical materials as a function of temperature (after Hoekstra et al., 1974). Note the abscissa should be shifted to the right by 0.2C.

The graph of resistivity versus temperature for Fairbanks silt given in Figure 2 clearly shows why it is possible to differentiate frozen saturated silts from unfrozen saturated silts using the electromagnetic induction methods. For common permafrost temperatures in the Fairbanks area

(~ -2°C (28°F)), the resistivity is about a decade greater than that of the unfrozen permafrost material. Ice can be some 10 to 1000 times as resistive as water (see Johnston et al., 1981), which indicates that interstitial ice plays an important role in the determination of soil resistivities.

It should also be noted in Figure 2 that the resistivity does not rise in a precisely stepwise manner as the temperature decreases past the freezing point of water. This is a consequence of the existence of unfrozen water in the pore spaces of the soil matrix, even when the temperature is below the freezing point of water, due to surface and curvature effects and presence of solutes within the water, which depress the freezing point of water in localized volumes. Some water in the pore spaces may not freeze until the temperature is far below the freezing point of pure water.

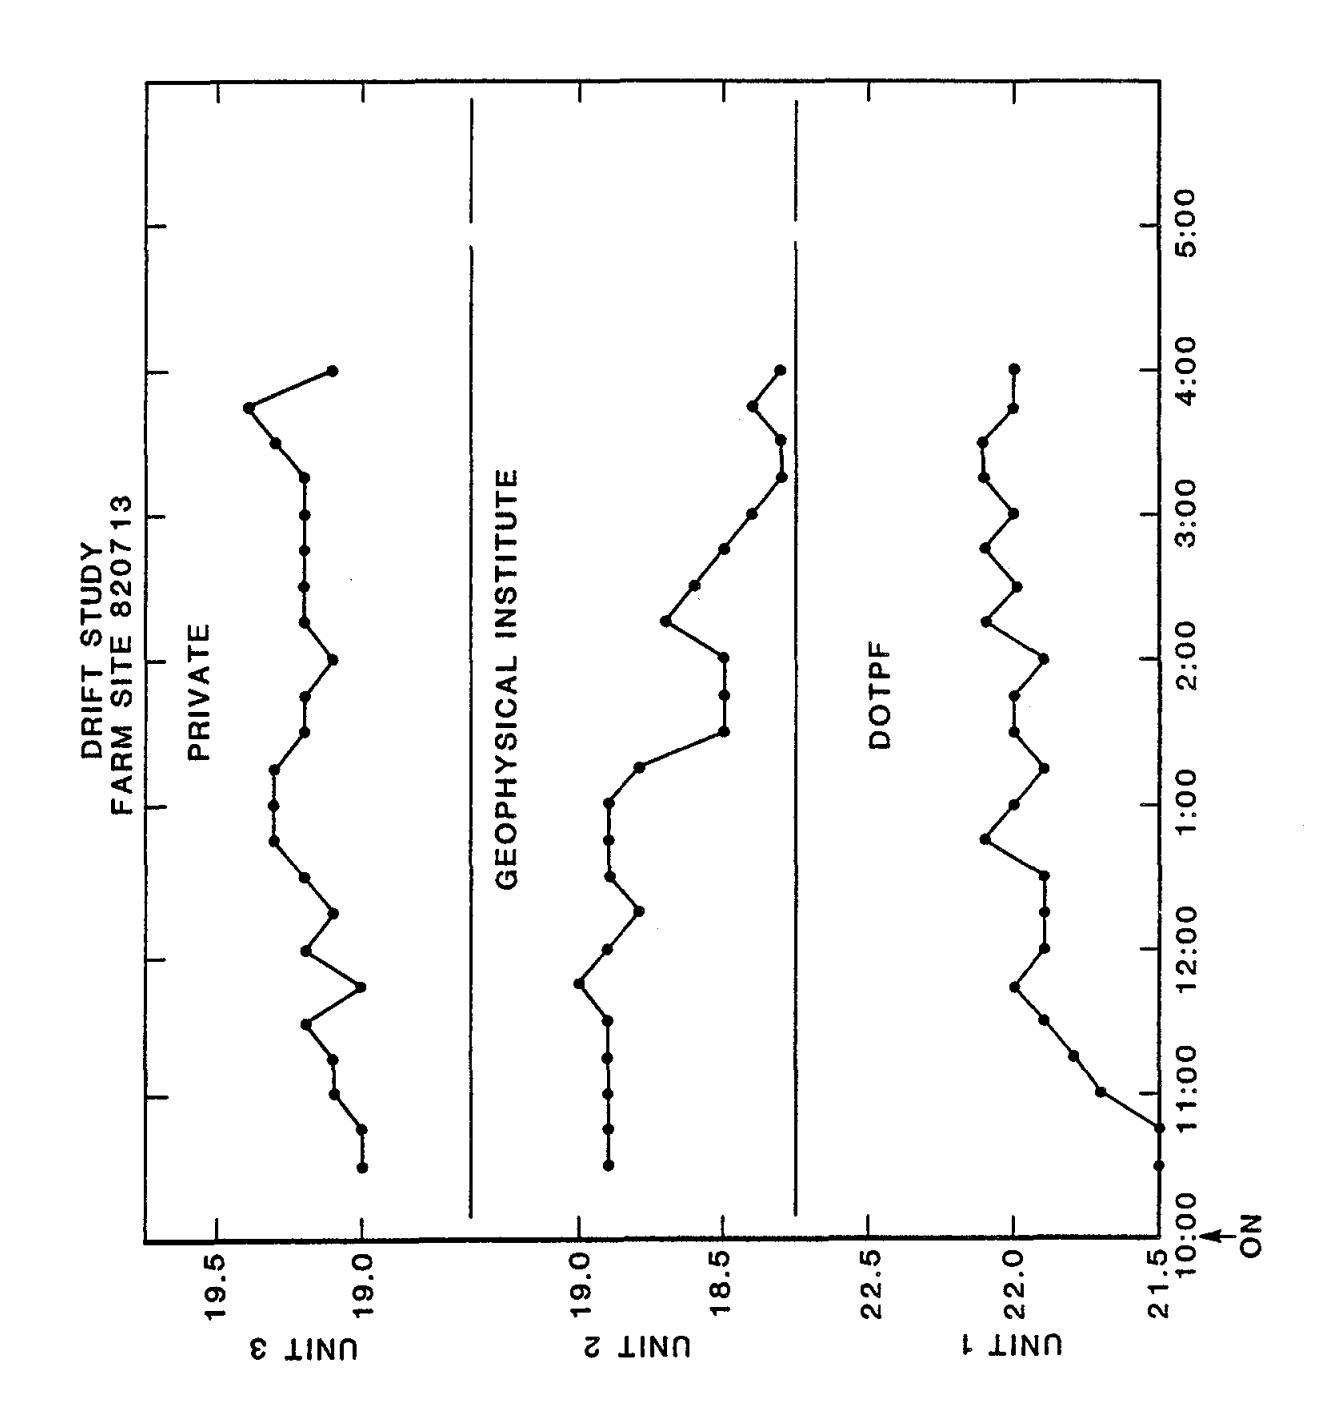
Figure 3. Instrumental drift of three different EM-31 units over a six hour period.

field surveys, our practice has been to replace the batteries after 6 to 8 hours or 1 day of use. Figure 3 suggests that the newer models may be more stable even after 6 hours of operation, so that the batteries may not have to be replaced for several more hours. The extremely low temperatures in Alaska are a serious constraint on battery lifetime. While such conditions require more frequent replacement of batteries, the instrument functions down to -50C.

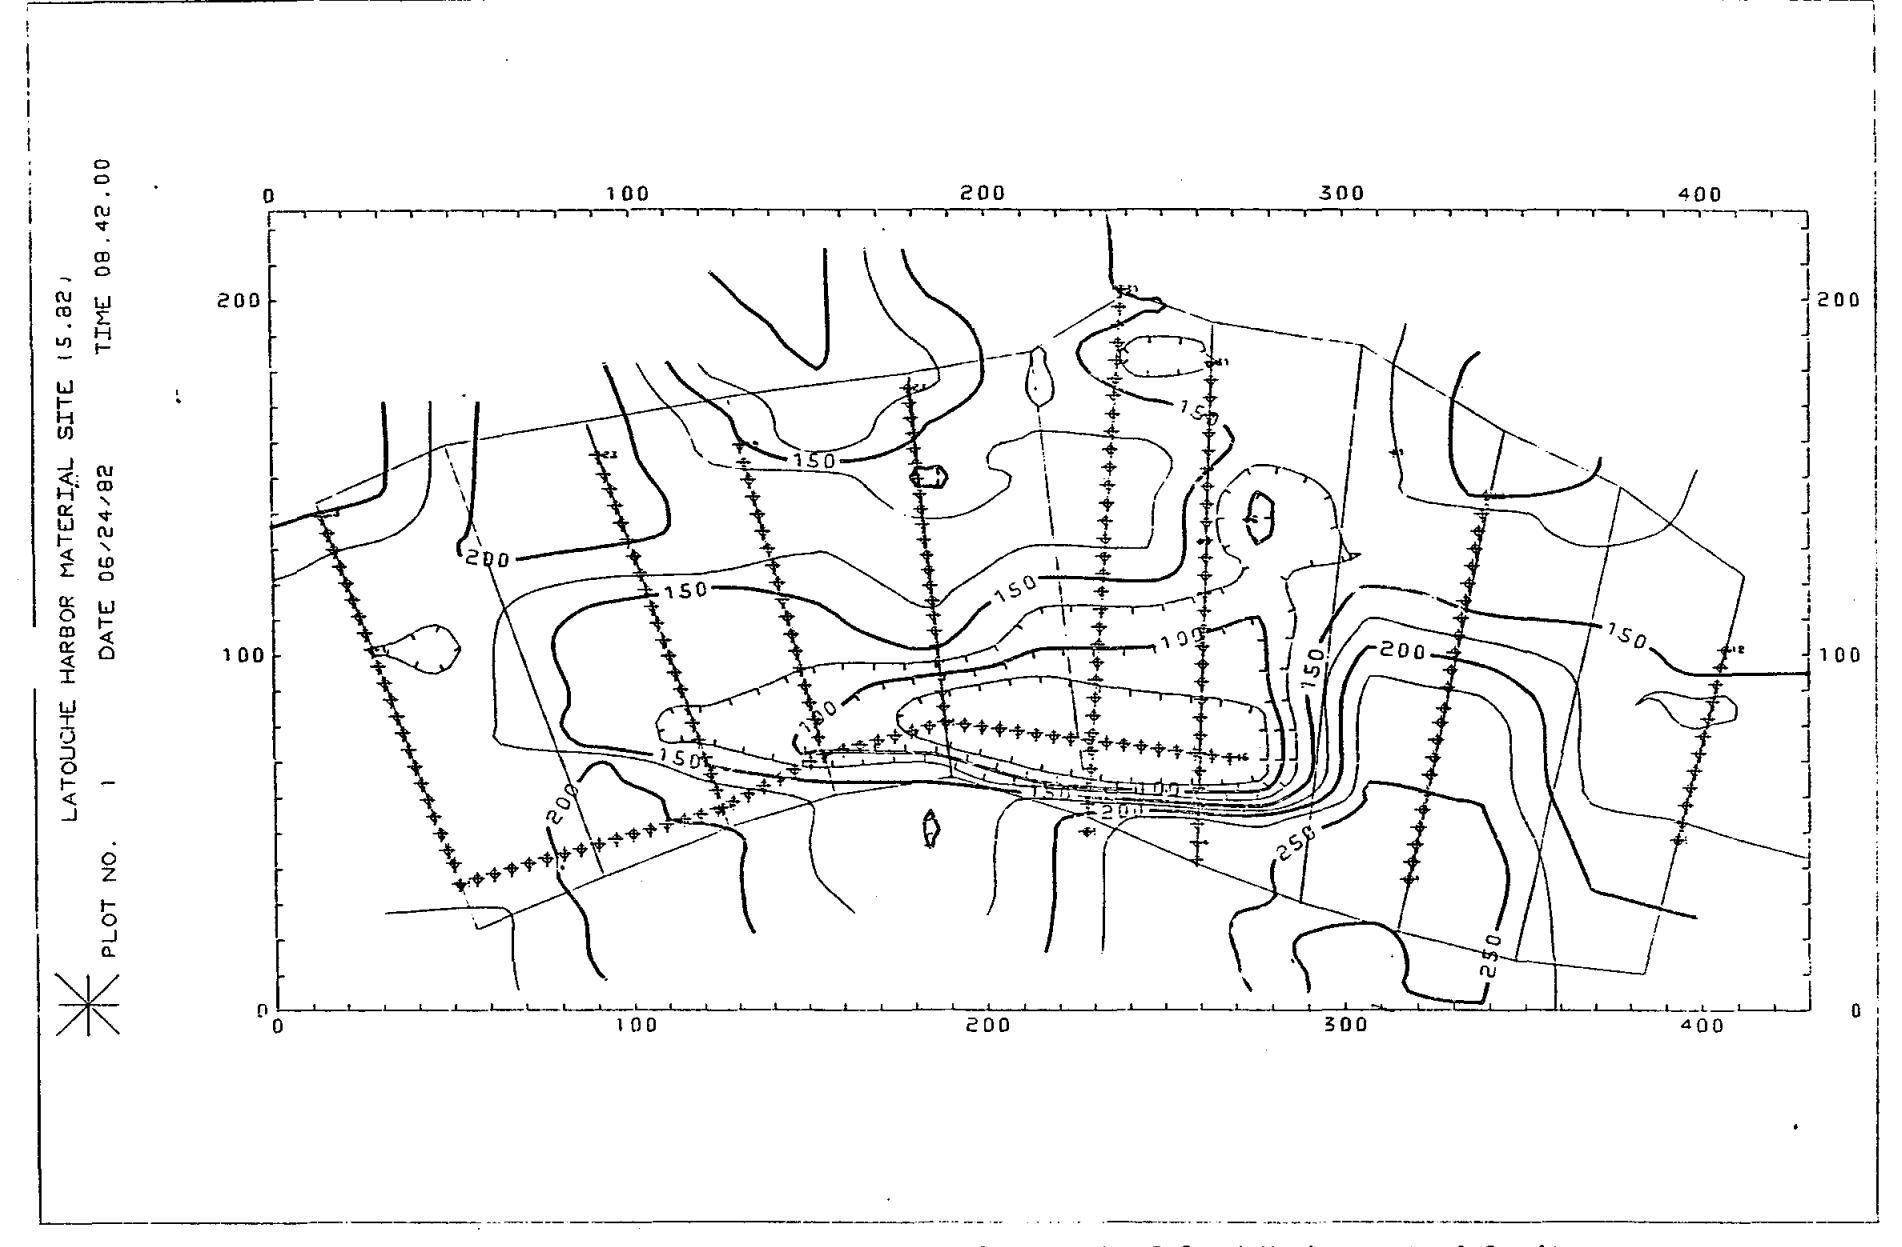
Figure 5. Isoresistivity contours of Latouche Island-Harbor material site in the township of Latouche.

- Data Plots: Figure 5 shows the results of the resistivity survey. There are two high points in the elevation located at (140, 120 ft; 43, 37 m) and 310, 30 ft; 95, 9 m) with height above sea level > 95 (26) and > 80 ft (24 m), respectively.
- Interpretation: The resistivity survey appears to have detected the more conductive, moisture-laden overburden of thick humus. A seismic survey taken over the area suggests the overburden of humus plus till/weathered rock is quite thick exceeding 20 ft. (6 m) in many places. Thus, if the seismic data are to be believed, the resistivity values are likely to be representative of the underlying solid bedrock in only a few areas. The duck-shaped low resistivity region

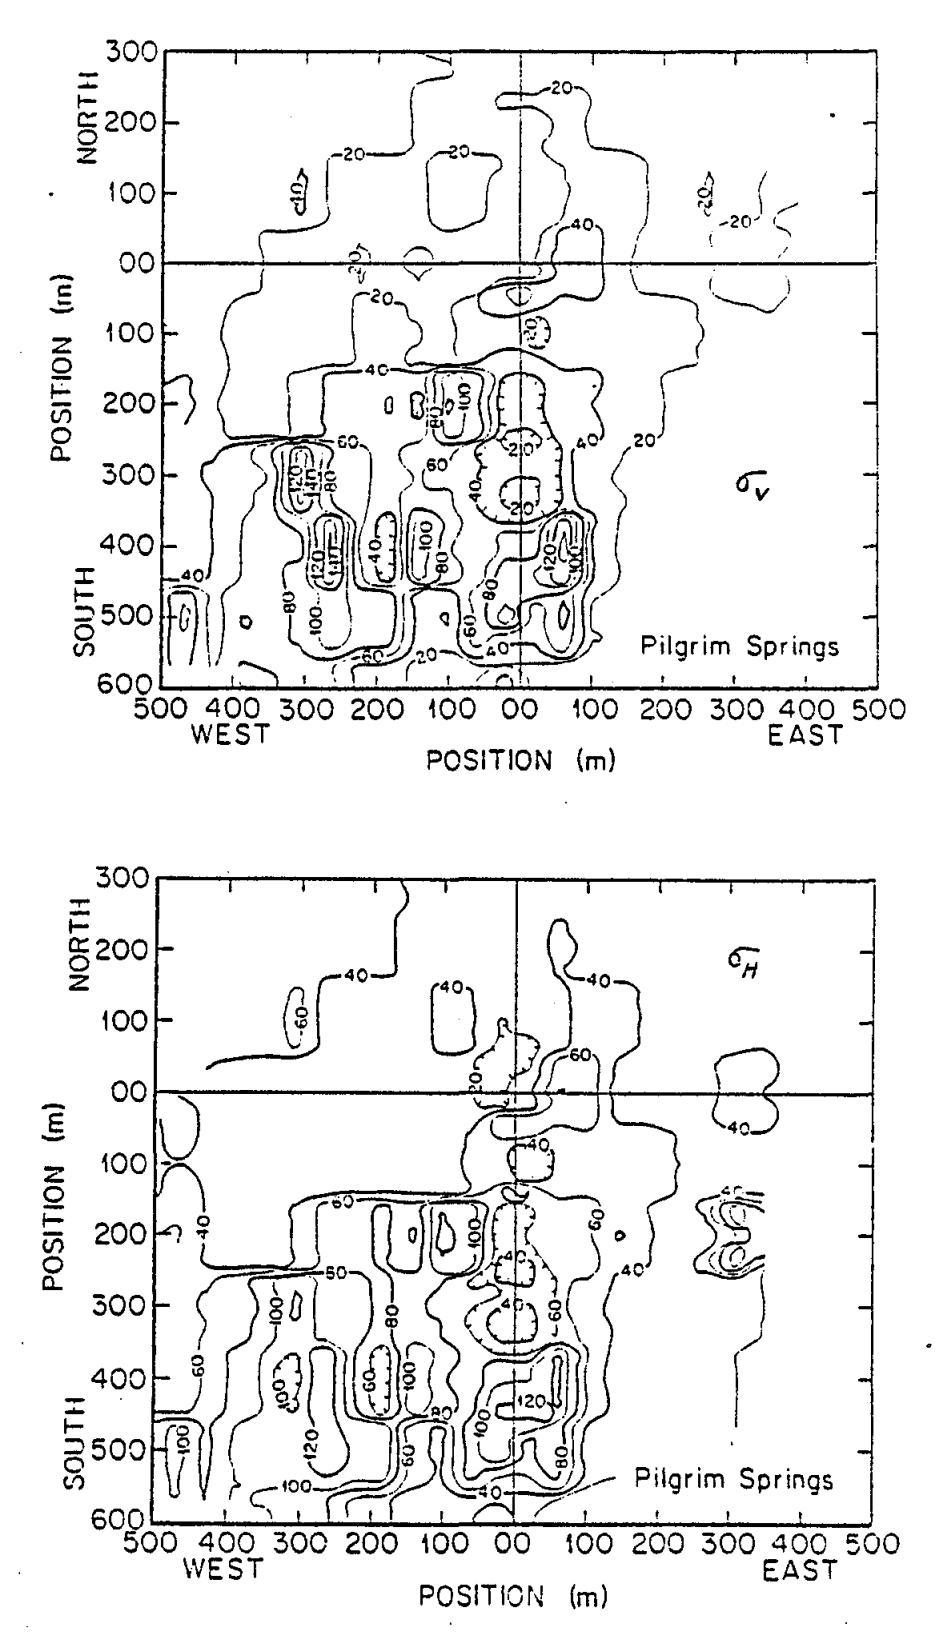
Figure 6. Isoconductivity contours of Pilgrim Springs geothermal site. The upper panel labelled σ_V gives the contours for the vertical coplanar mode and the lower that for the horizontal coplanar mode σ_H . Note subscript V and H here and in Figures 7, 8 and 9 have opposite meaning from those of Figure 1 (and subsequent discussions) where V denotes vertical dipole and H horizontal dipole orientations.

- Location: New Pilgrim Springs airstrip extending from about (0,100S) to (150W, 350S) of Figure 6.
- Purpose: To delineate thermal convective hydrologic flow by the use of conductivity (resistivity) data.

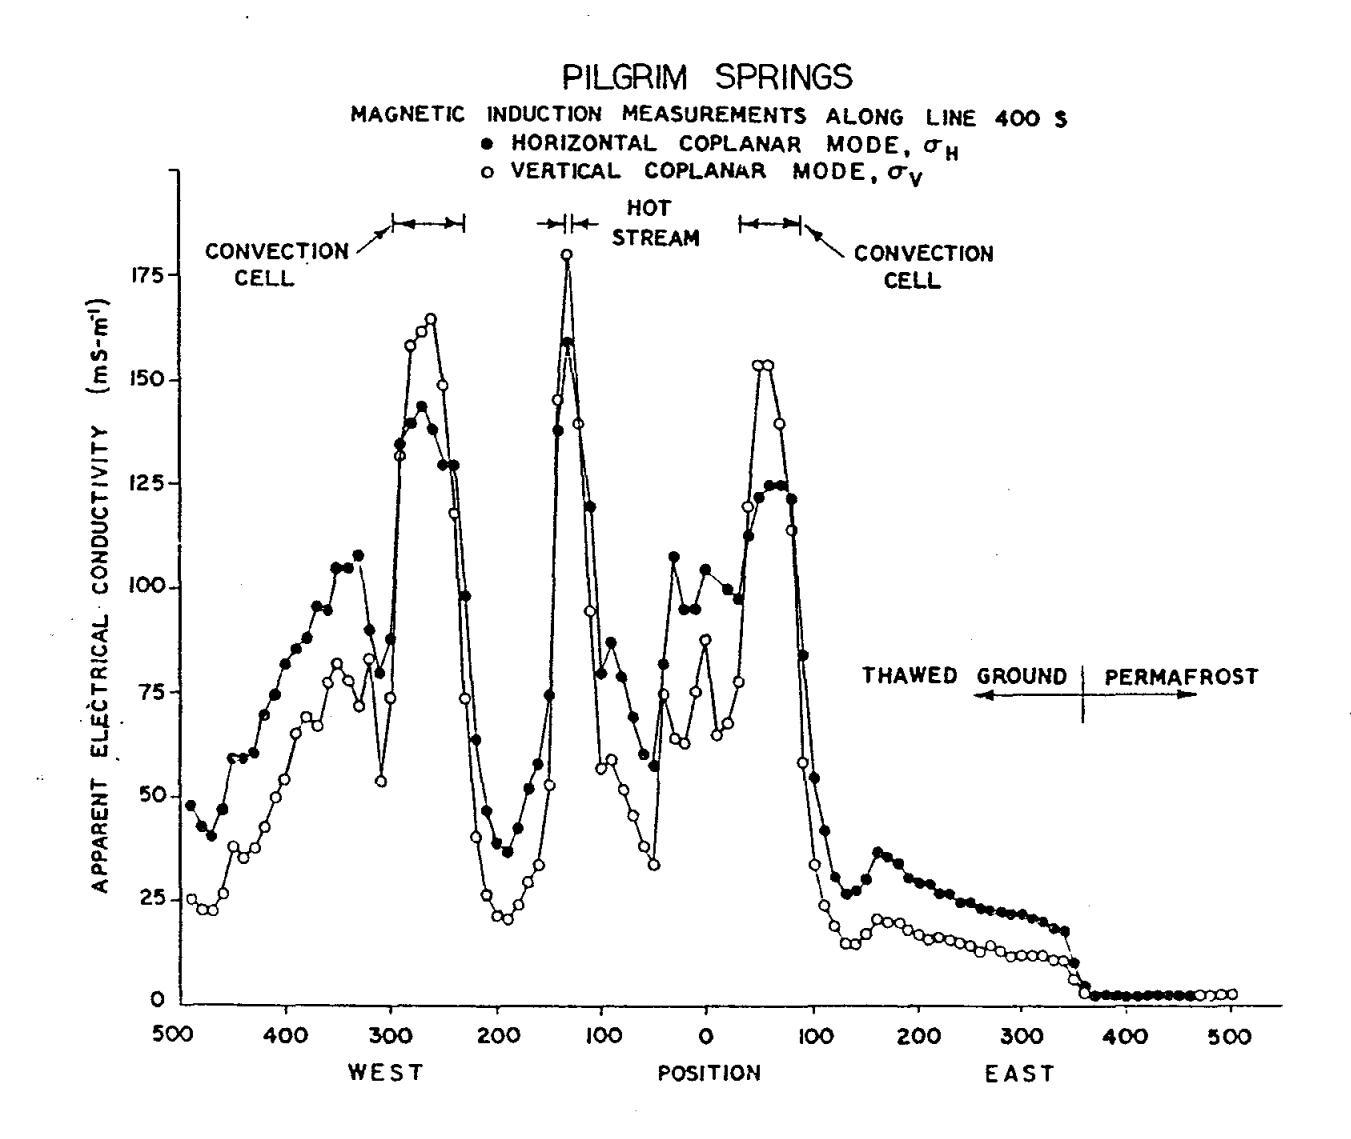
Figure 7. Conductivity profiles for vertical coplanar mode V and horizontal coplanar H along the 400 S grid line of Figure 6.

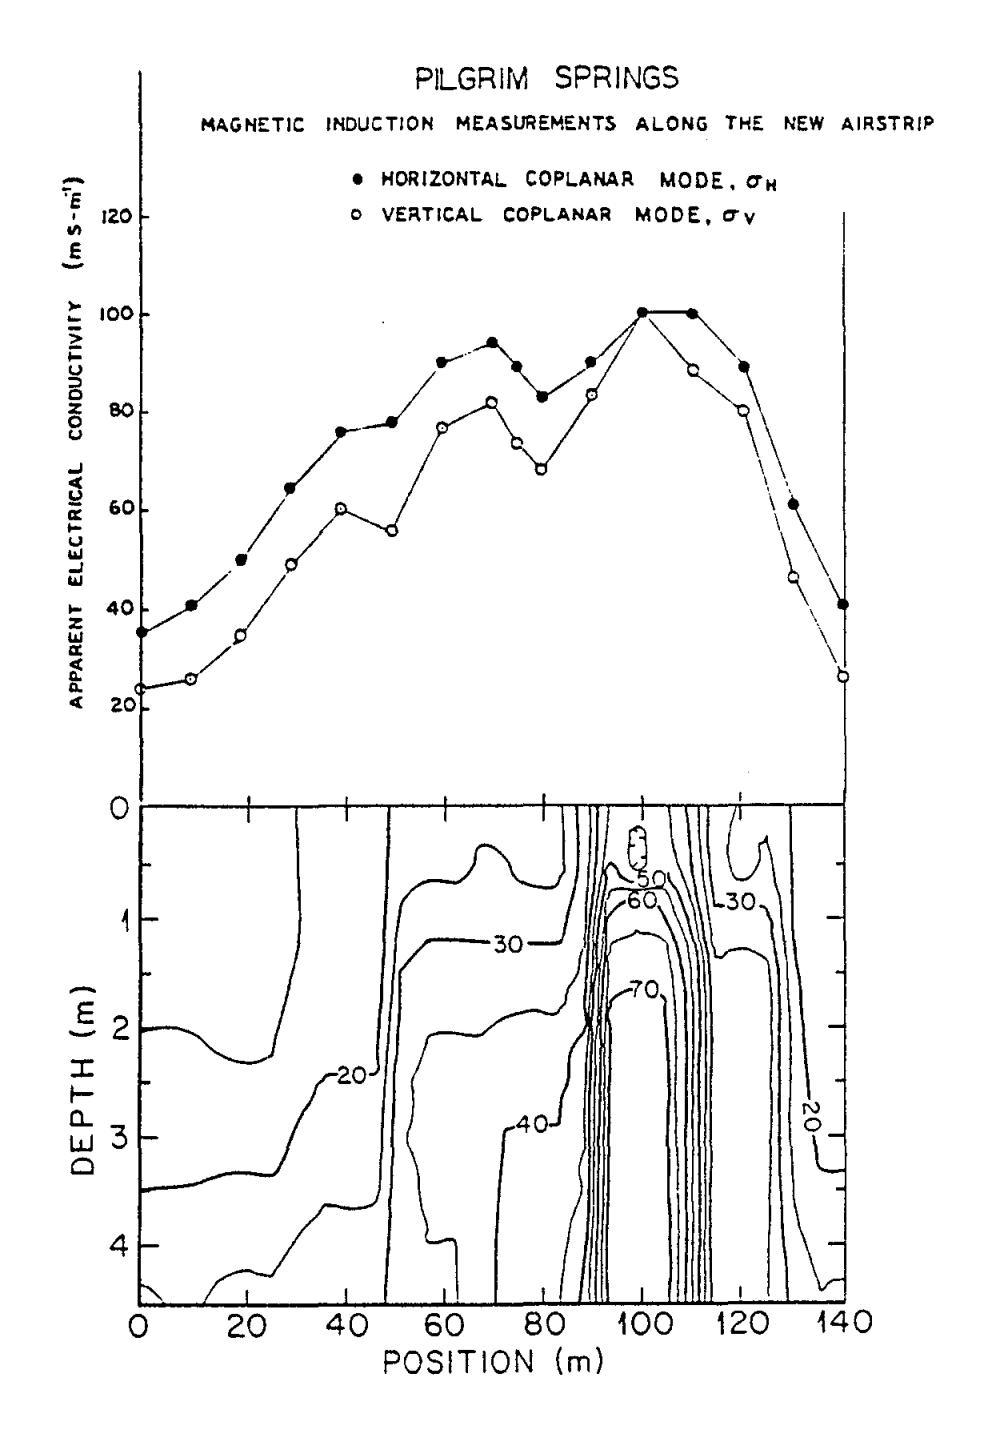
Figure 8. Conductivity profiles σ_V and σ_H (vertical and horizontal coplanar orientations, respectively) along centerline of new Pilgrim Springs airstrip (upper panel) and isotemperature contours to the 4.5 m depth along the same line.

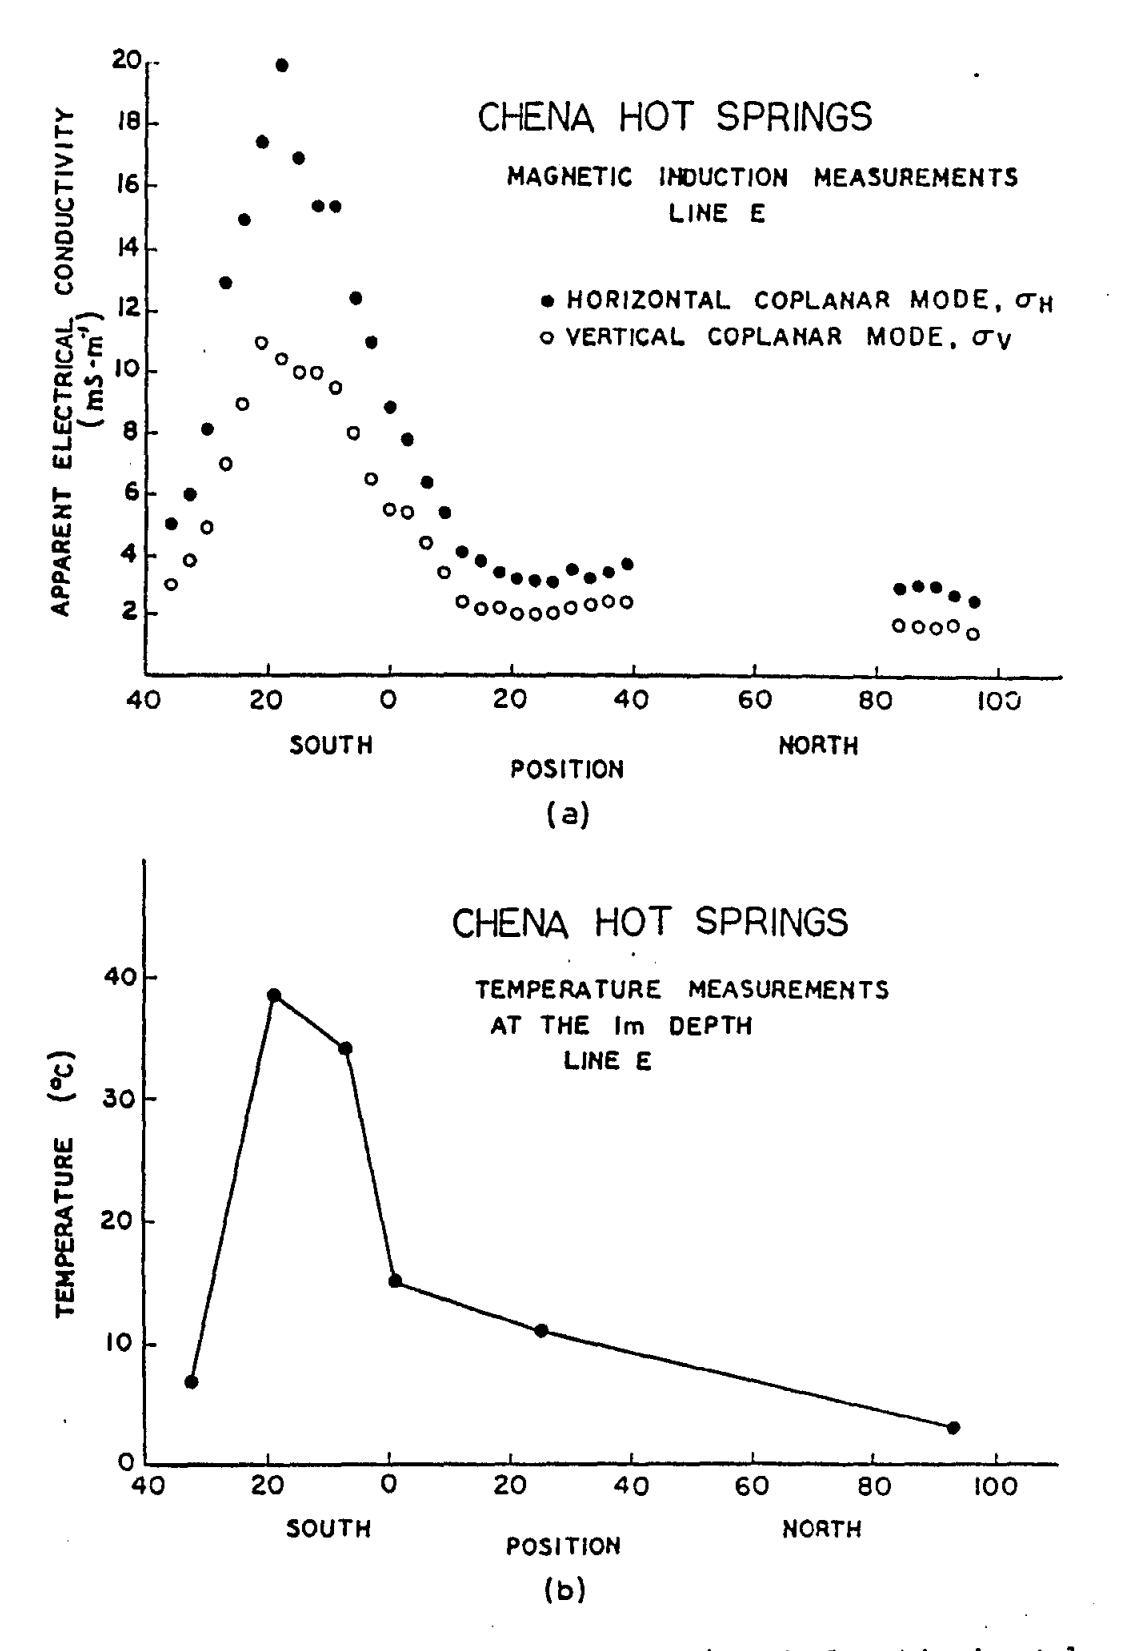
Figure 9. Conductivity profiles oy and o_H (vertical and horizontal coplanar orientations, respectively) along a 140 m line across a hot spot and warm stream at Chena Hot Springs and temperature at 1 m depth along the same line.

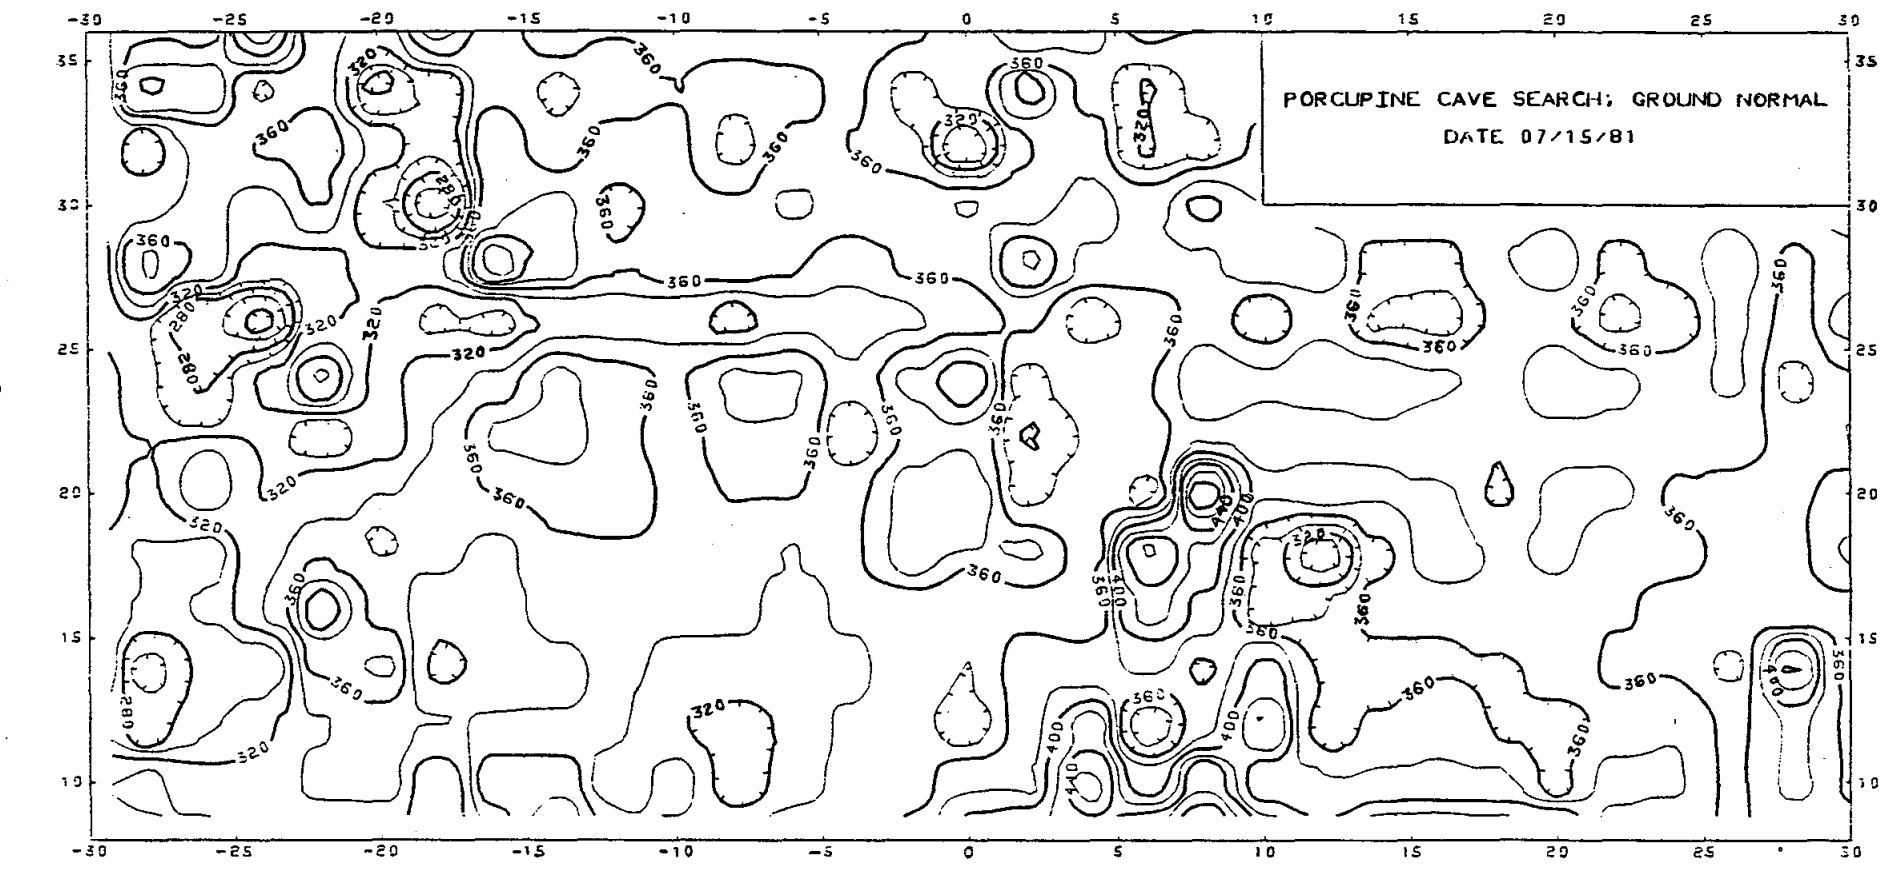
Figure 10. Isoresistivity contours of Porcupine River Archaeological site in normal mode (= vertical dipoles = horizontal coplanar) at ground level.

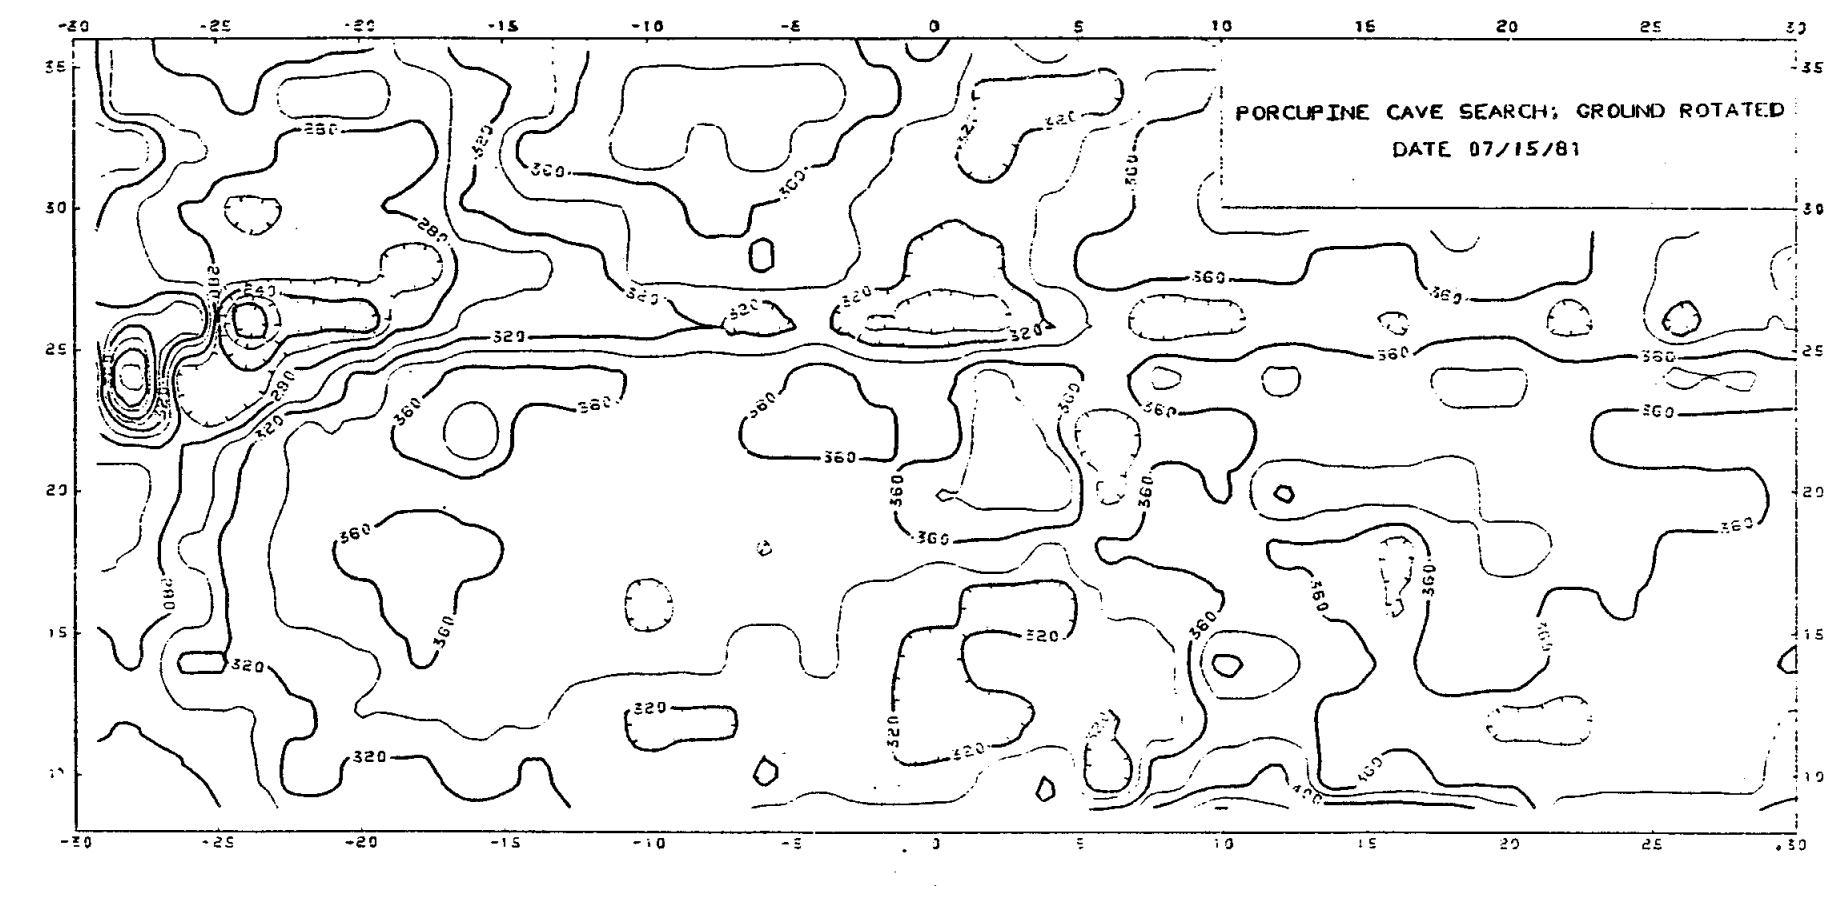
Figure 11. Isoresistivity contours of Procupine River Archaeological site in rotated mode (= horizontal dipoles = vertical coplanar) at ground level.

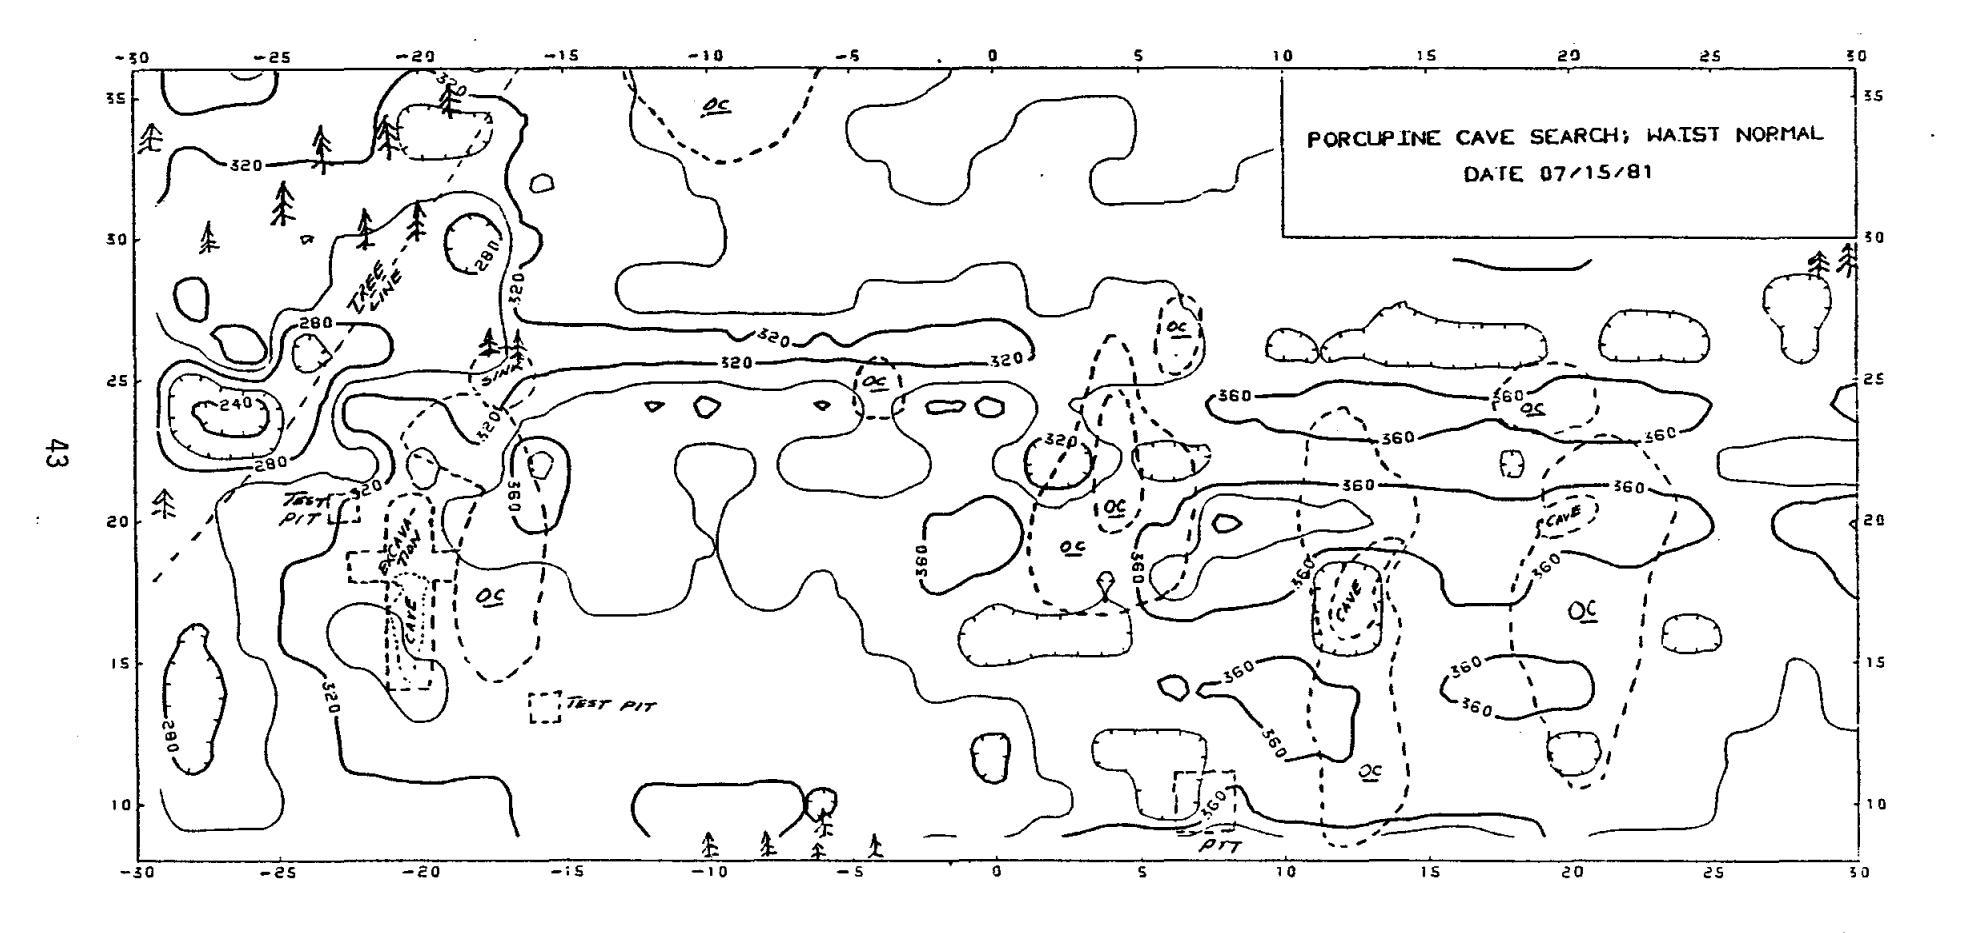
Figure 12. Isoresistivity contours of Procupine River Archaeological site in normal mode at waist level together with mappings of vegetation, limestone outcrops, caves, etc.

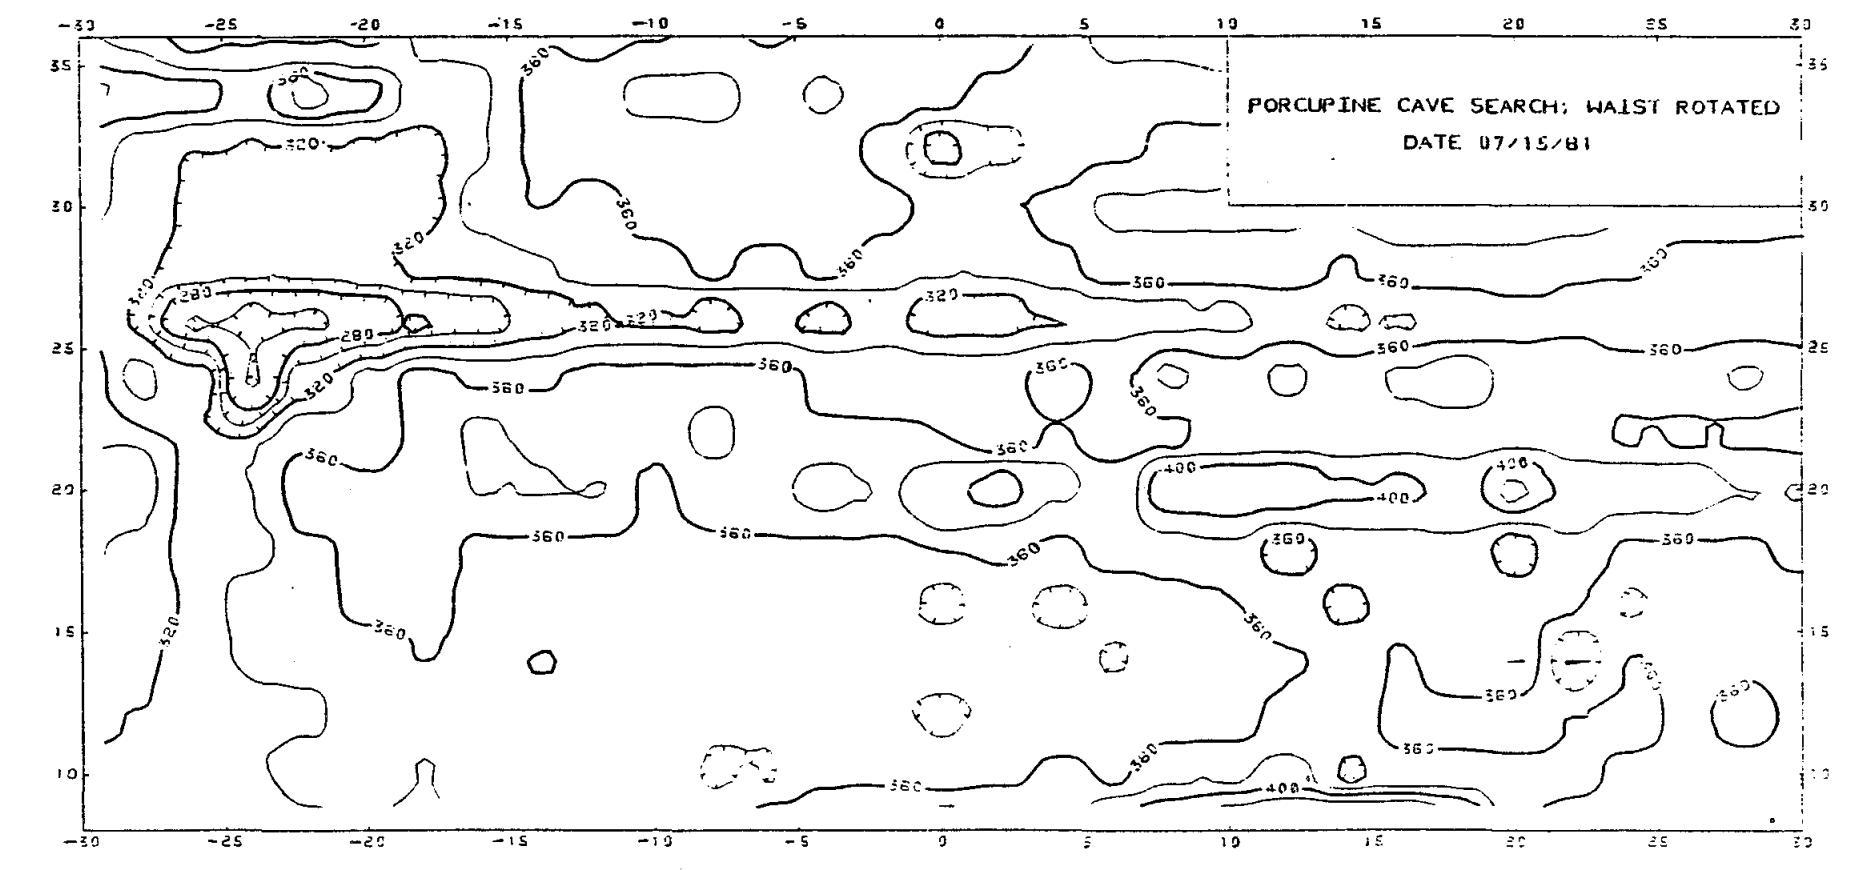
Figure 13. Isoresistivity contours of Porcupine River Archaeological site in rotated mode at waist level.
