ELECTROMAGNETIC INDUCTION MEASUREMENTS IN PERMAFROST TERRAIN FOR DETECTING GROUND ICE AND ICE-RICH SOILS

FINAL REPORT

Koji Kawasaki and Thomas E. Osterkamp Geophysical Institute University of Alaska Fairbanks, Alaska 99701

December 1984

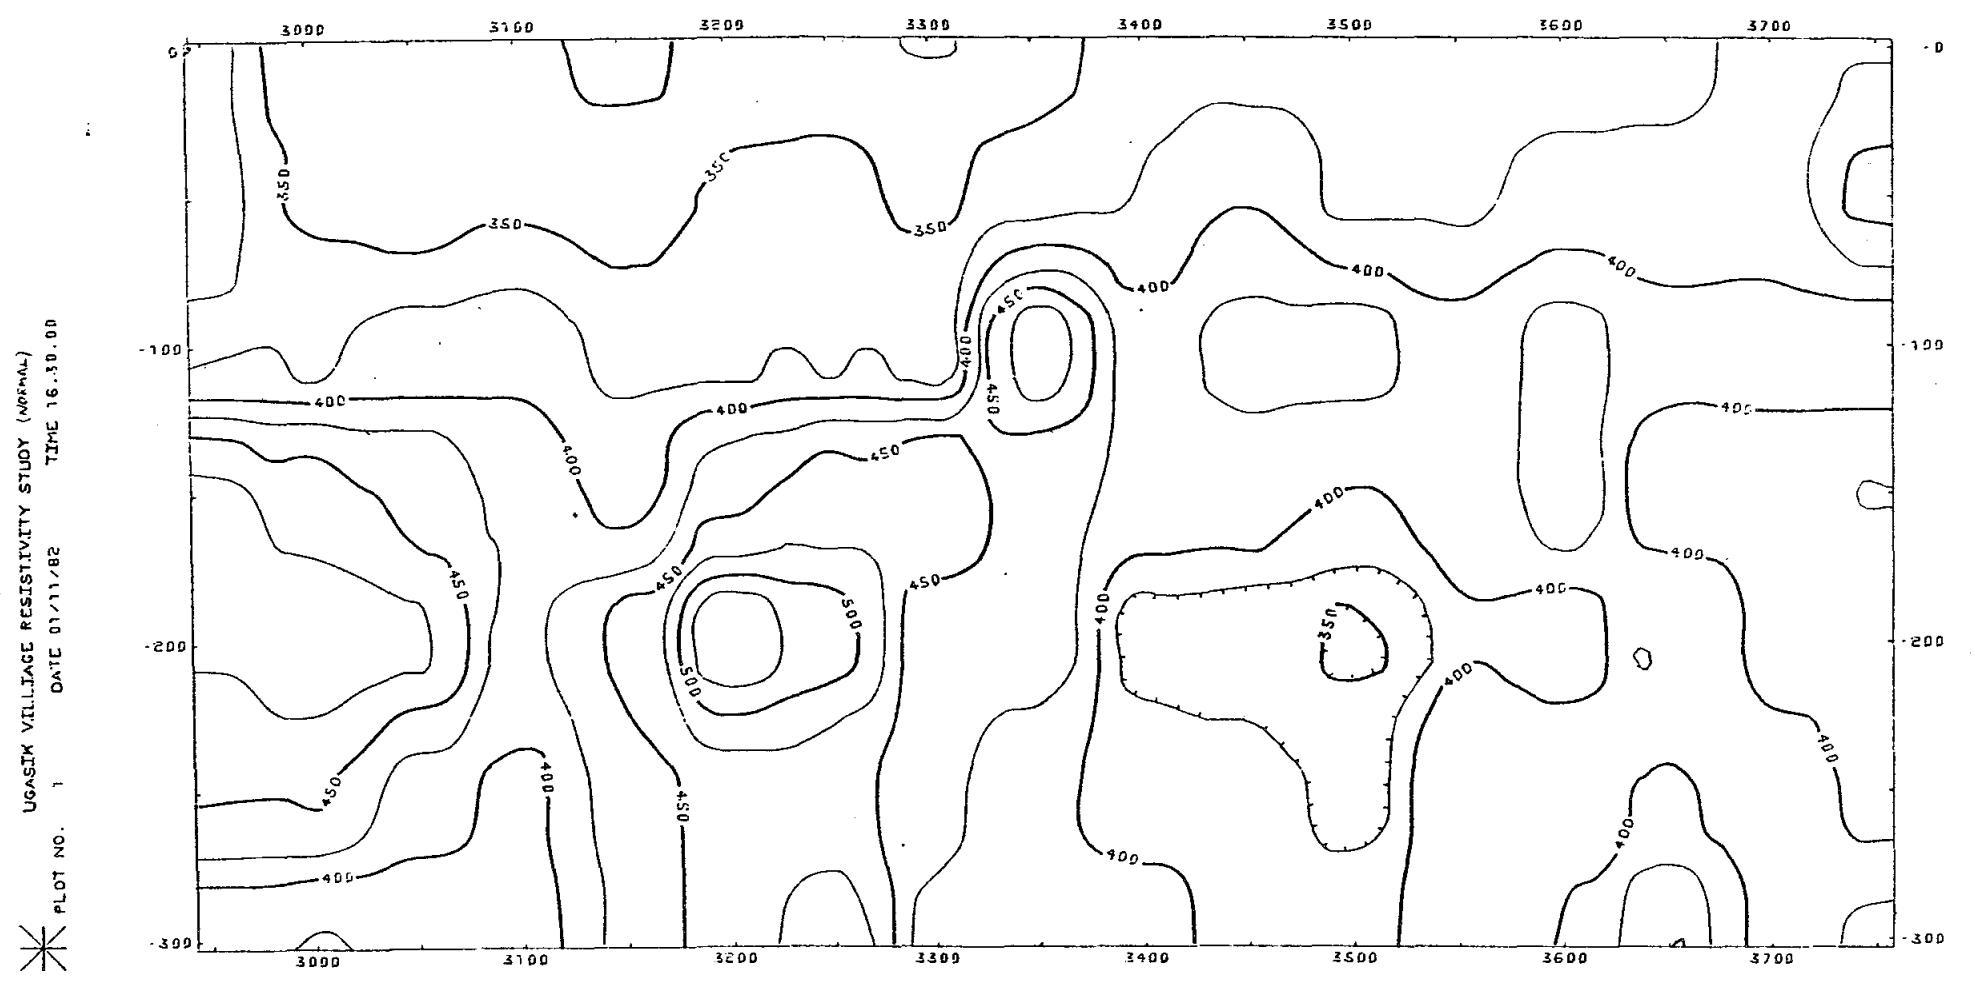
Figure 14. Isoresistivity contours of proposed Ugashik airport borrow site in normal mode at waist level.

Date Plot(s): Figure 14, 15 and 16 show the results of the survey over the potential borrow site. The grid spacing used was 50' (~ 15 m), so that 119 separate readings were taken over an area 800 x 300 ft. (244 x 91 m). This spacing was deemed sufficient for mapping a borrow site, since considerable material is generally required and smaller scale anomalies possibly corresponding to suitable paving material would not be of economic interest. Figure 14 and 15 give the isoresistivity contours in the waist-high, normal and rotated positions, while Figure 16 shows the isointensity contours of the ratio of the rotated to normal readings.

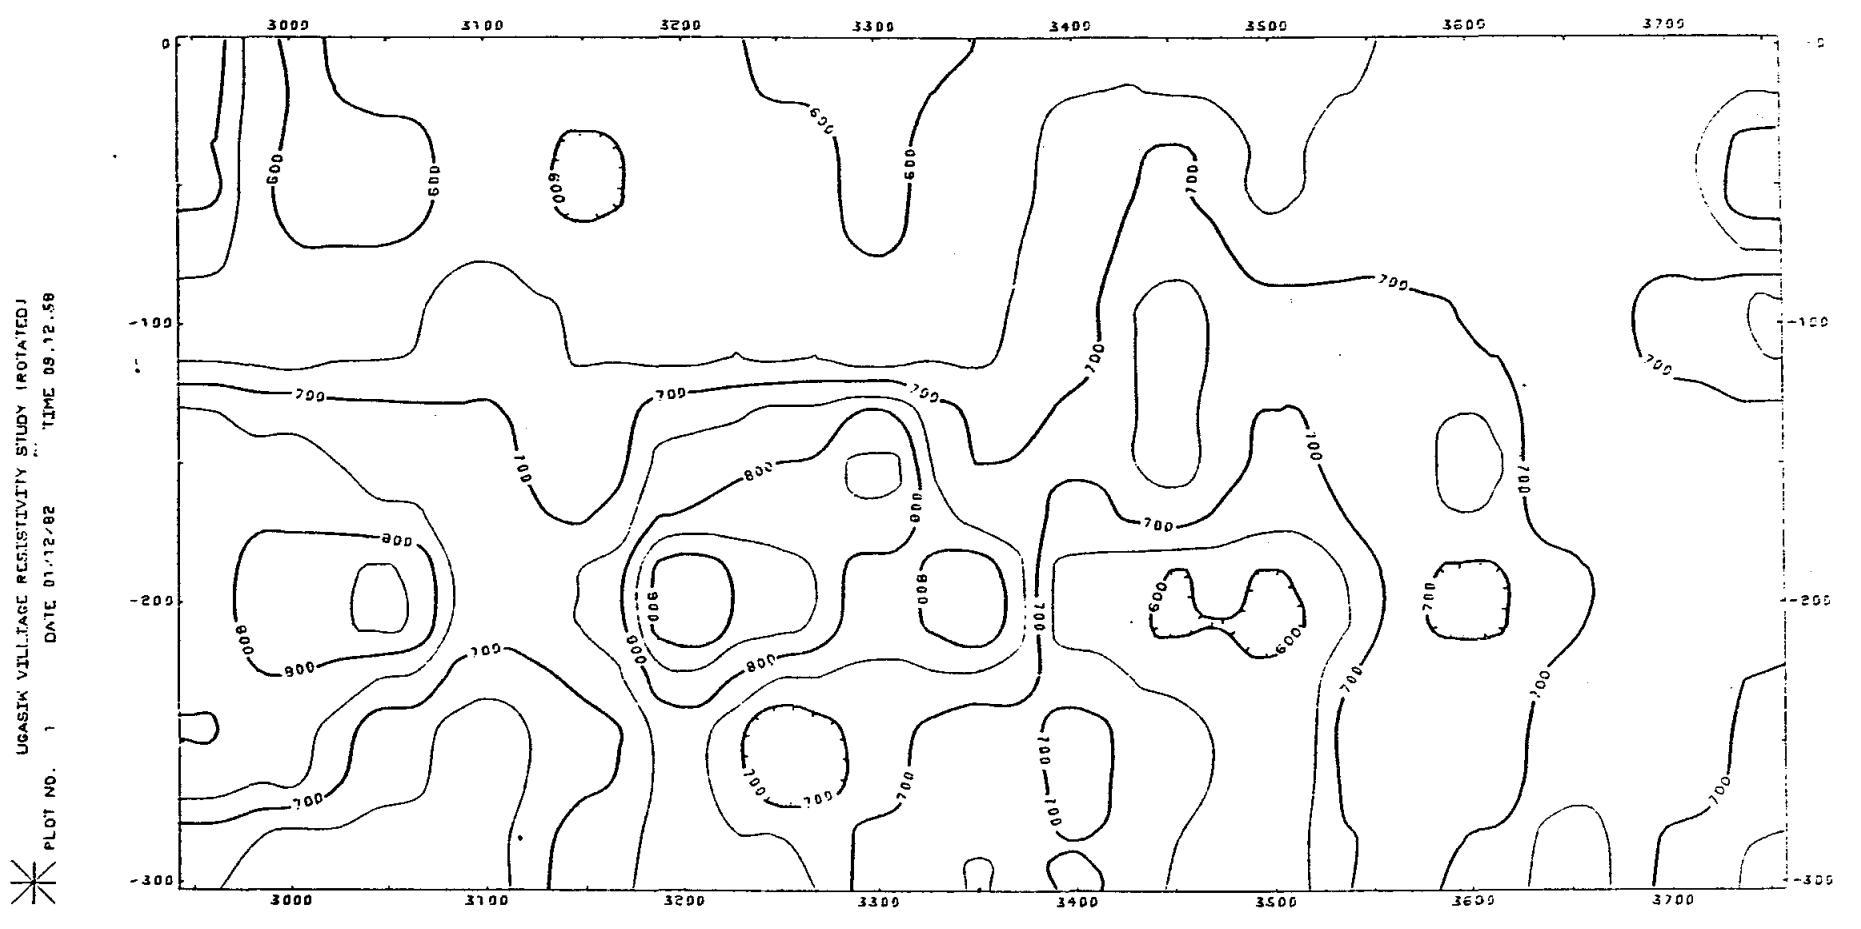
Figure 15. Isoresistivity contours of proposed Ugashik airport borrow site in rotated mode at waist level.

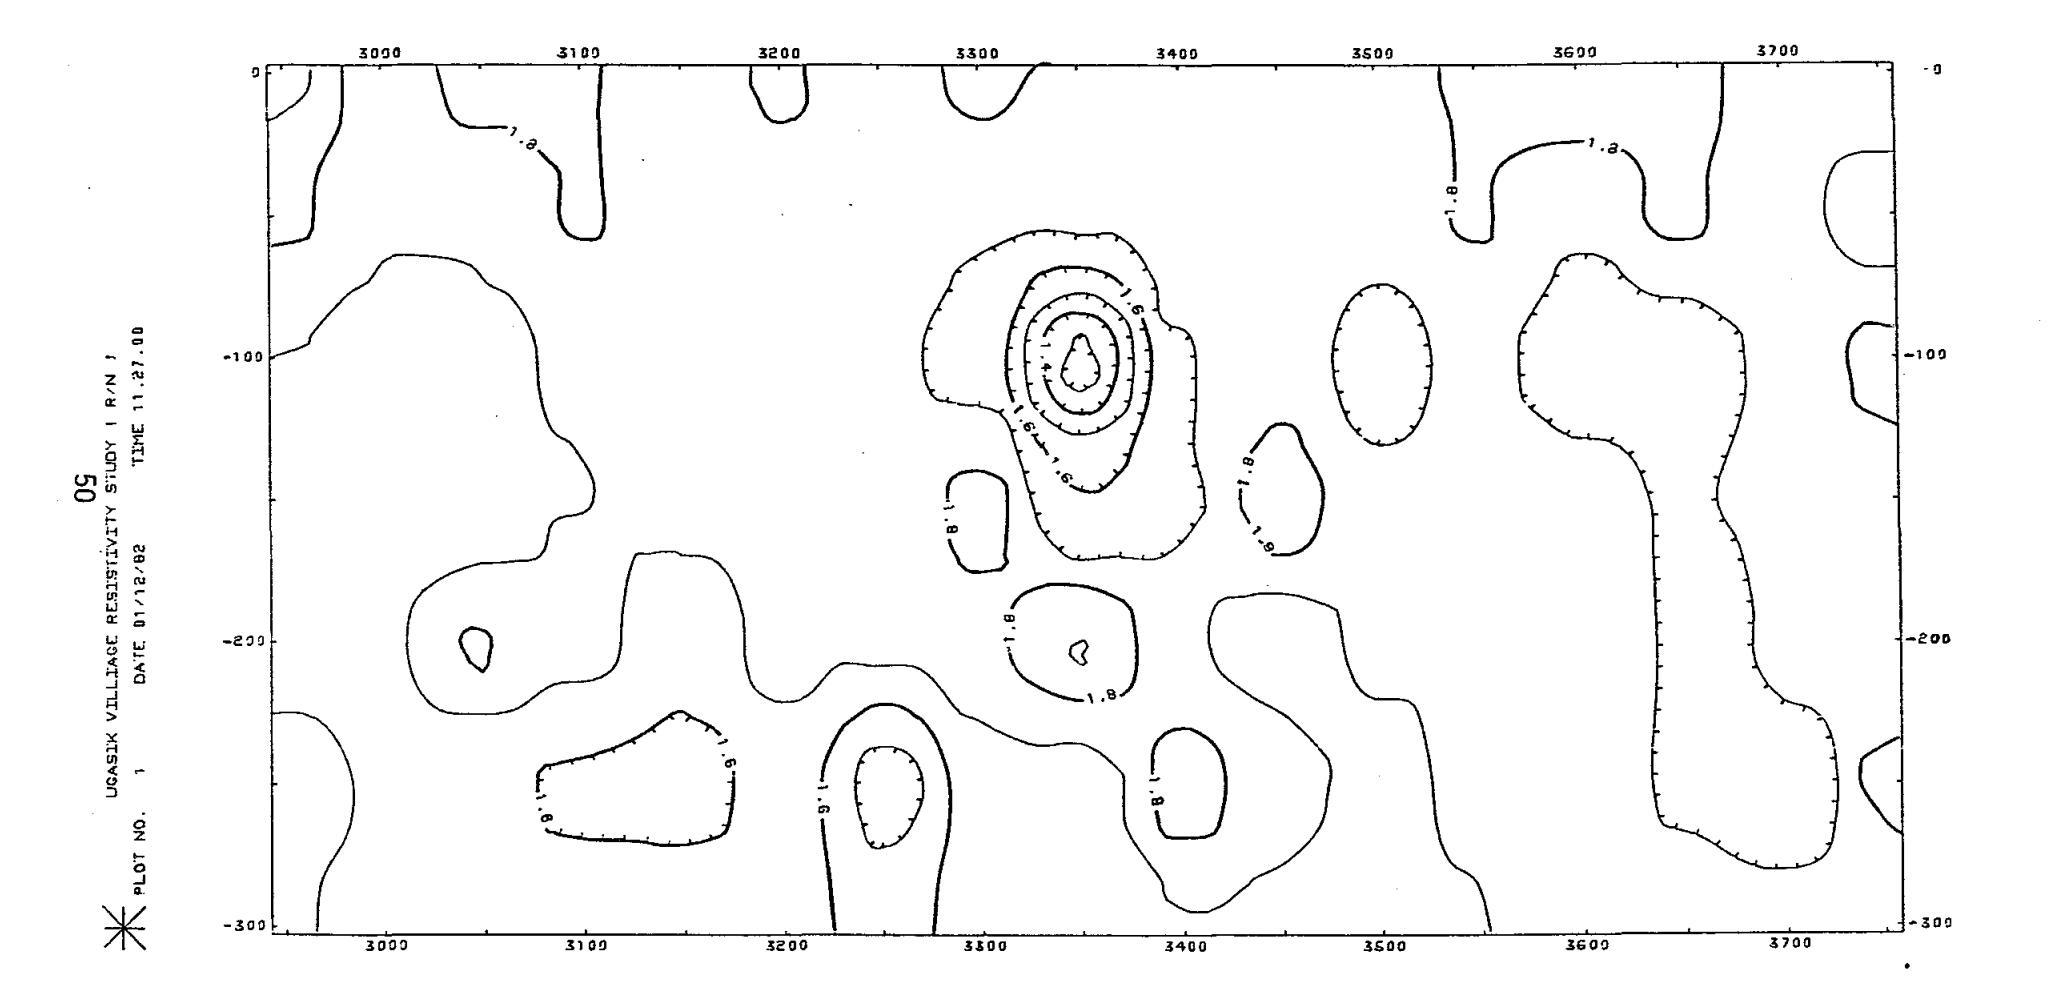
Figure 16. Isointensity contours of the ratio of rotated to normal resistivity values at proposed Ugashik airport borrow site.

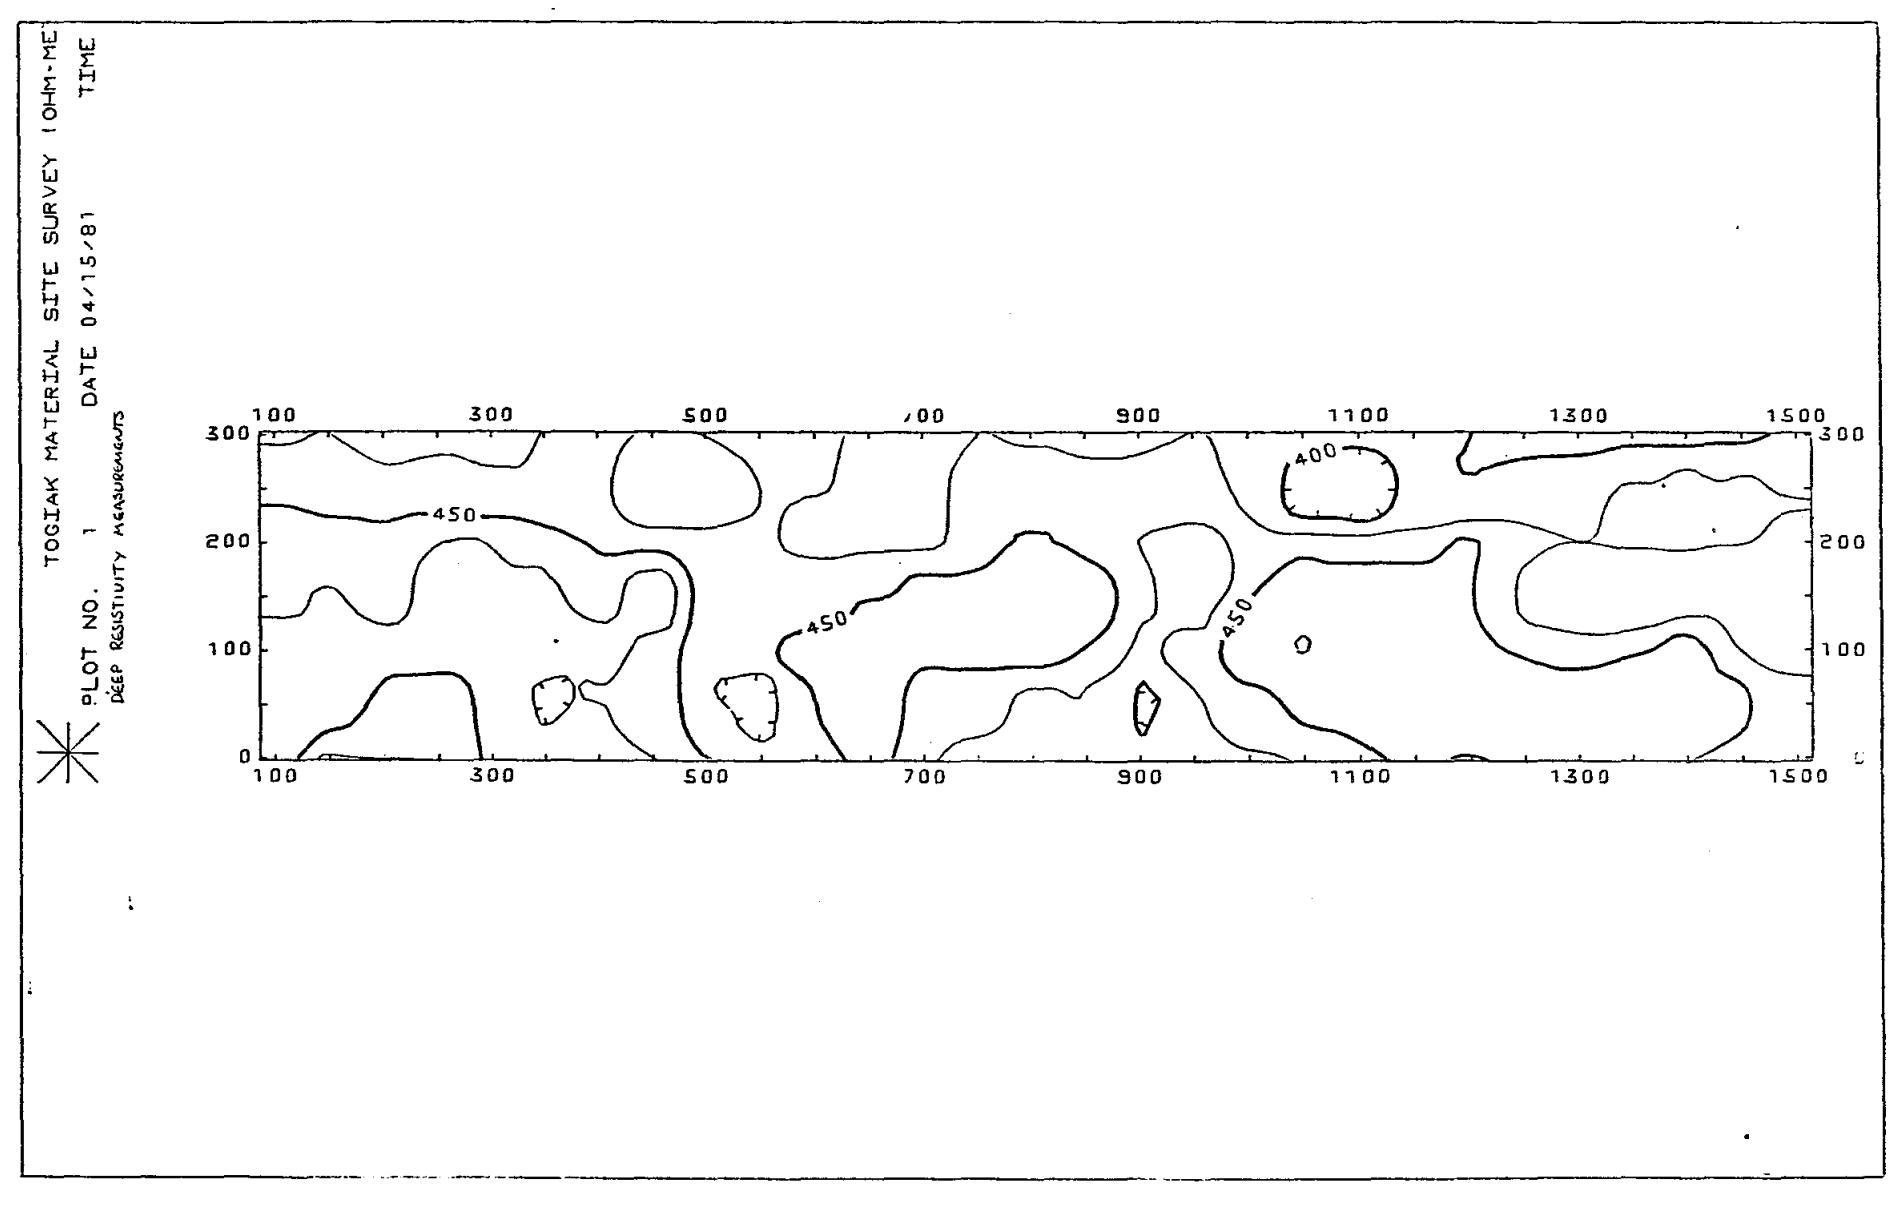
Figure 17. Isoresistivity contours of borrow site for proposed Togiak airstrip in normal mode at waist level.

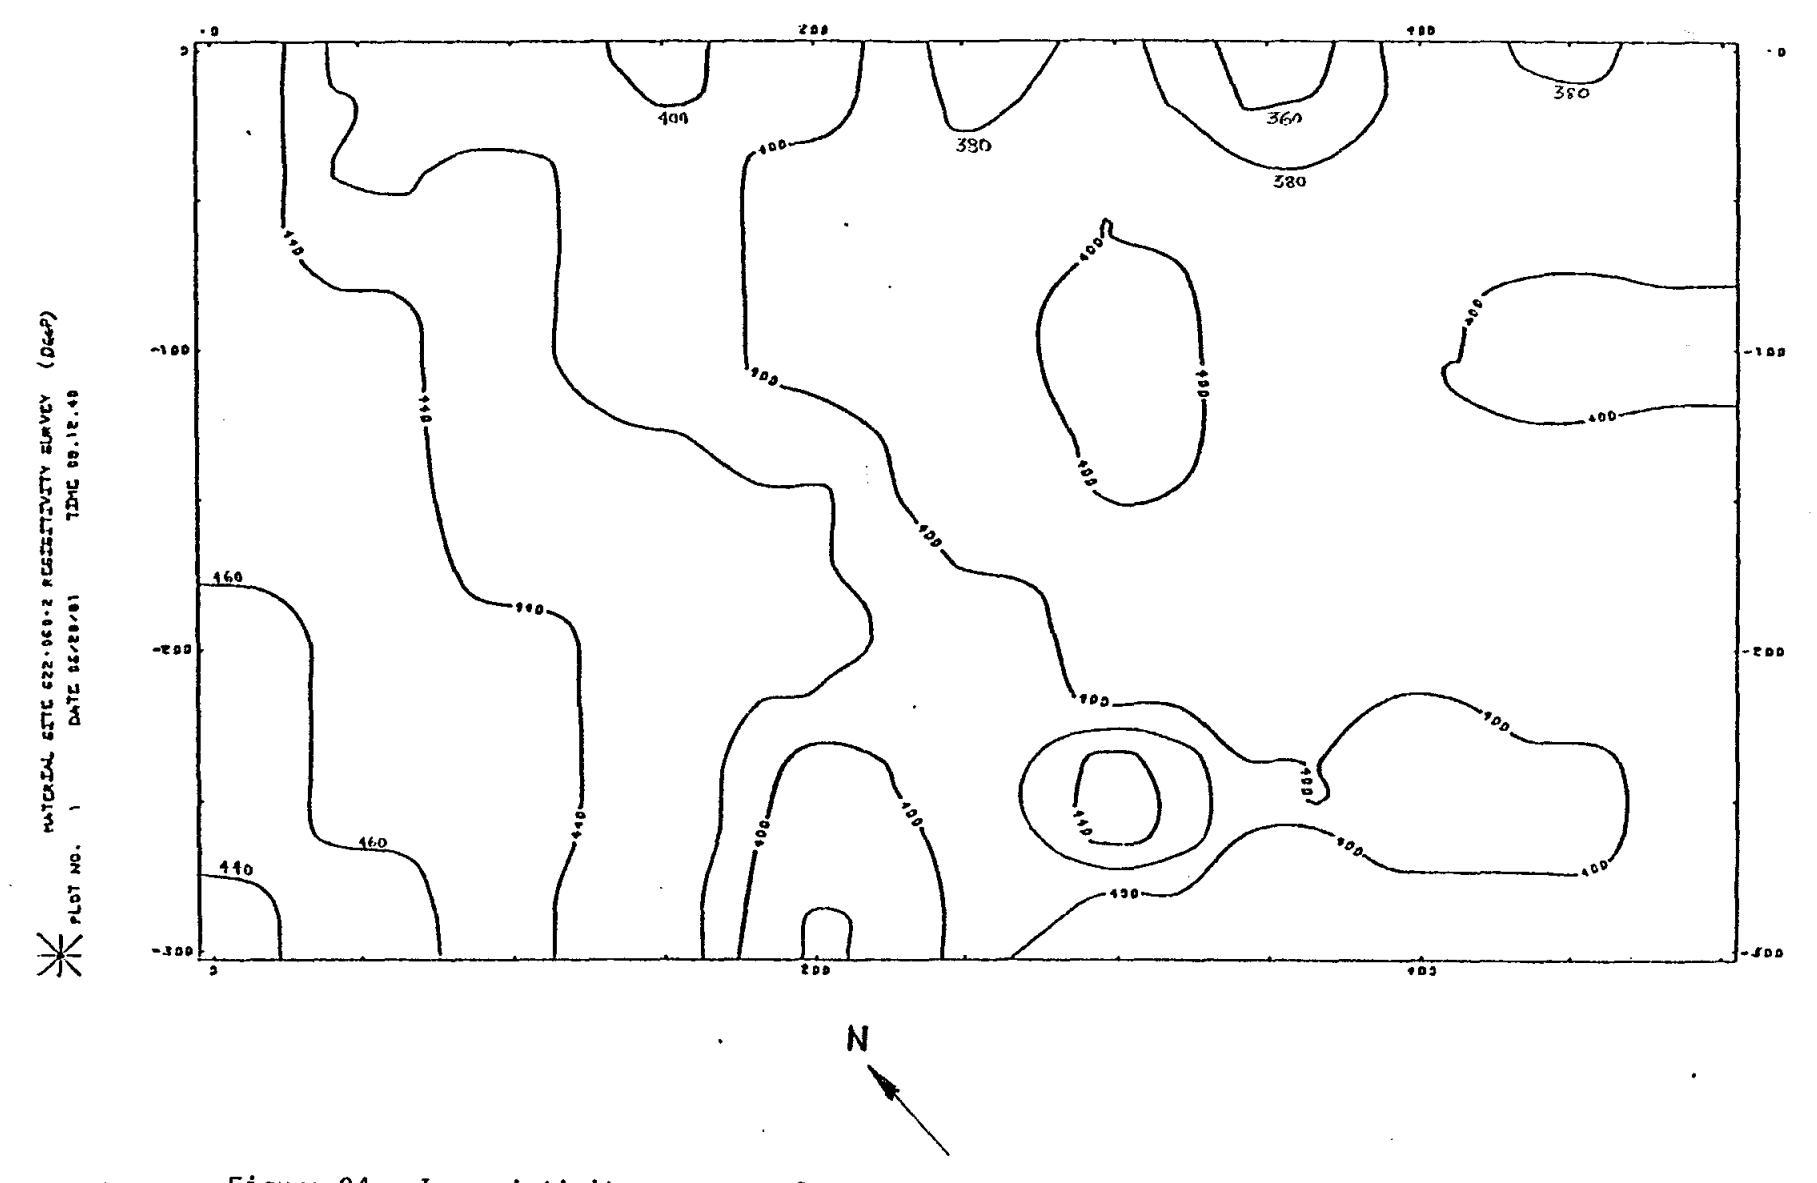
Figure 24. Isoresistivity contours for waist-high, normal mode at borrow material site 62-2-060-2 near Dot Lake.

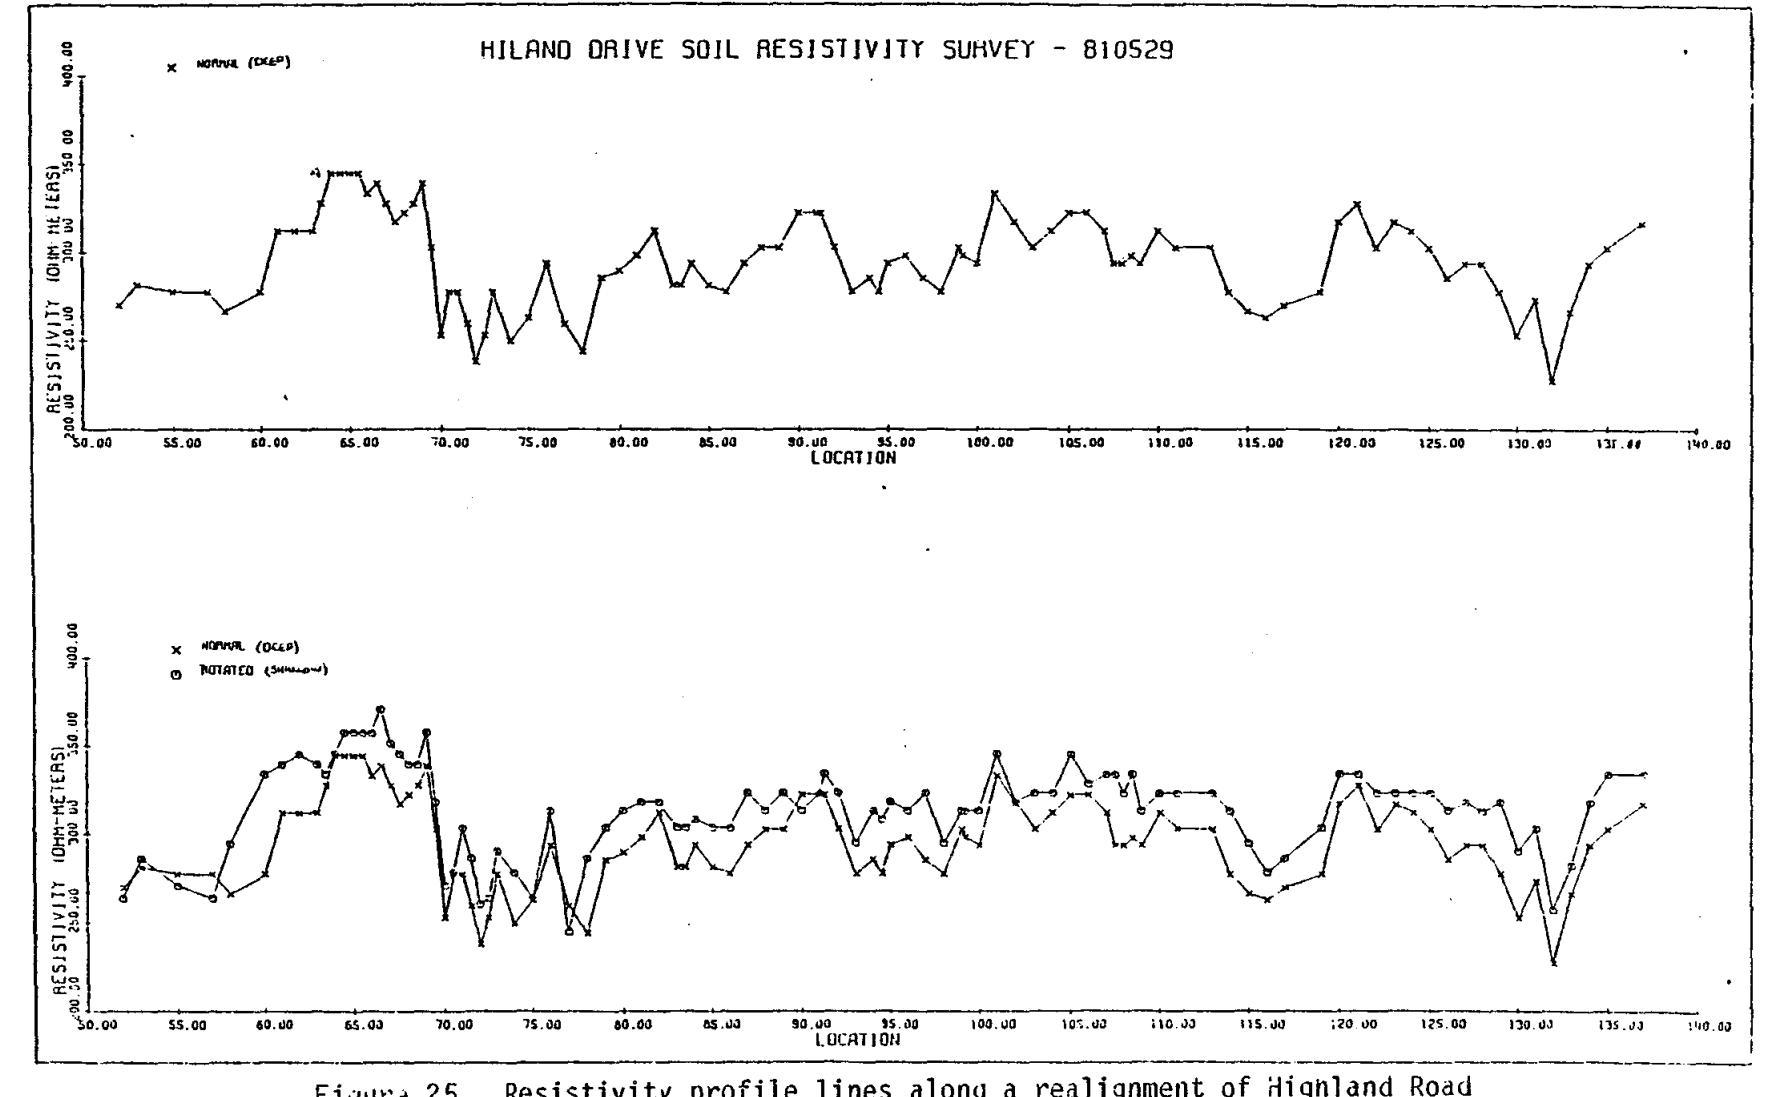
Figure 25. Resistivity profile lines along a realignment of Highland Road near Eagle River; upper panel---waist-high normal mode and lower panel---waist high rotated and normal modes.

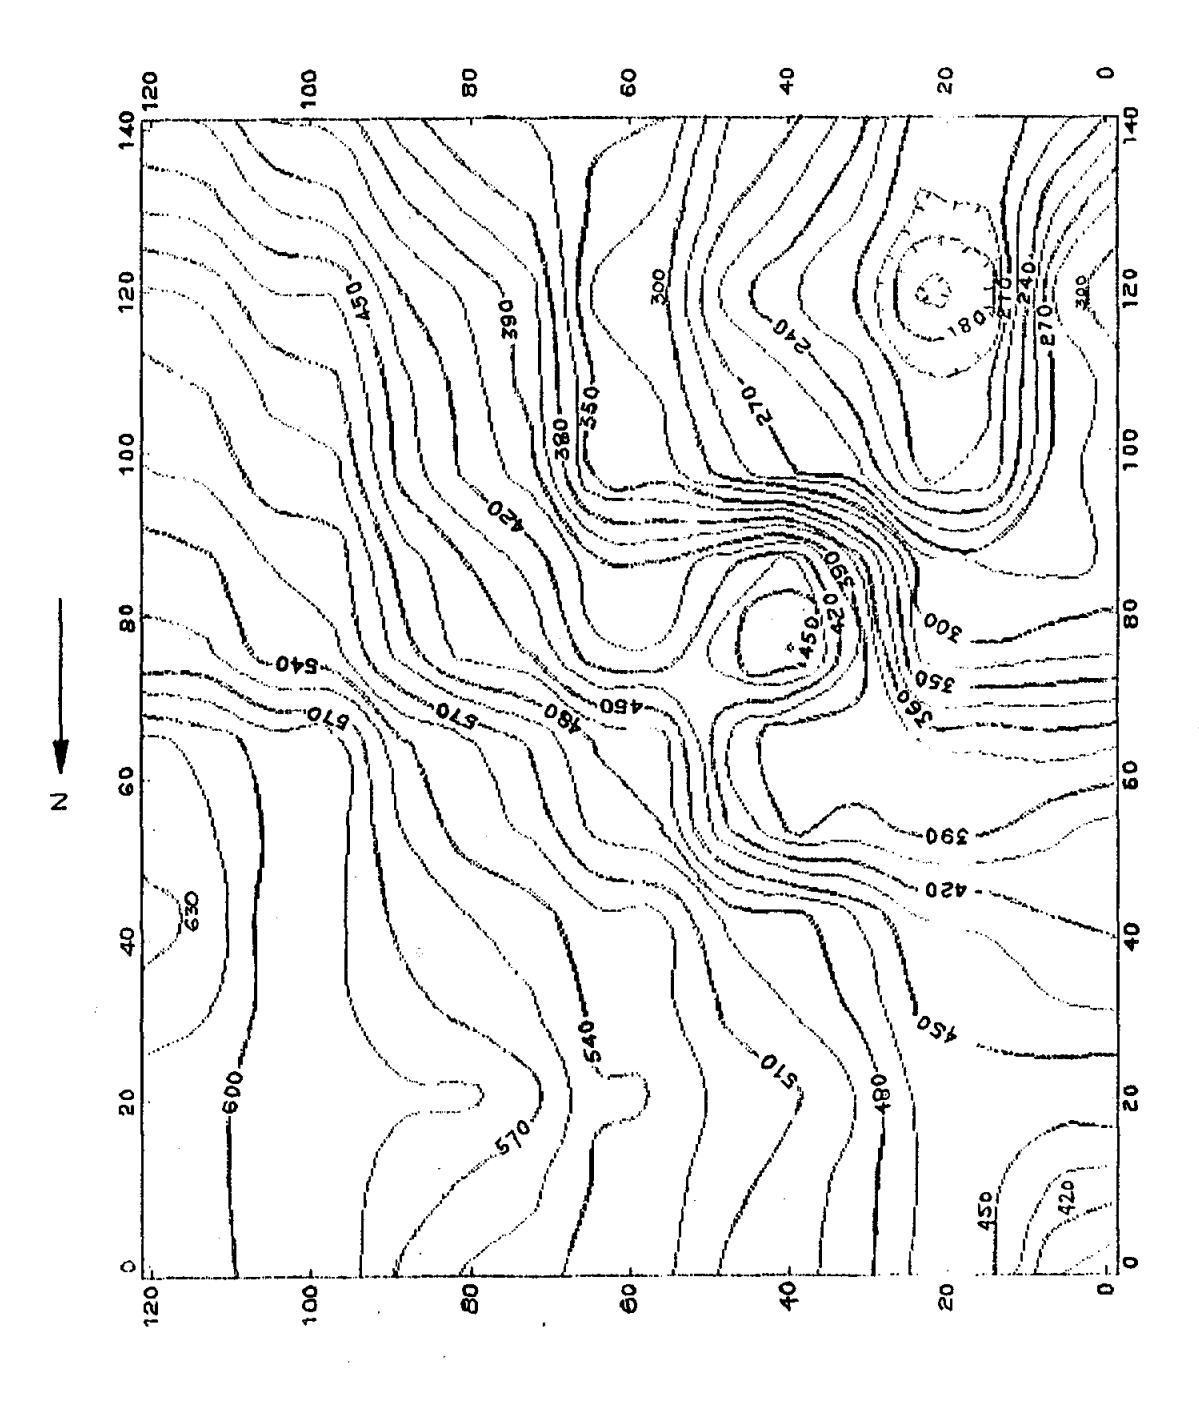
Figure 27. Isoresistivity contours for waist-high, normal mode at the CRREL Farmers Loop site near Fairbanks.

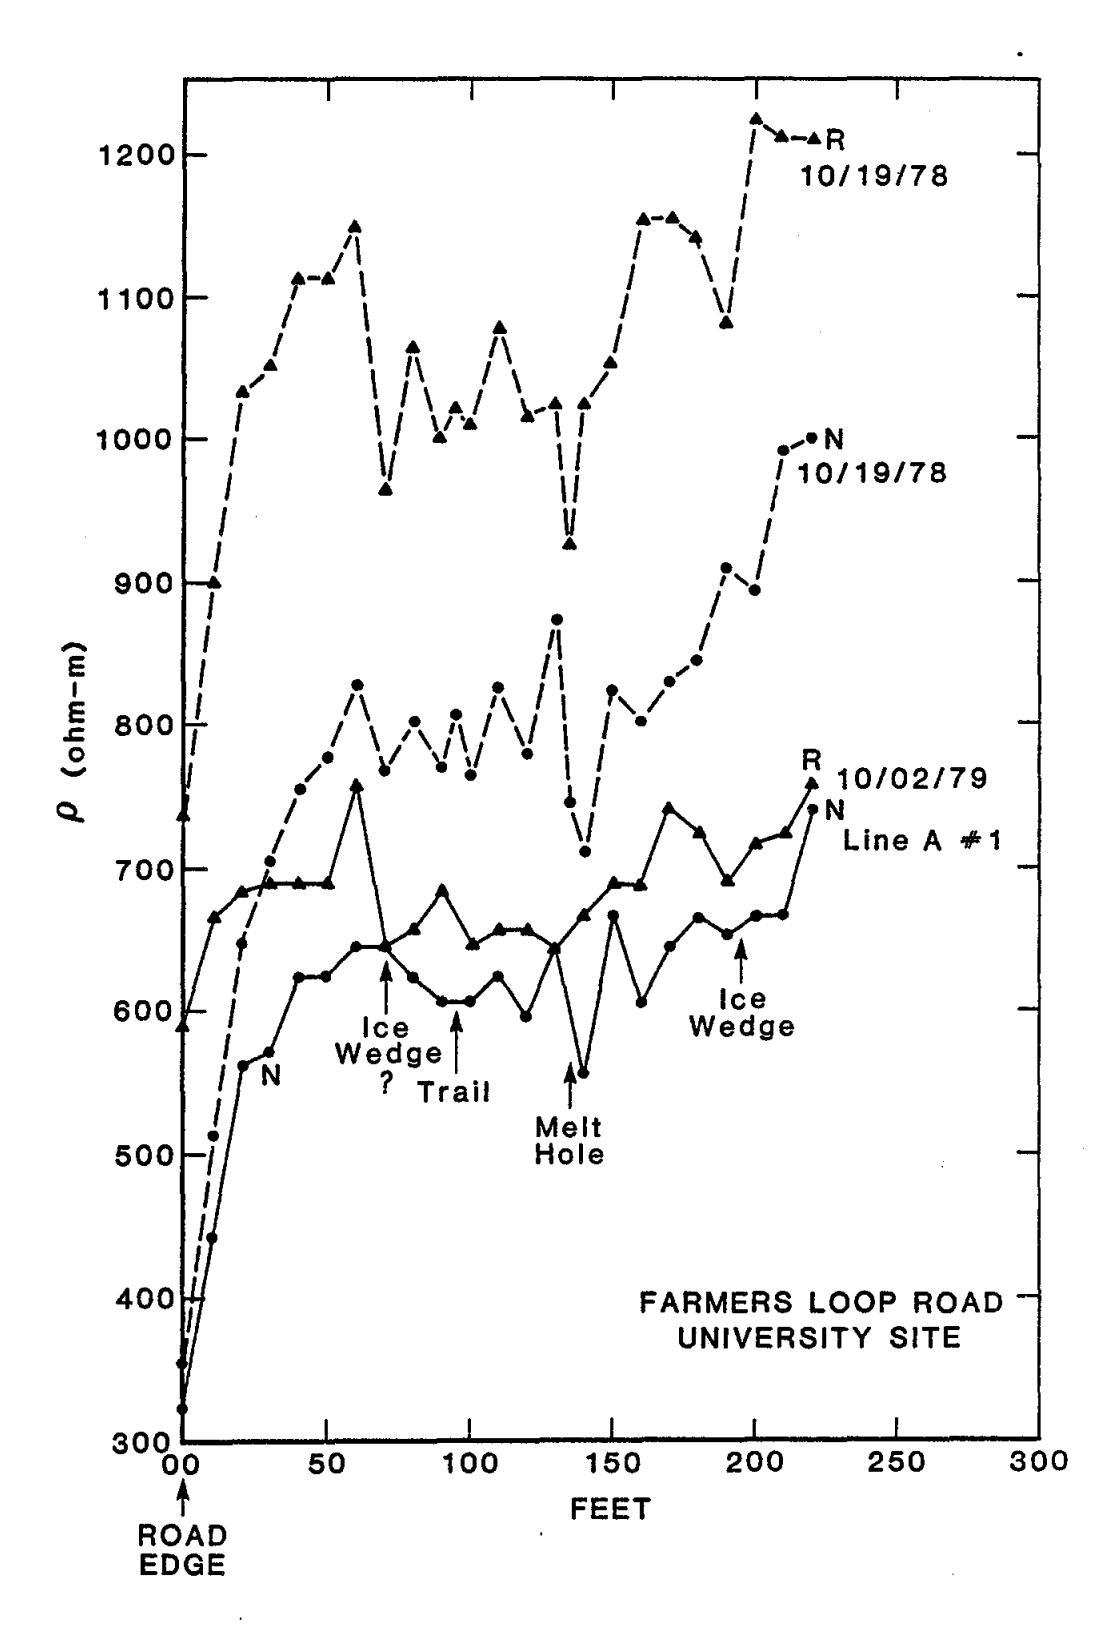
Figure 28. Resistivity profiles along an approximate east-west transect starting near the eastern edge of Farmers Loop Road just north of the Taku Drive entrance of the University of Alaska, Fairbanks. Surface features along the transect are also noted. The data for both normal and rotated modes are shown for two dates.

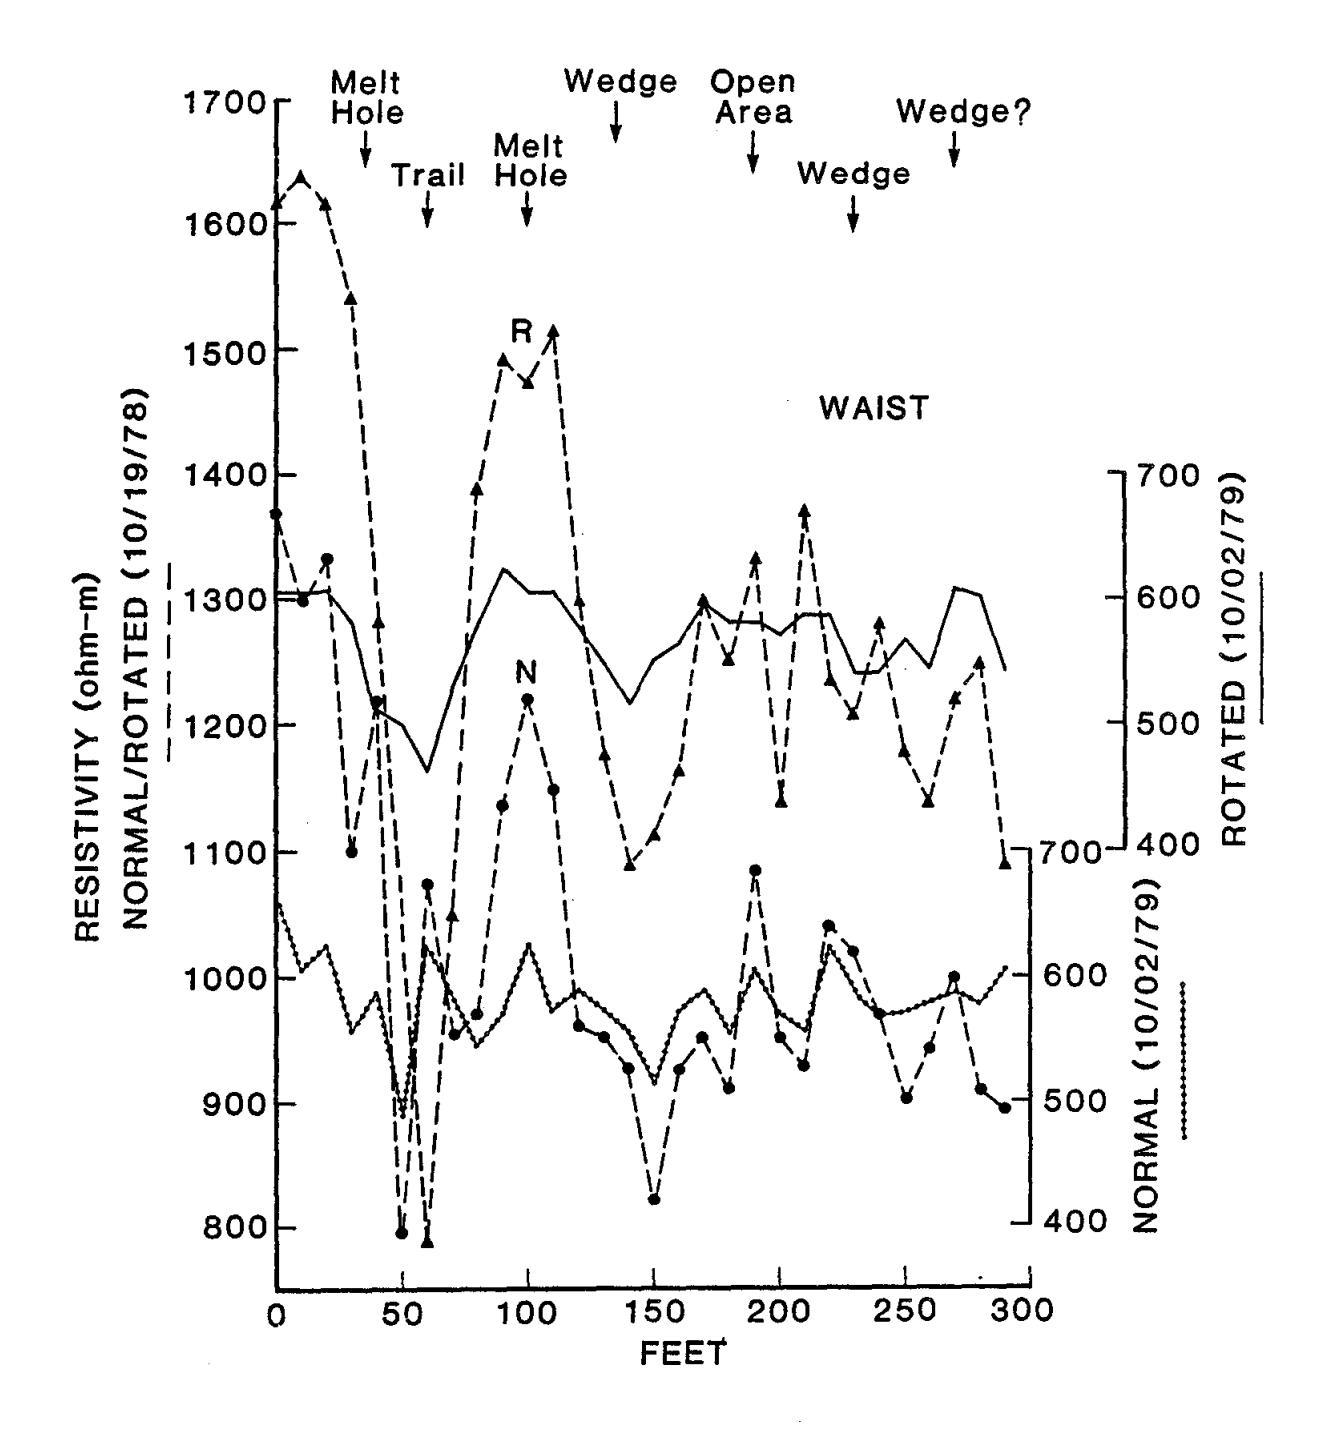
Figure 29. Resistivity profiles for both normal and rotated modes for two dates along an east-west transect approximately parallel to transect of Figure 28, but displaced to the north. Surface features are also noted.

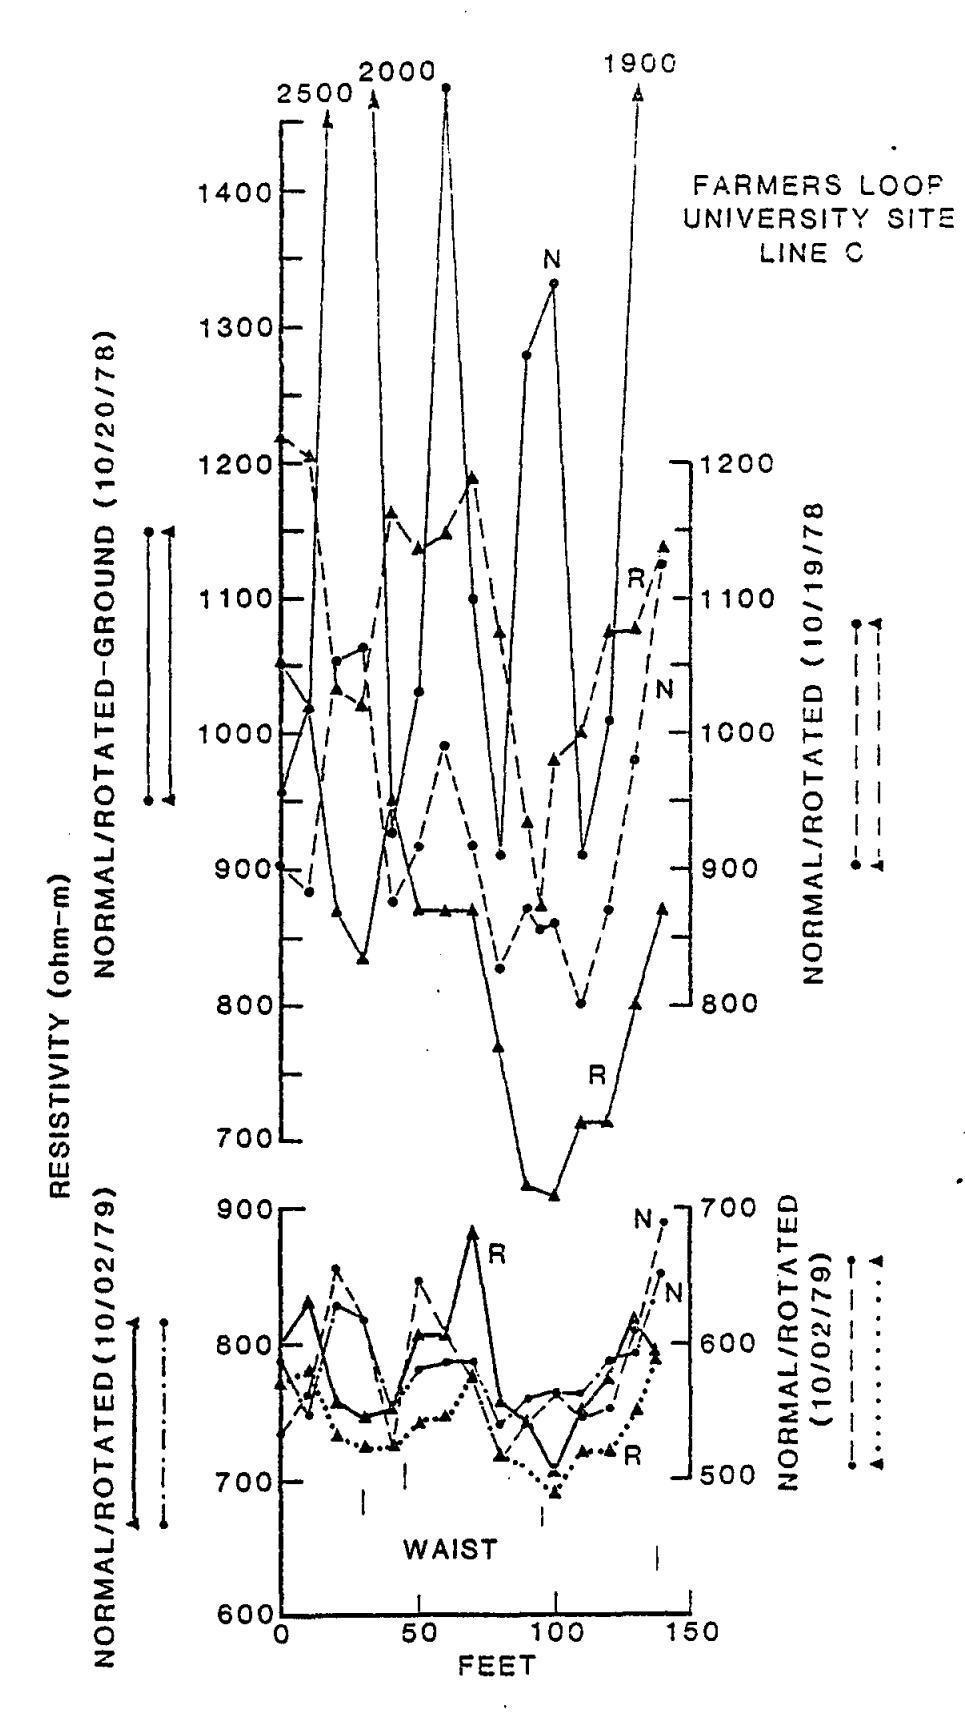
Figure 30. Resistivity profiles for both normal and rotated modes in the same general area as Figure 28, but directed north-south. Two separate sets of measurements for one date are shown as well as the ground level and waist-high readings for two other dates. Surface features are also noted.

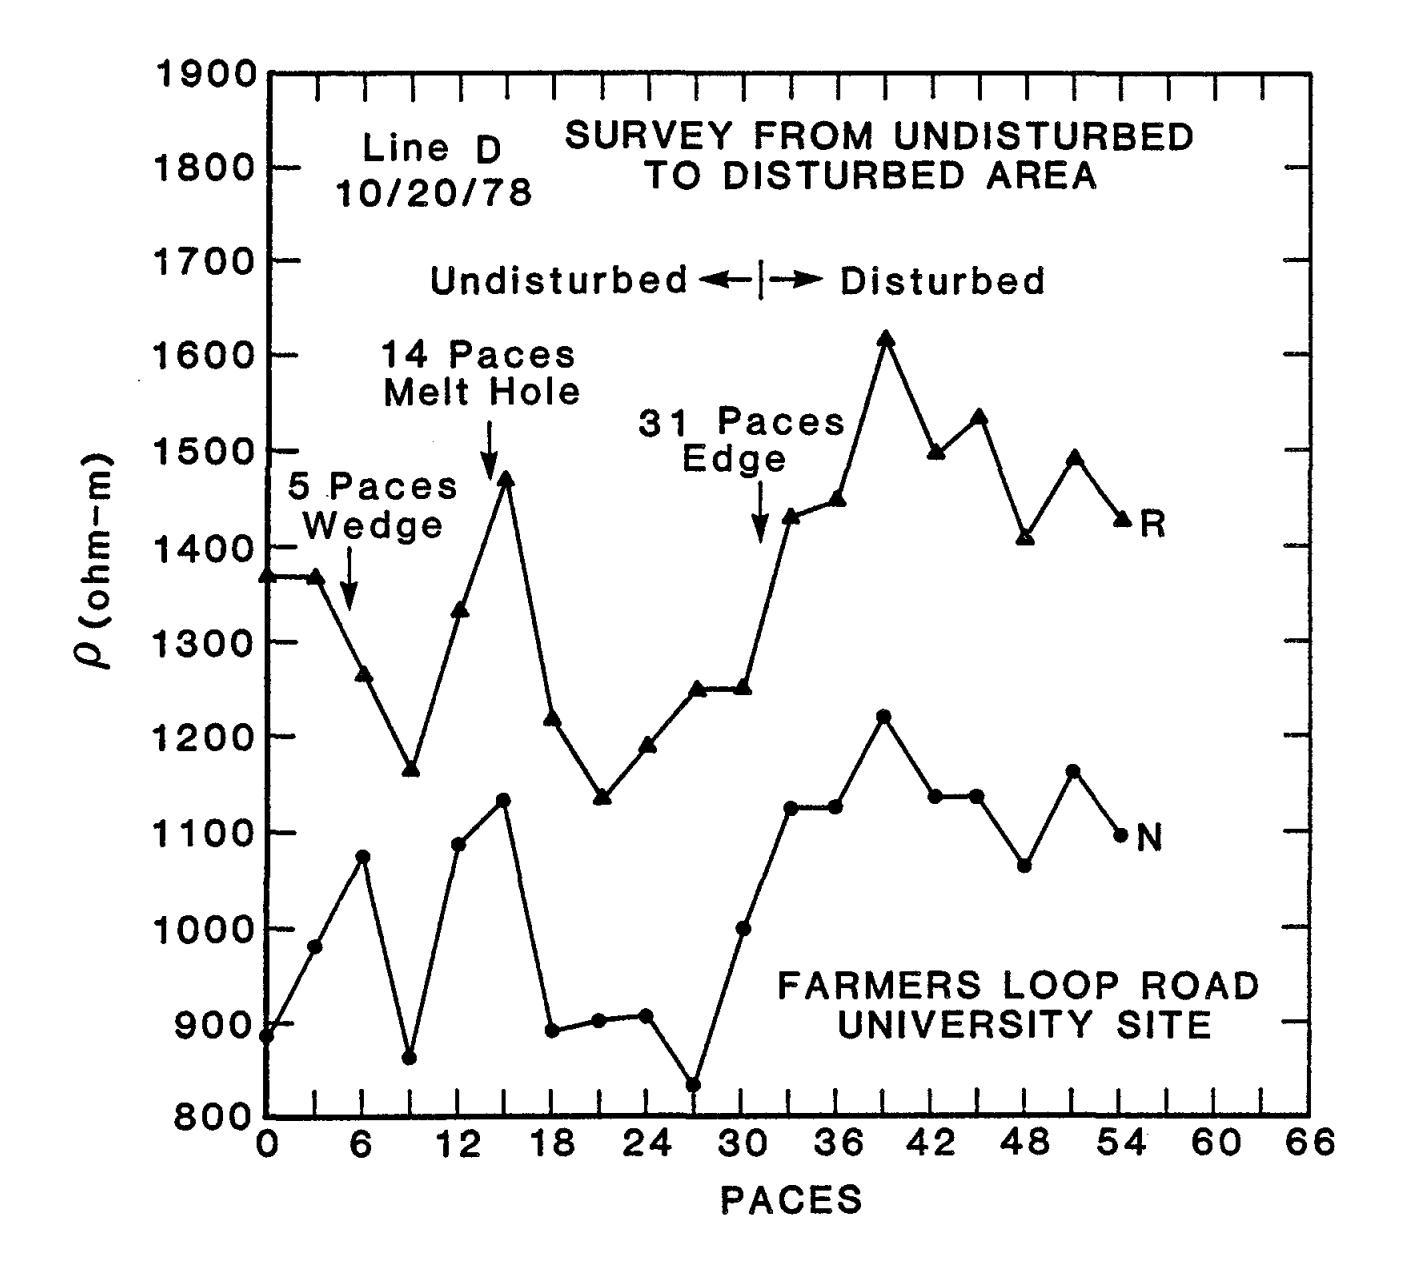
Figure 31. Resistivity profiles for both normal and rotated modes in the same general area as Figure 28. This rough east-west profile was measured in paces and crossed into a disturbed area. Surface features are also noted.
