ELECTROMAGNETIC INDUCTION MEASUREMENTS IN PERMAFROST TERRAIN FOR DETECTING GROUND ICE AND ICE-RICH SOILS

FINAL REPORT

Koji Kawasaki and Thomas E. Osterkamp Geophysical Institute University of Alaska Fairbanks, Alaska 99701

December 1984

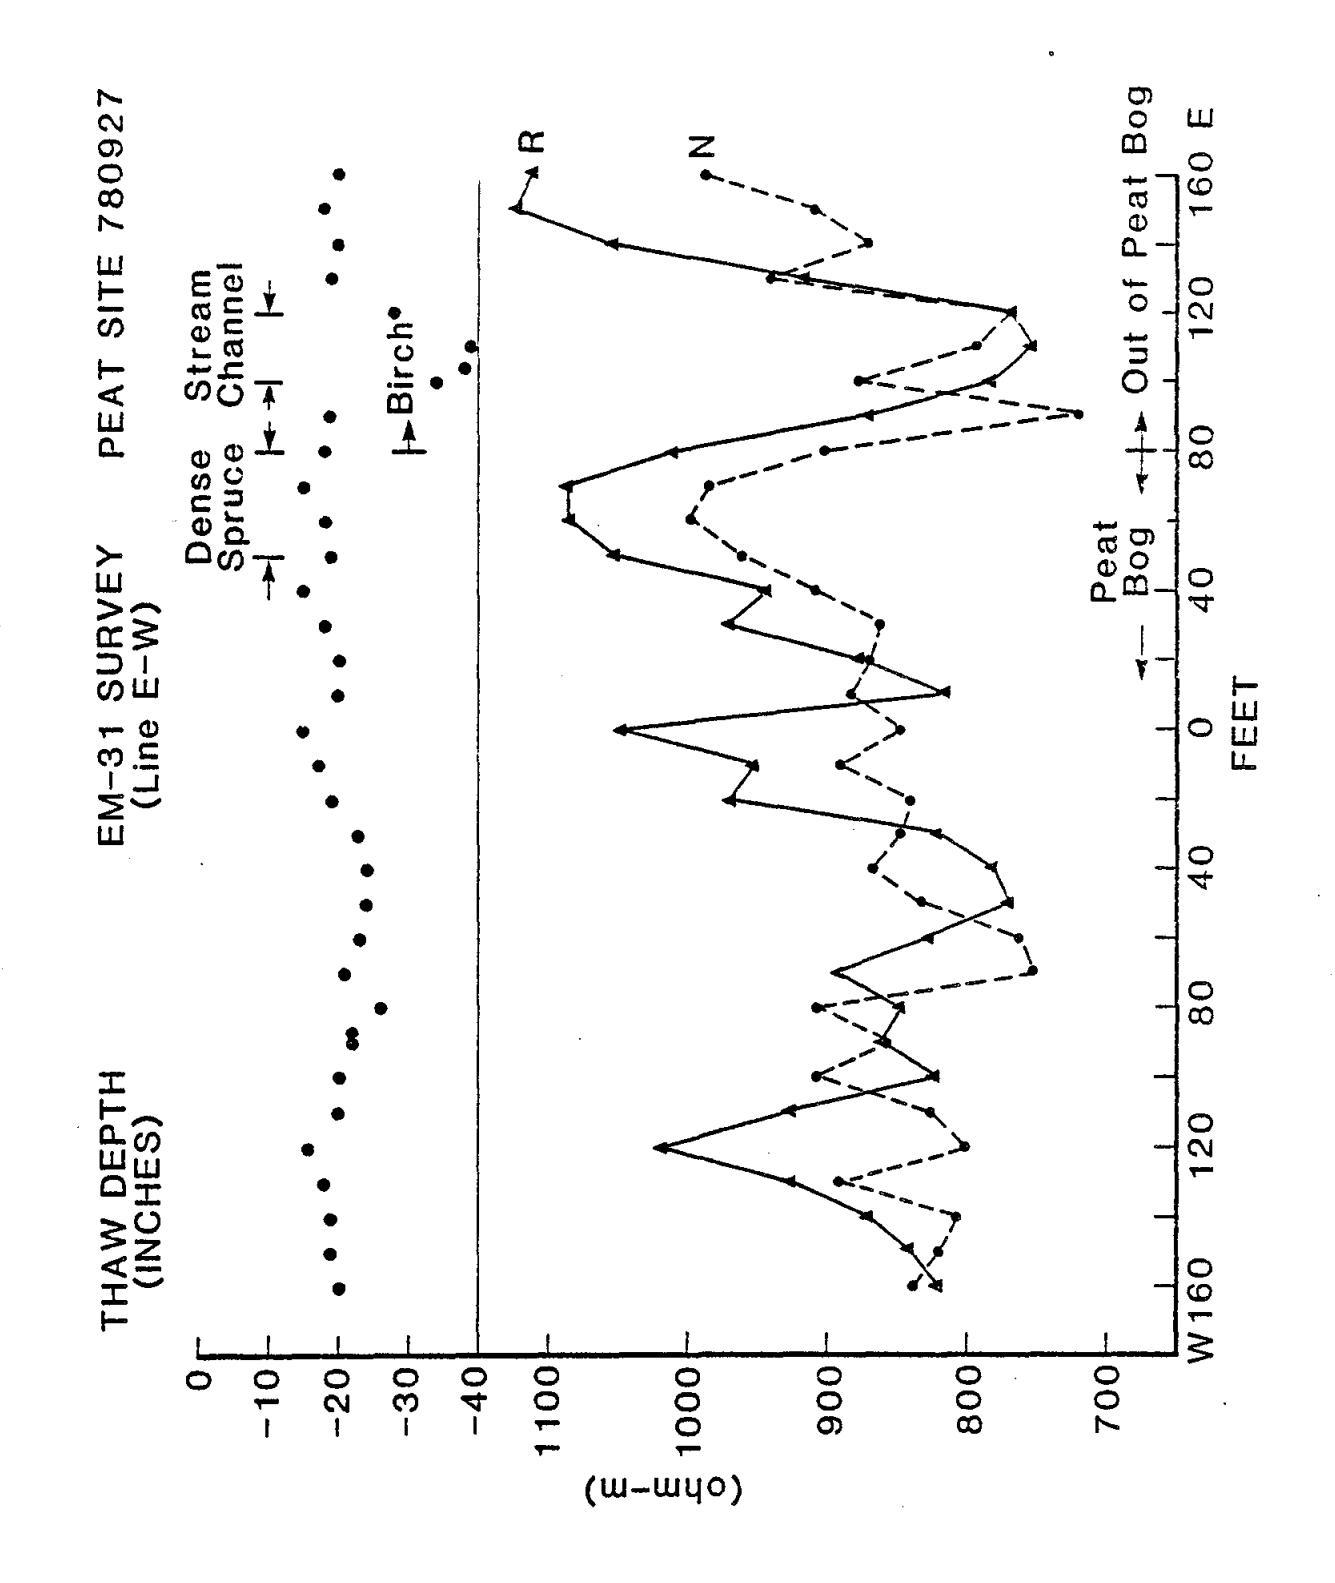
Figure 32. Resistivity profiles for normal and rotated modes over a peat bog north of College Road approximately 1.61 km (1 mile) from University of Alaska by road. The thaw depth along the profile and surface features are also noted.

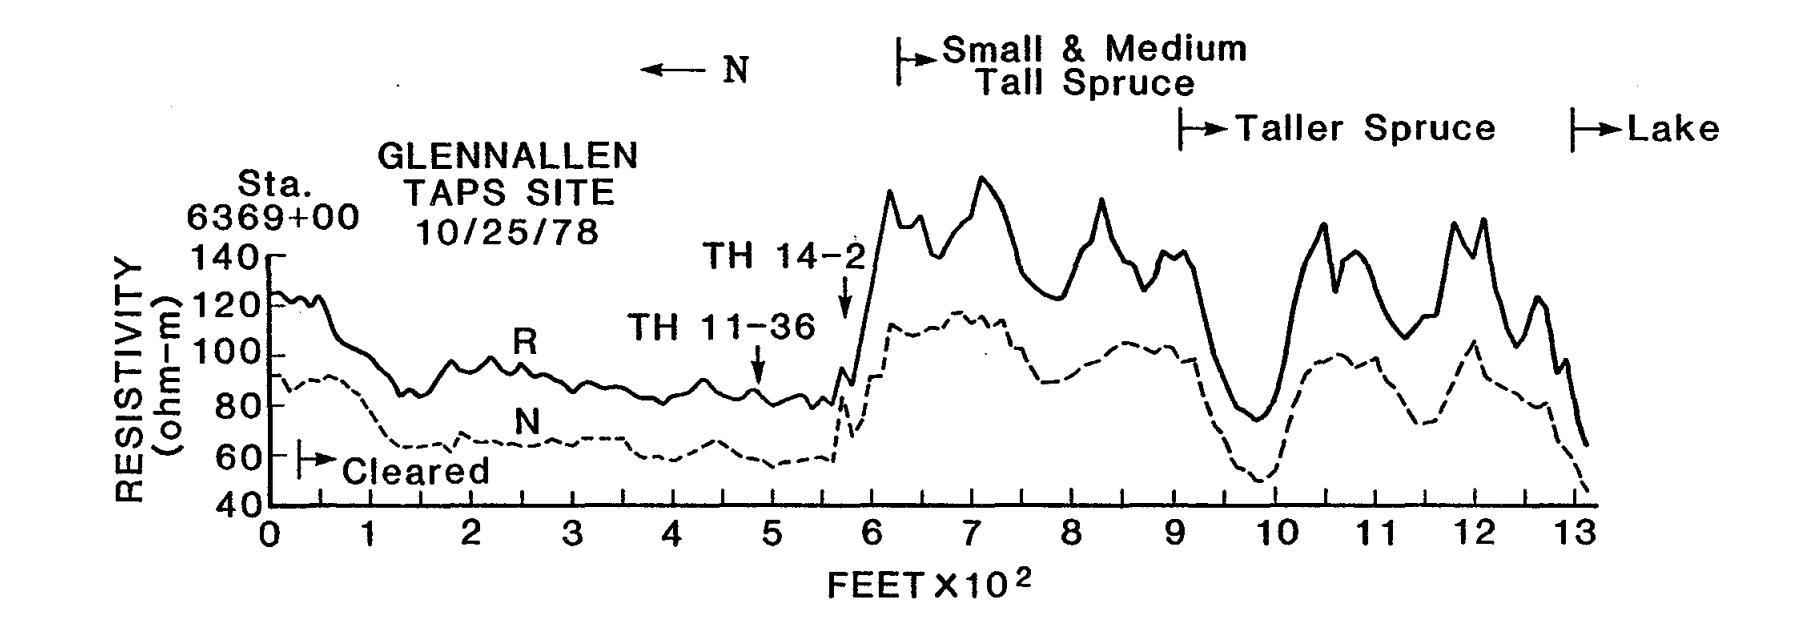
Figure 33. Resistivity profiles for normal and rotated modes along Trans Alaska Pipeline System (TAPS) site near Glennallen. Some surface features and borehole locations are also indicated.

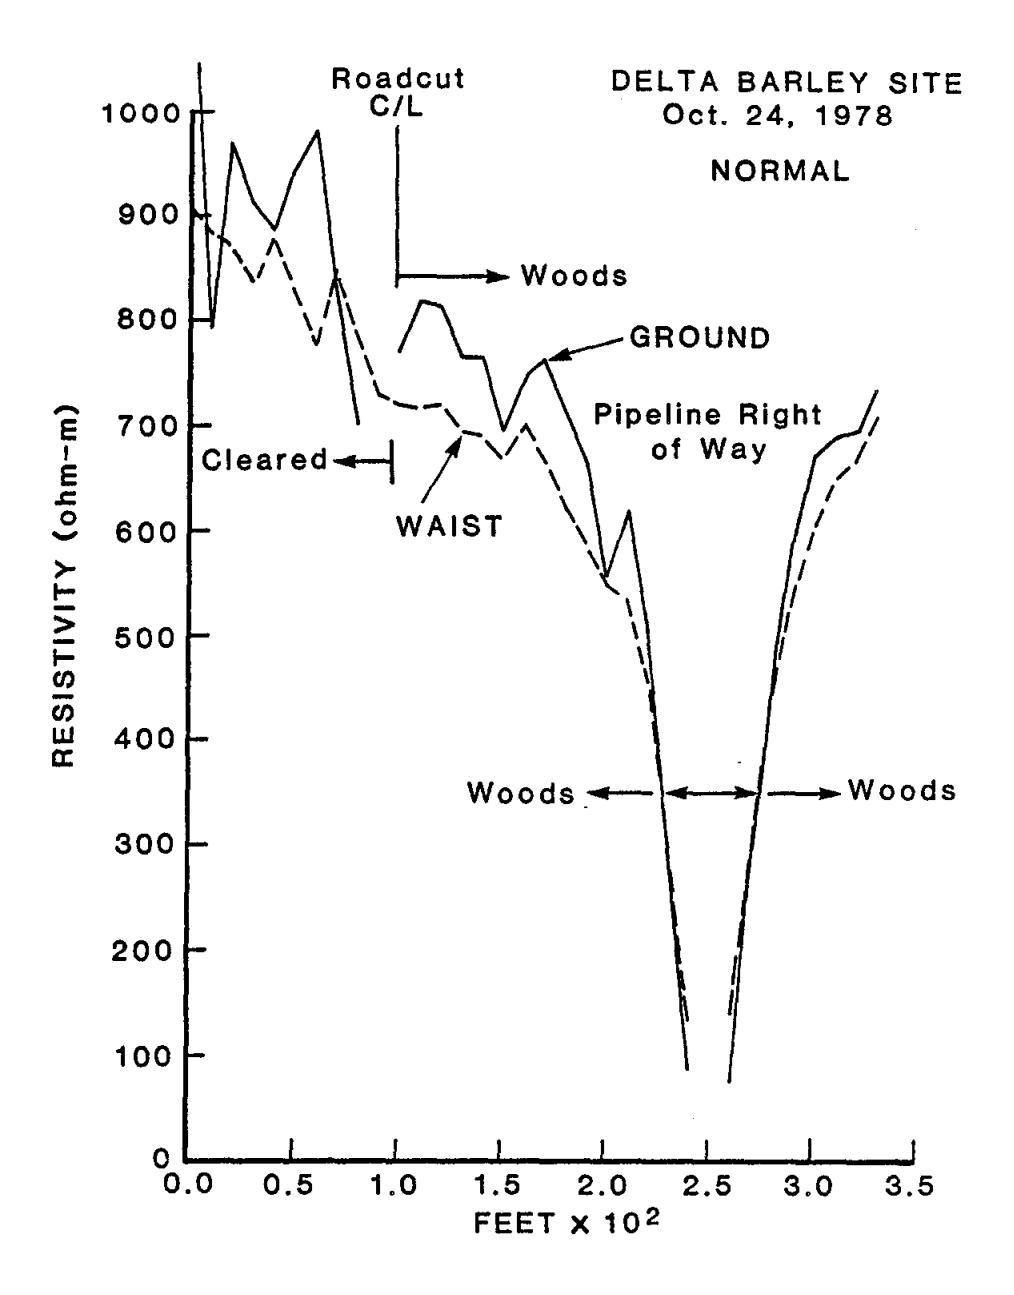
Figure 34. Resistivity profiles for normal orientation at waist and ground levels at Delta Barley site near Delta Junction. Surface features and other information are noted.

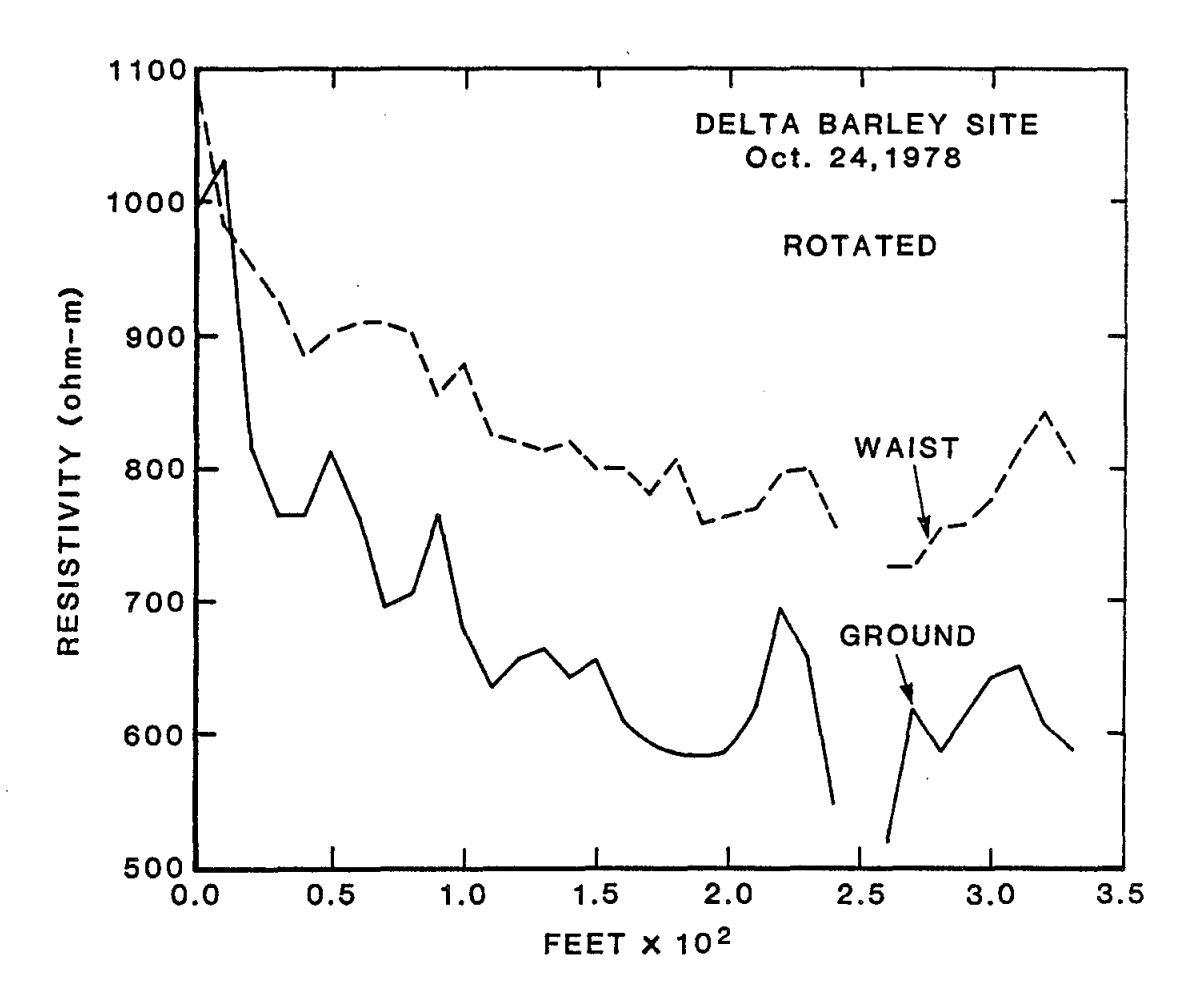
Figure 35. Resistivity profiles for rotated orientation at waist and ground levels at Delta Barley site.
was from the northeast to the southwest. Vegetation and other boundaries are noted.

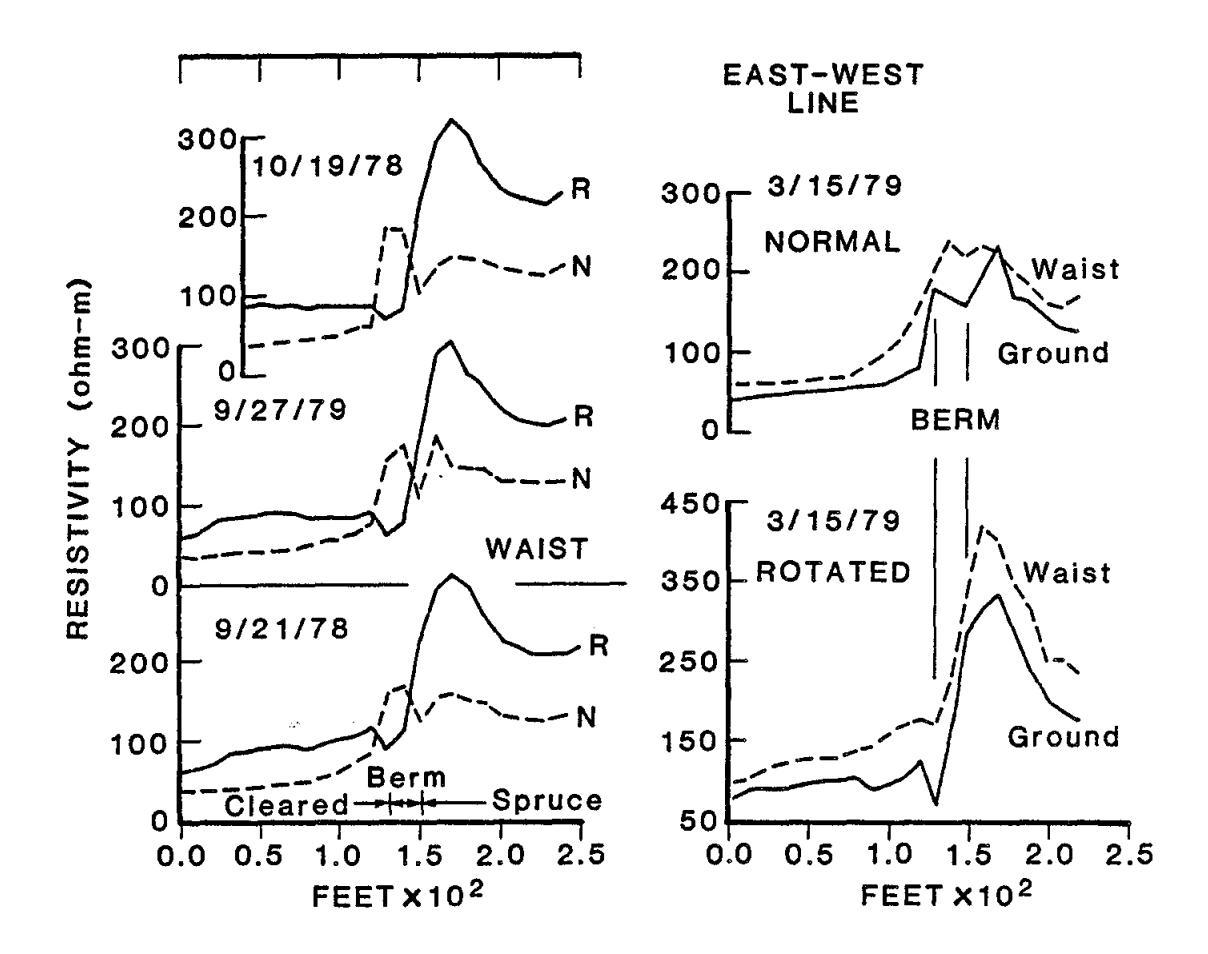
Figure 36. Resistivity profiles for waist high and one set of ground level readings in the normal and rotated modes for several dates in 1978 and 1979. The profiles for a west-to-east transect across cleared and undisturbed land at the University of Alaska Agricultural Experiment Station (UAF-AES) are shown.

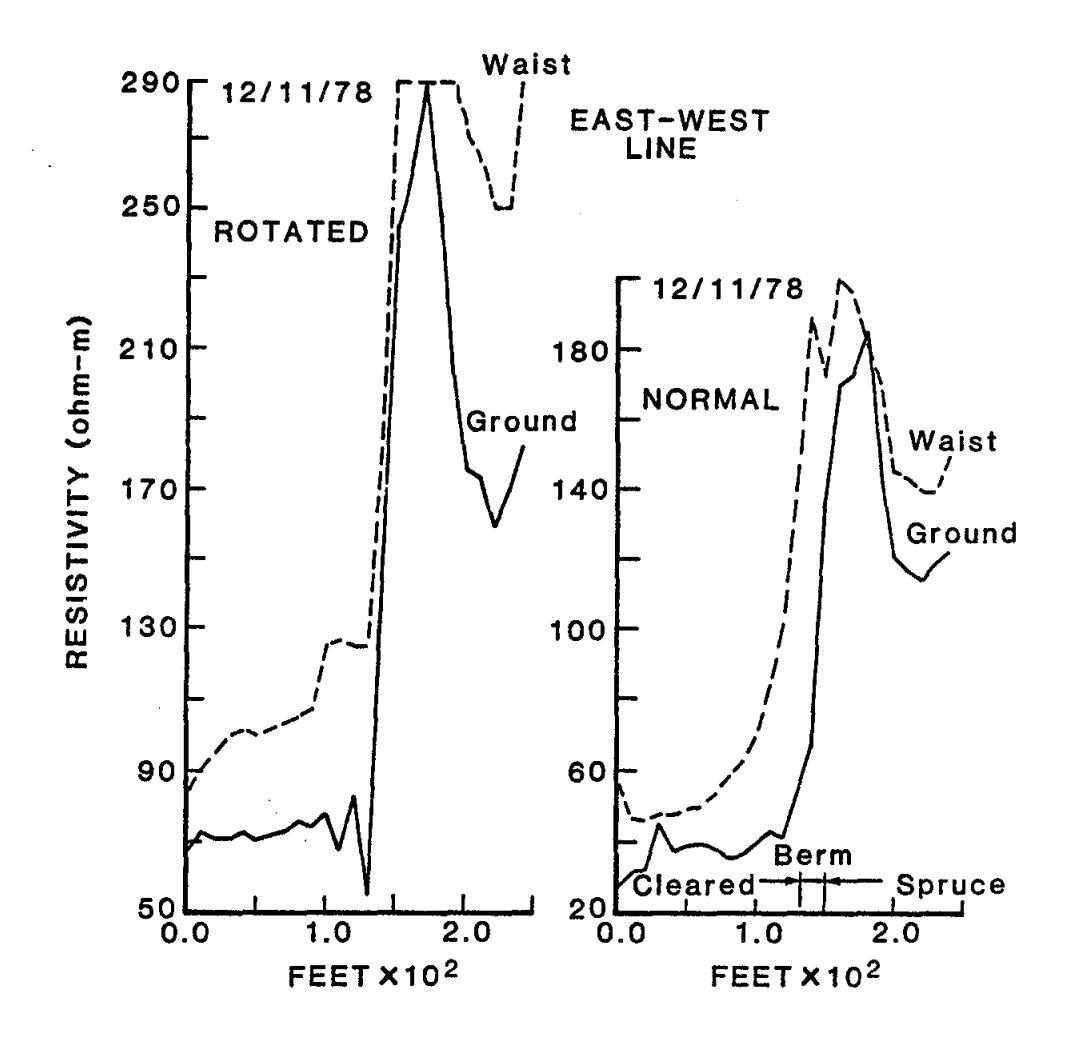
Figure 37. Resistivity profiles for waist high and ground level readings in the normal and rotated modes for late fall, 1979 at the UAF-AES for the same transect line as in Figure 36.

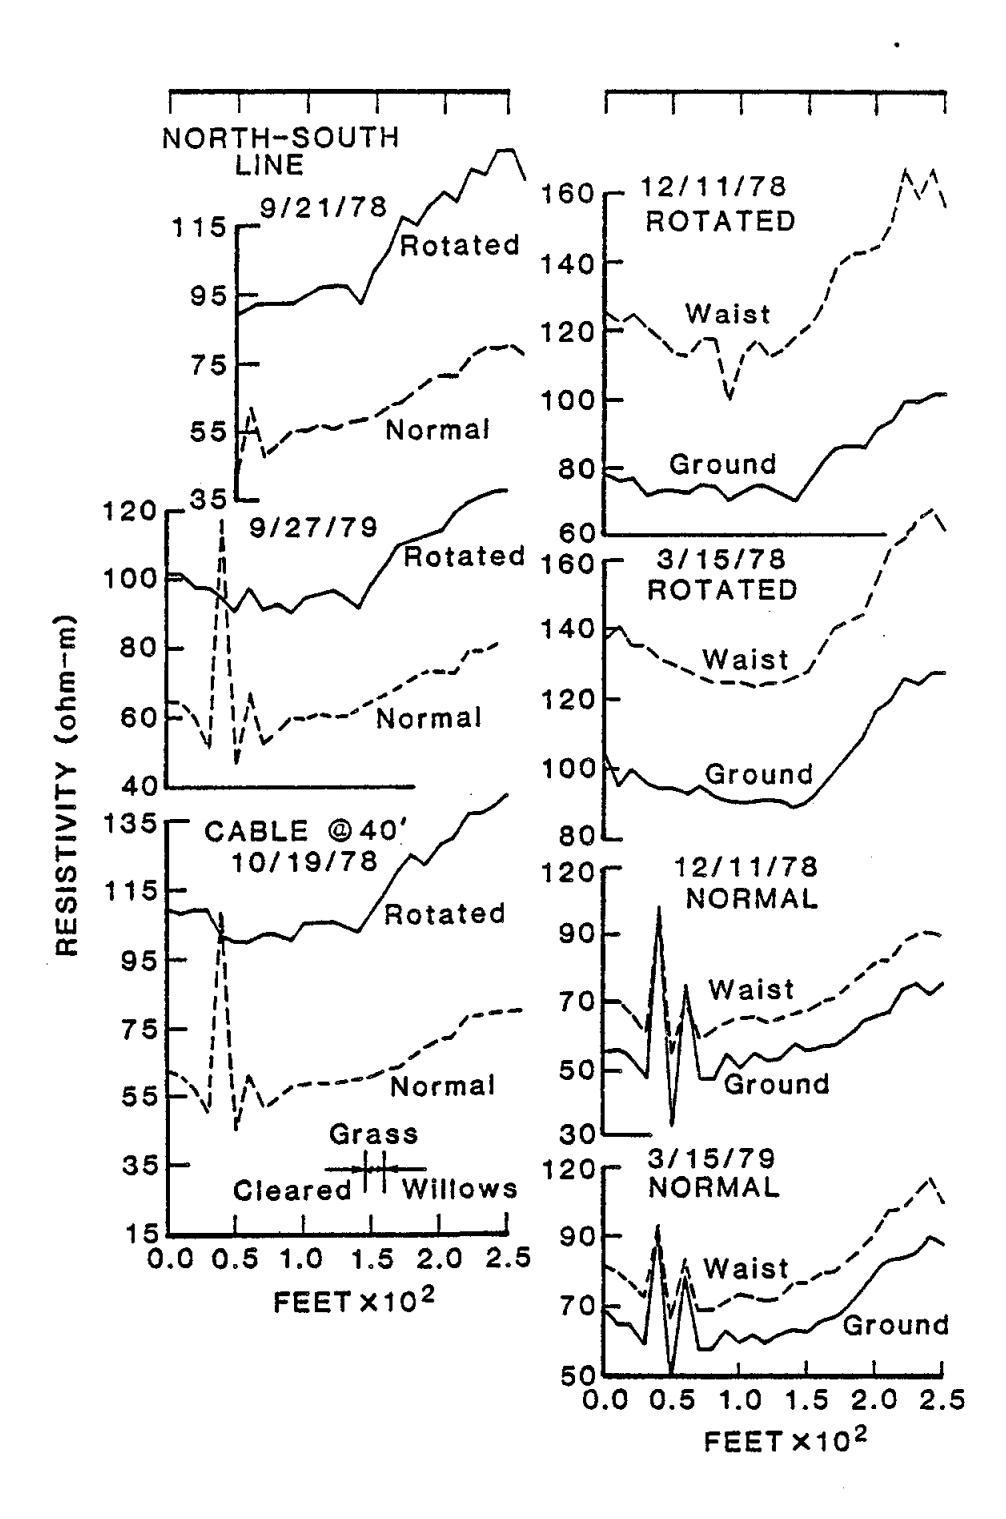
Figure 38. Resistivity profiles for waist high and some ground level readings in the normal and rotated modes for several dates in 1978 and 1979. These profiles are for a north-to-south transect across cleared land and over an area of secondary growth at the UAF-AES in vicinity of the Figure 36 transect.

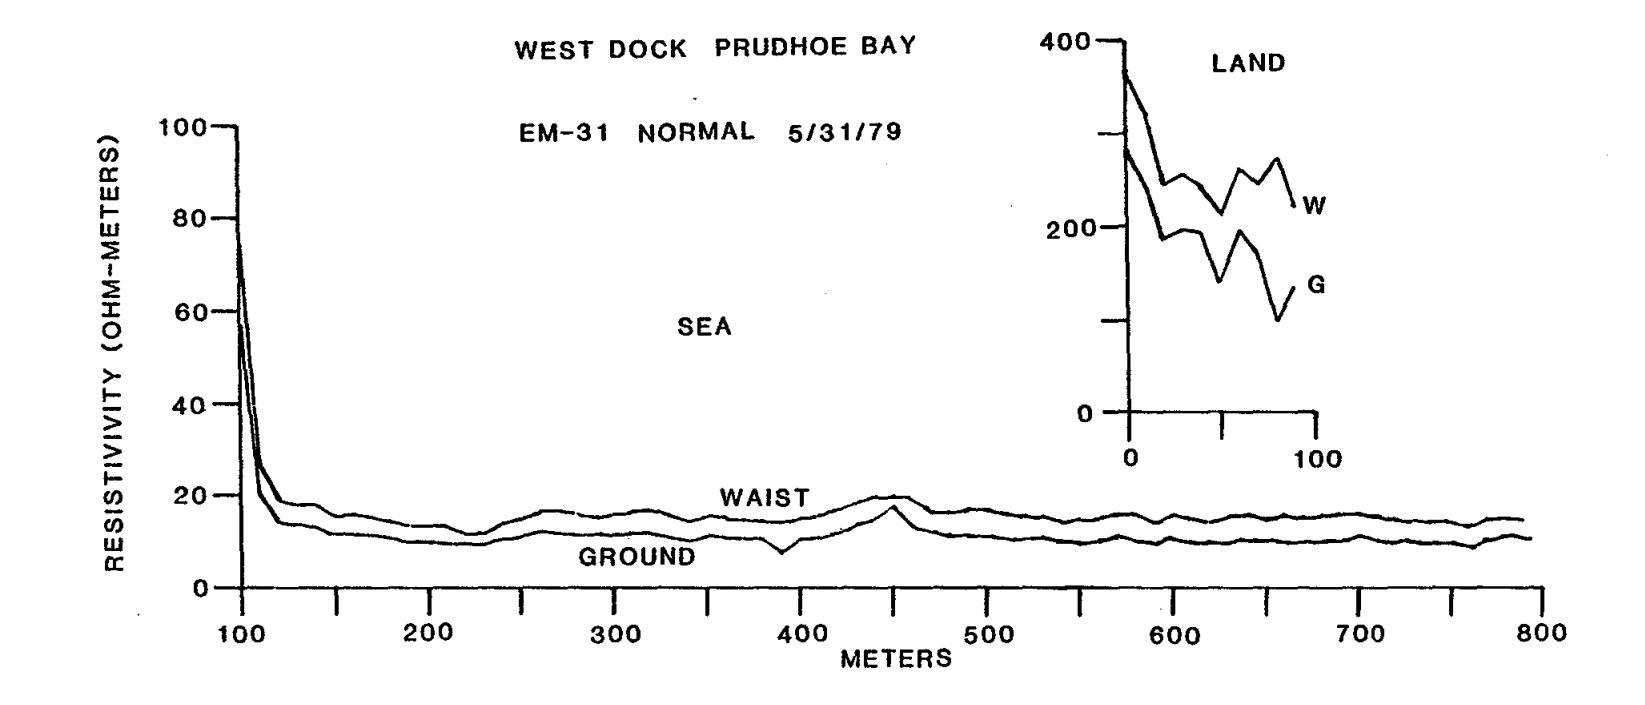
Figure 39. Resistivity profiles for waist and ground level normal mode from a point 100 m inland (inset) to 700 m offshore near the West Dock at Prudhoe Bay.

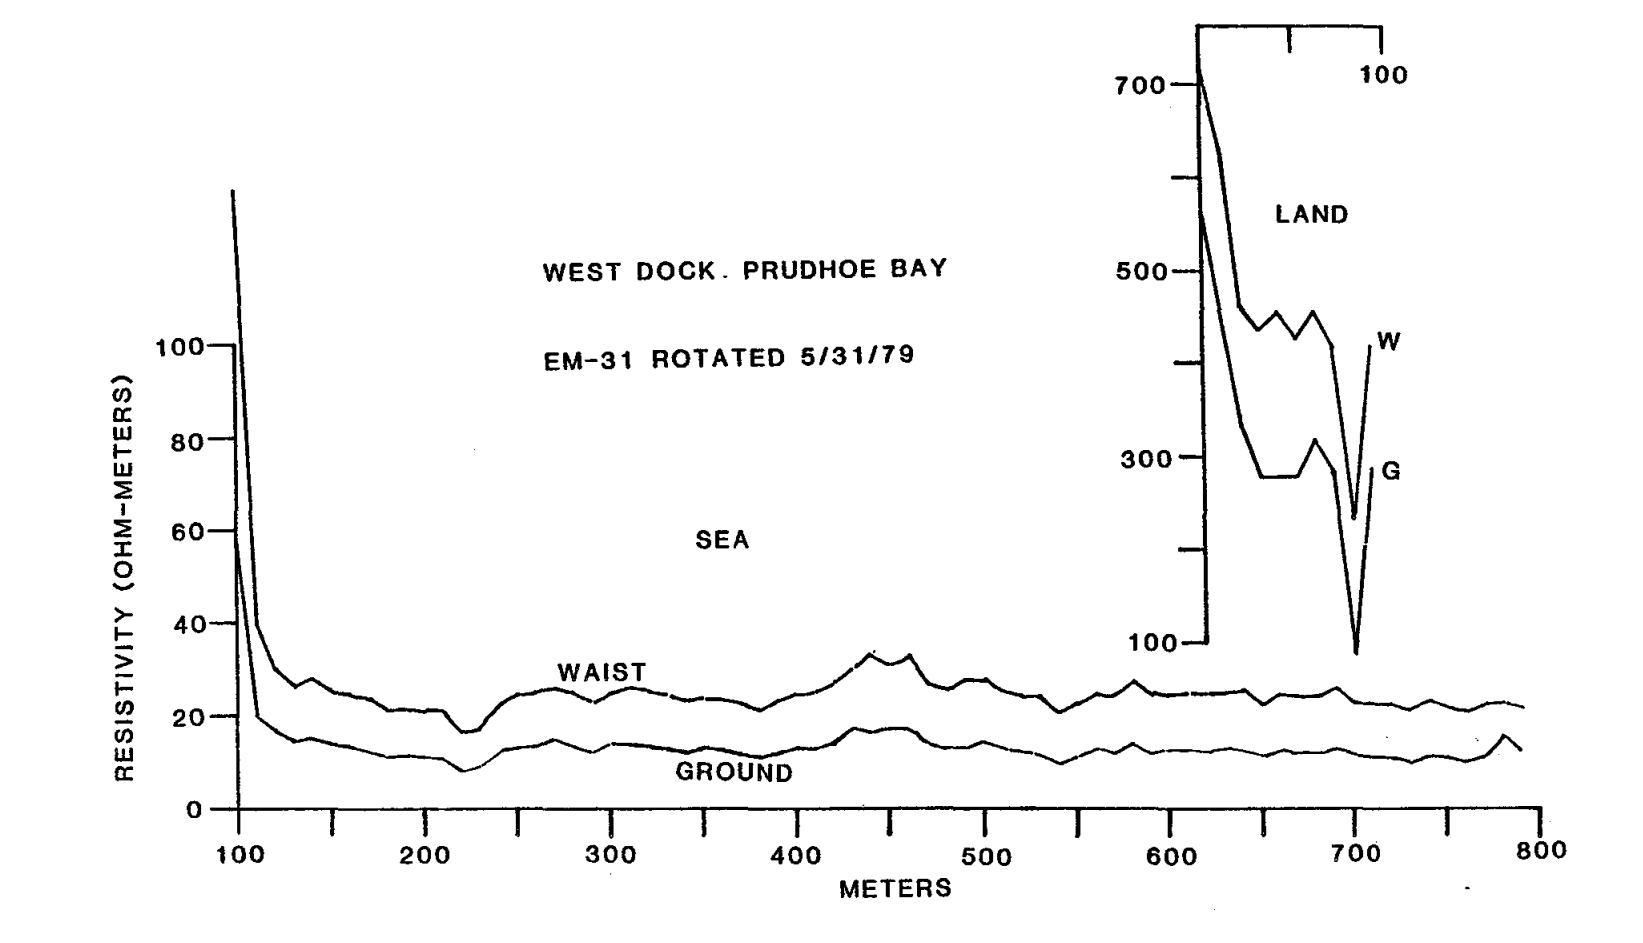
Figure 40. Resistivity profiles for waist and ground level rotated mode corresponding to normal mode survey of Figure 39.

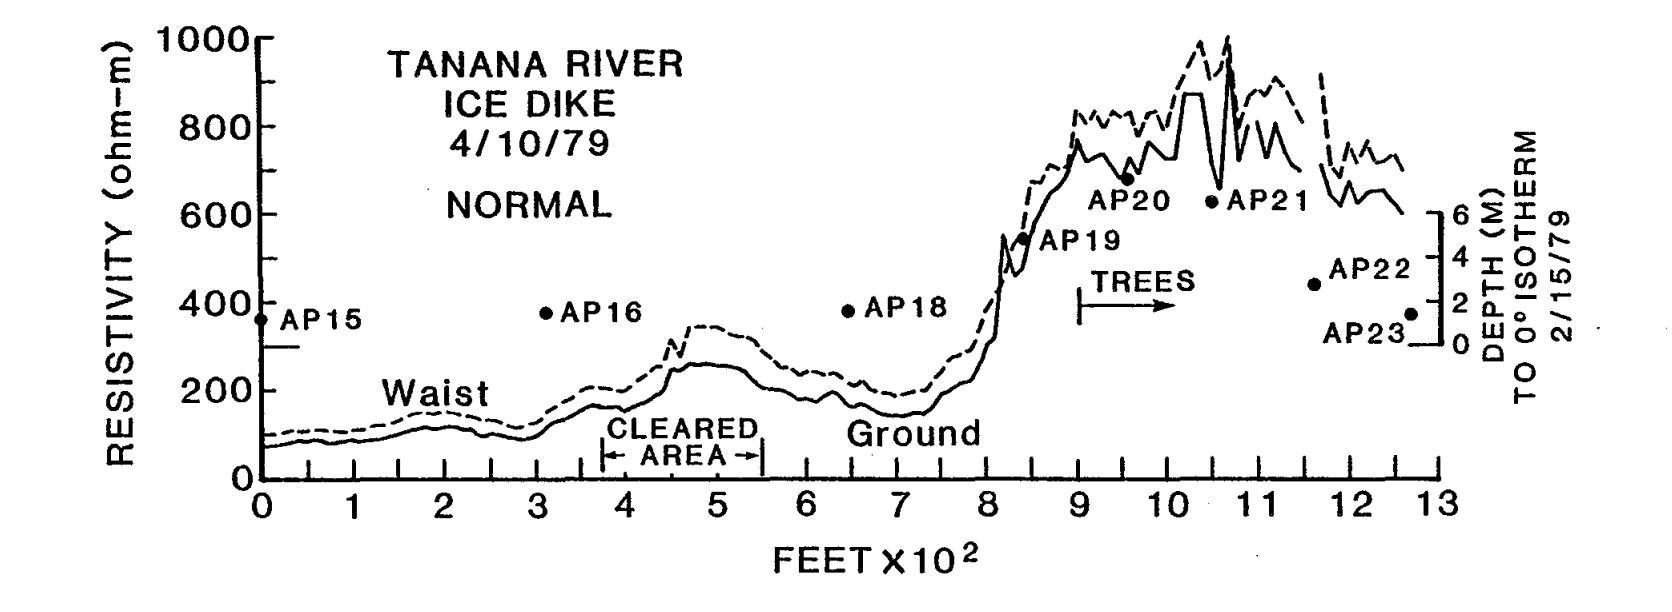
Figure 41. Resistivity profiles for waist and ground level normal mode at Tanana River Ice Revetment site at southwest corner of Fairbanks International Airport. The depth of the OC isotherm measured in several boreholes and surface features are also shown.

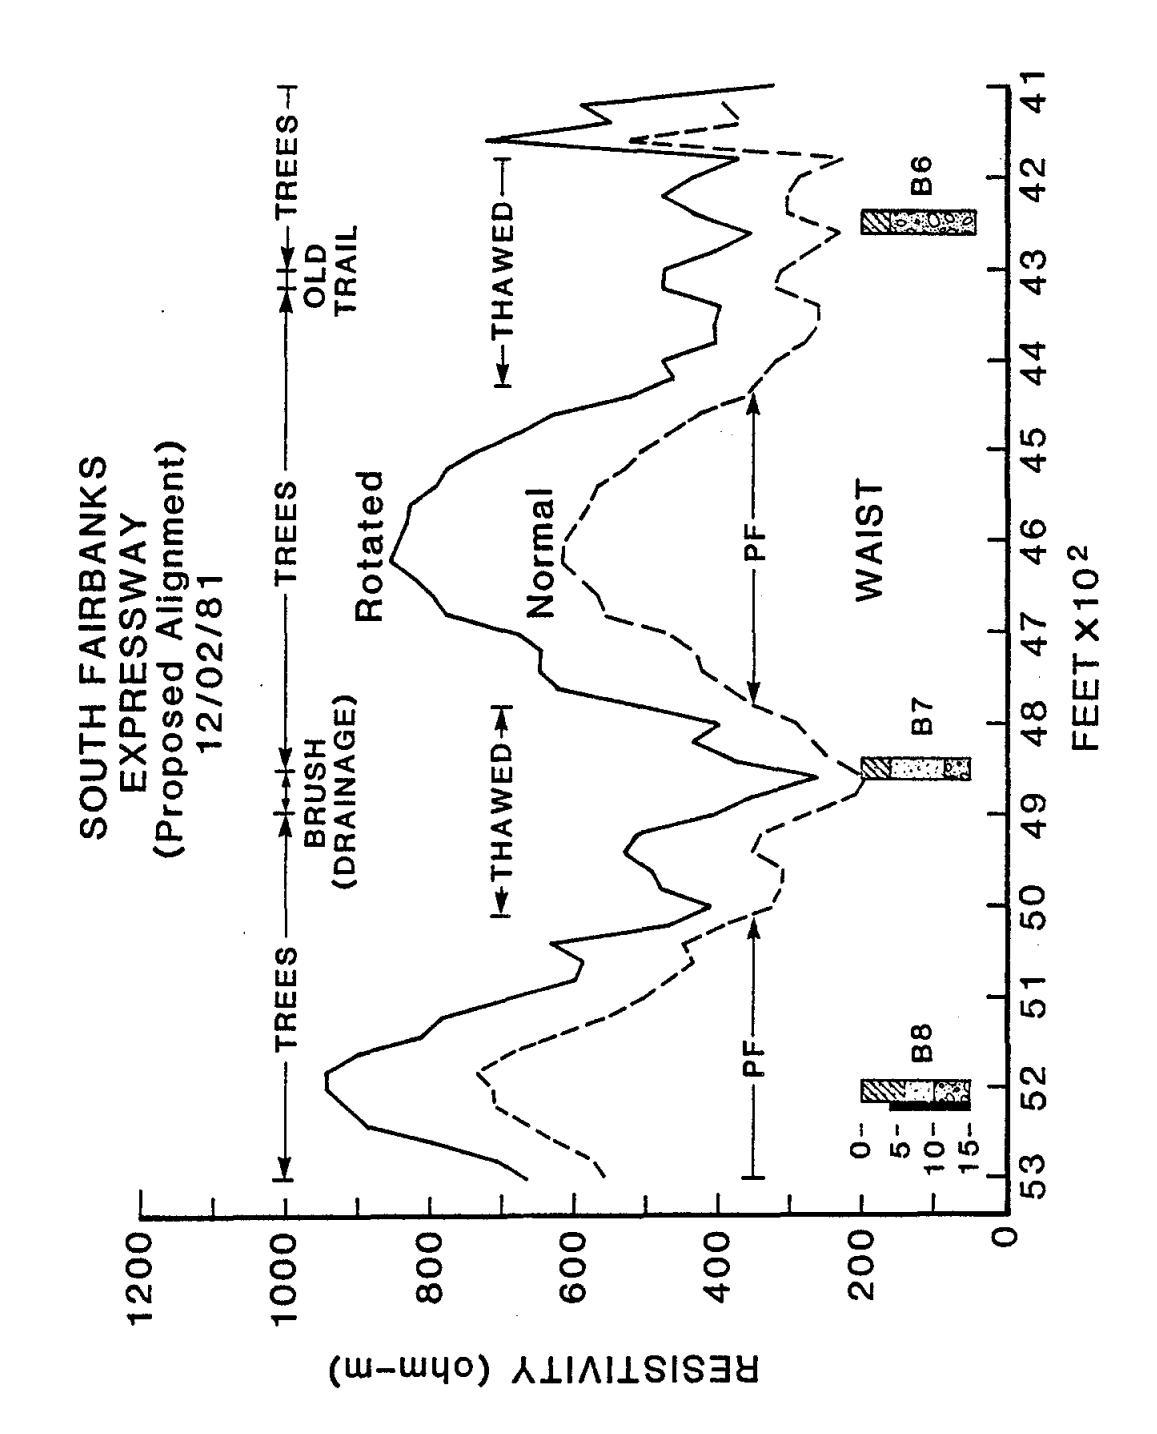
Figure 42. Resistivity profiles for waist level normal and rotated modes along proposed alignment of South Fairbanks Expressway from station 41 (x 100') from Airport Road to station 53 (x 100'). Borehole information and surface conditions are also indicated.

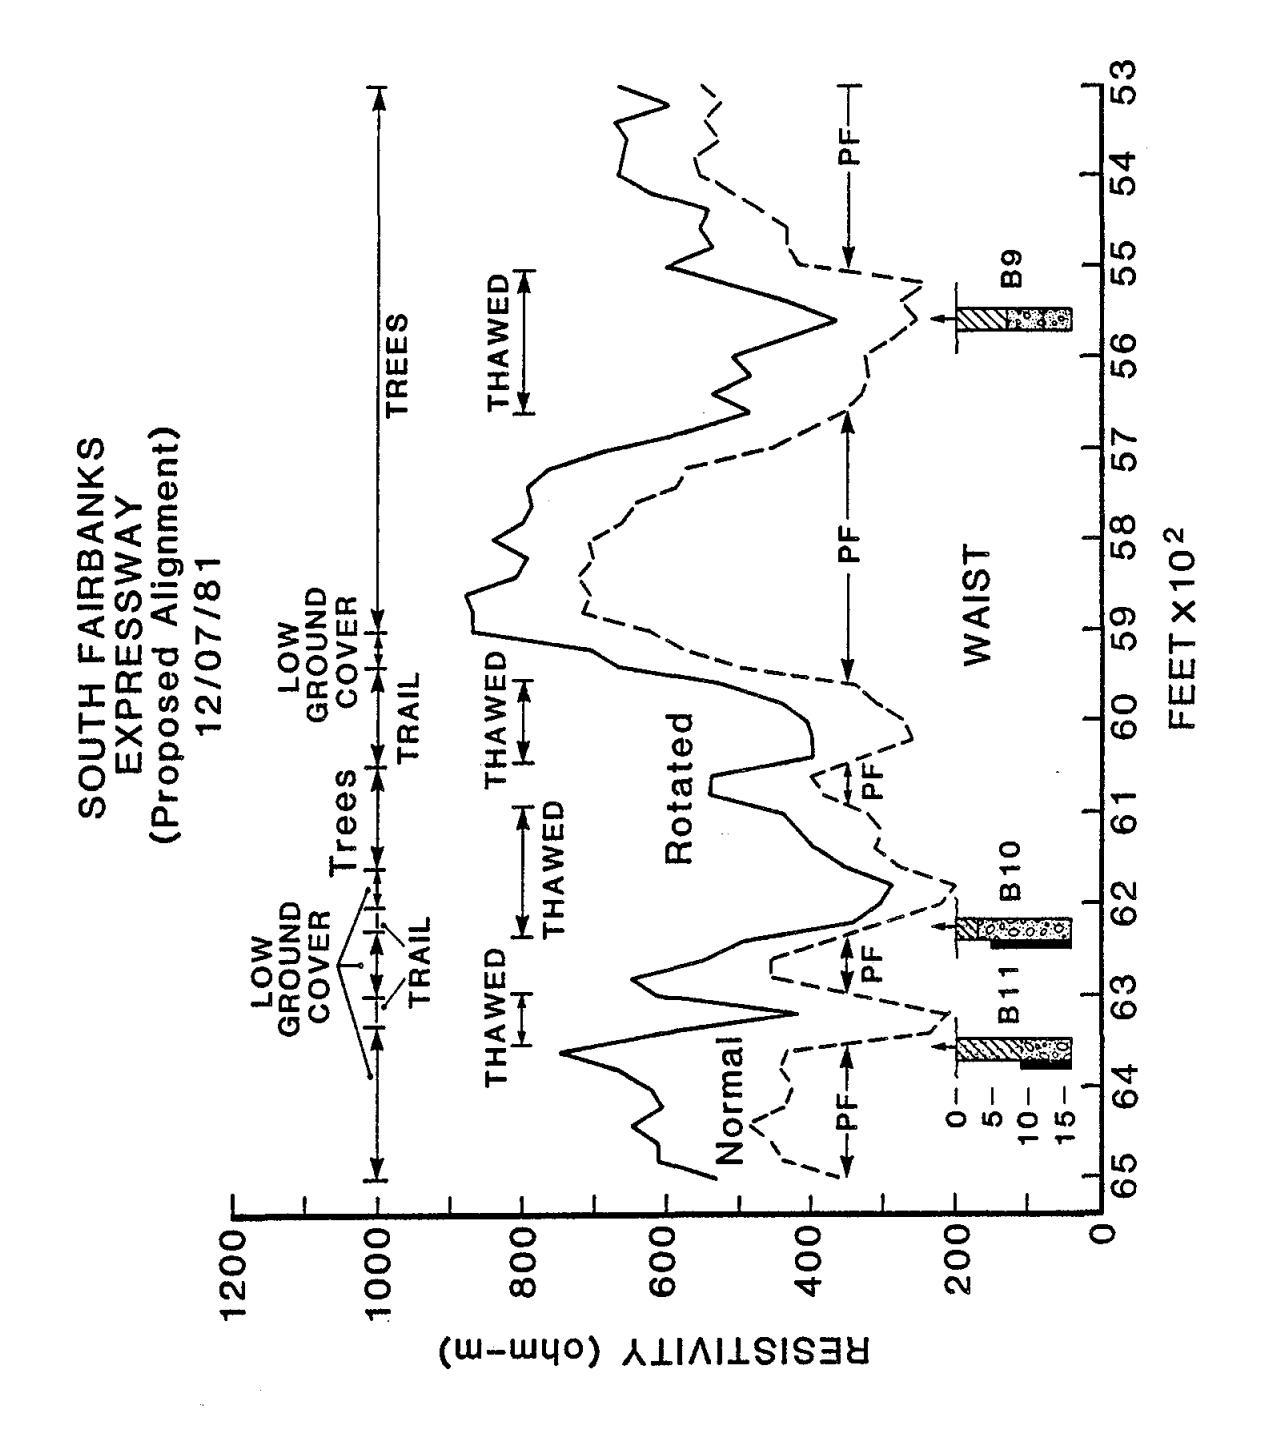
Figure 43. Resisitivity profiles for waist high normal and rotated modes along the proposed alignment (Figure 42) from station 53 to station 65 together with borehole and surface information.

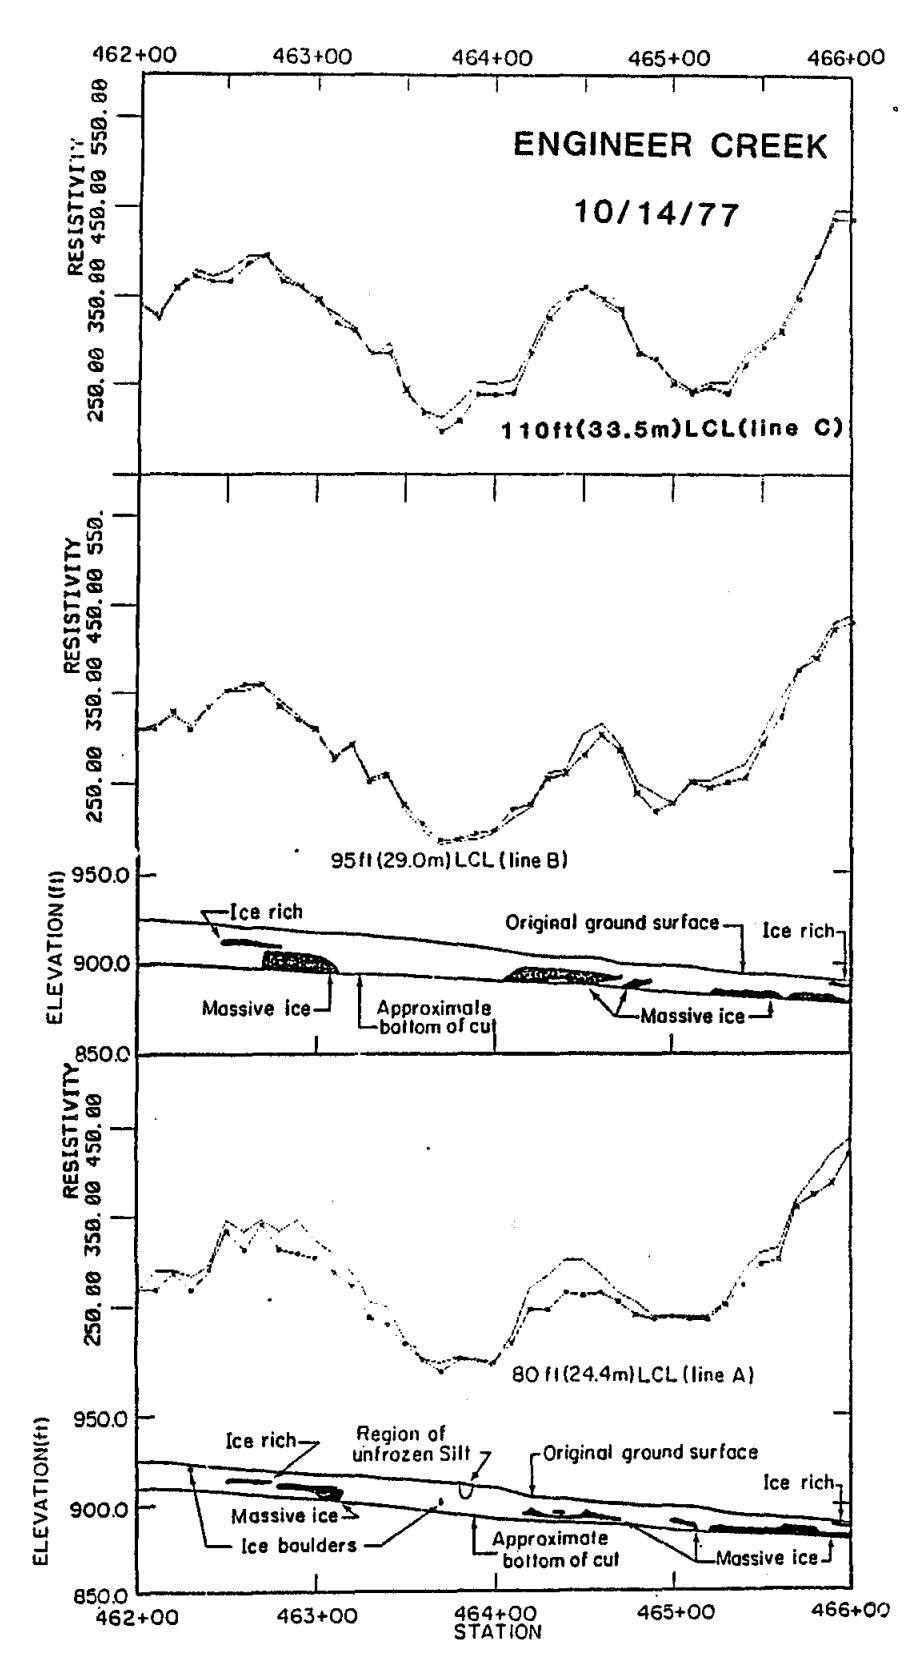
Figure 44. Resistivity profiles for waist high normal mode along three parallel lines (A, B and C) at Engineer Creek roadcut realignment of Steese Highway made prior to construction; the two profiles shown for each line were made with booms parallel to the line and perpendicular. A schematic of the ground ice cross-sections along lines A and B are also shown.

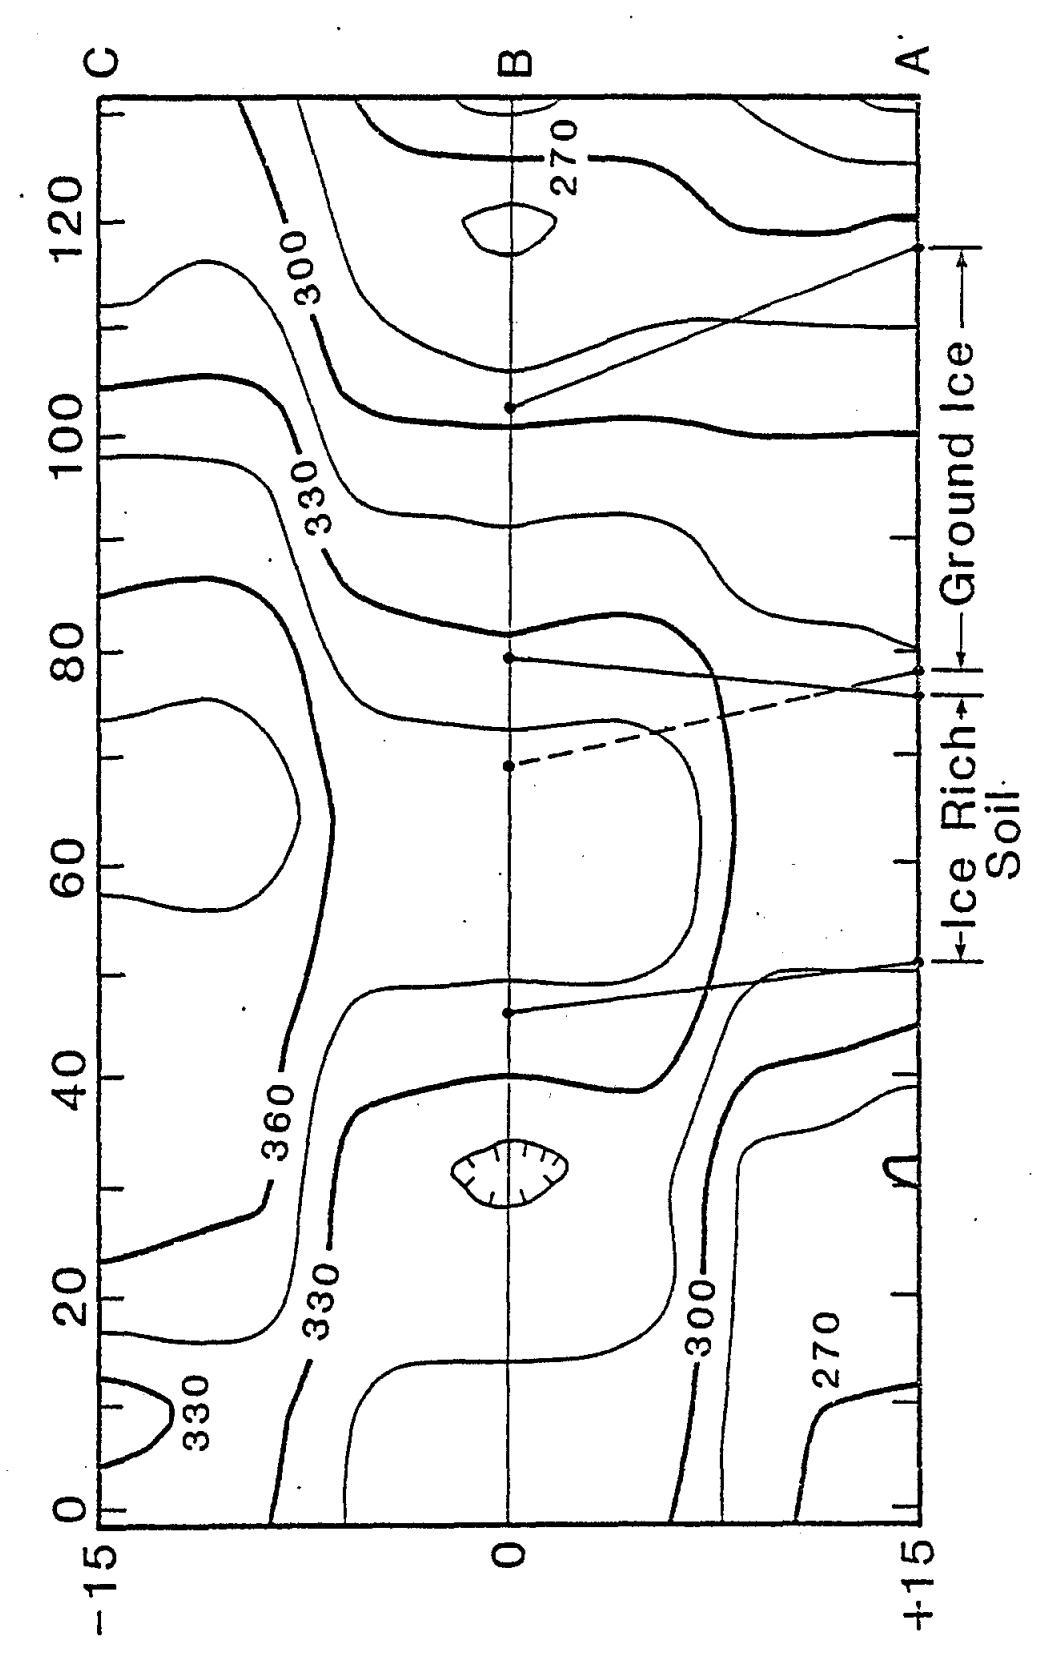
Figure 45. Isoresistivity contours along first 130' (39.6 m) of the grid of values obtained from the three profile lines of Figure 44. The lateral extents of the ice masses and ice-rich soils from Figure 44 are also shown.

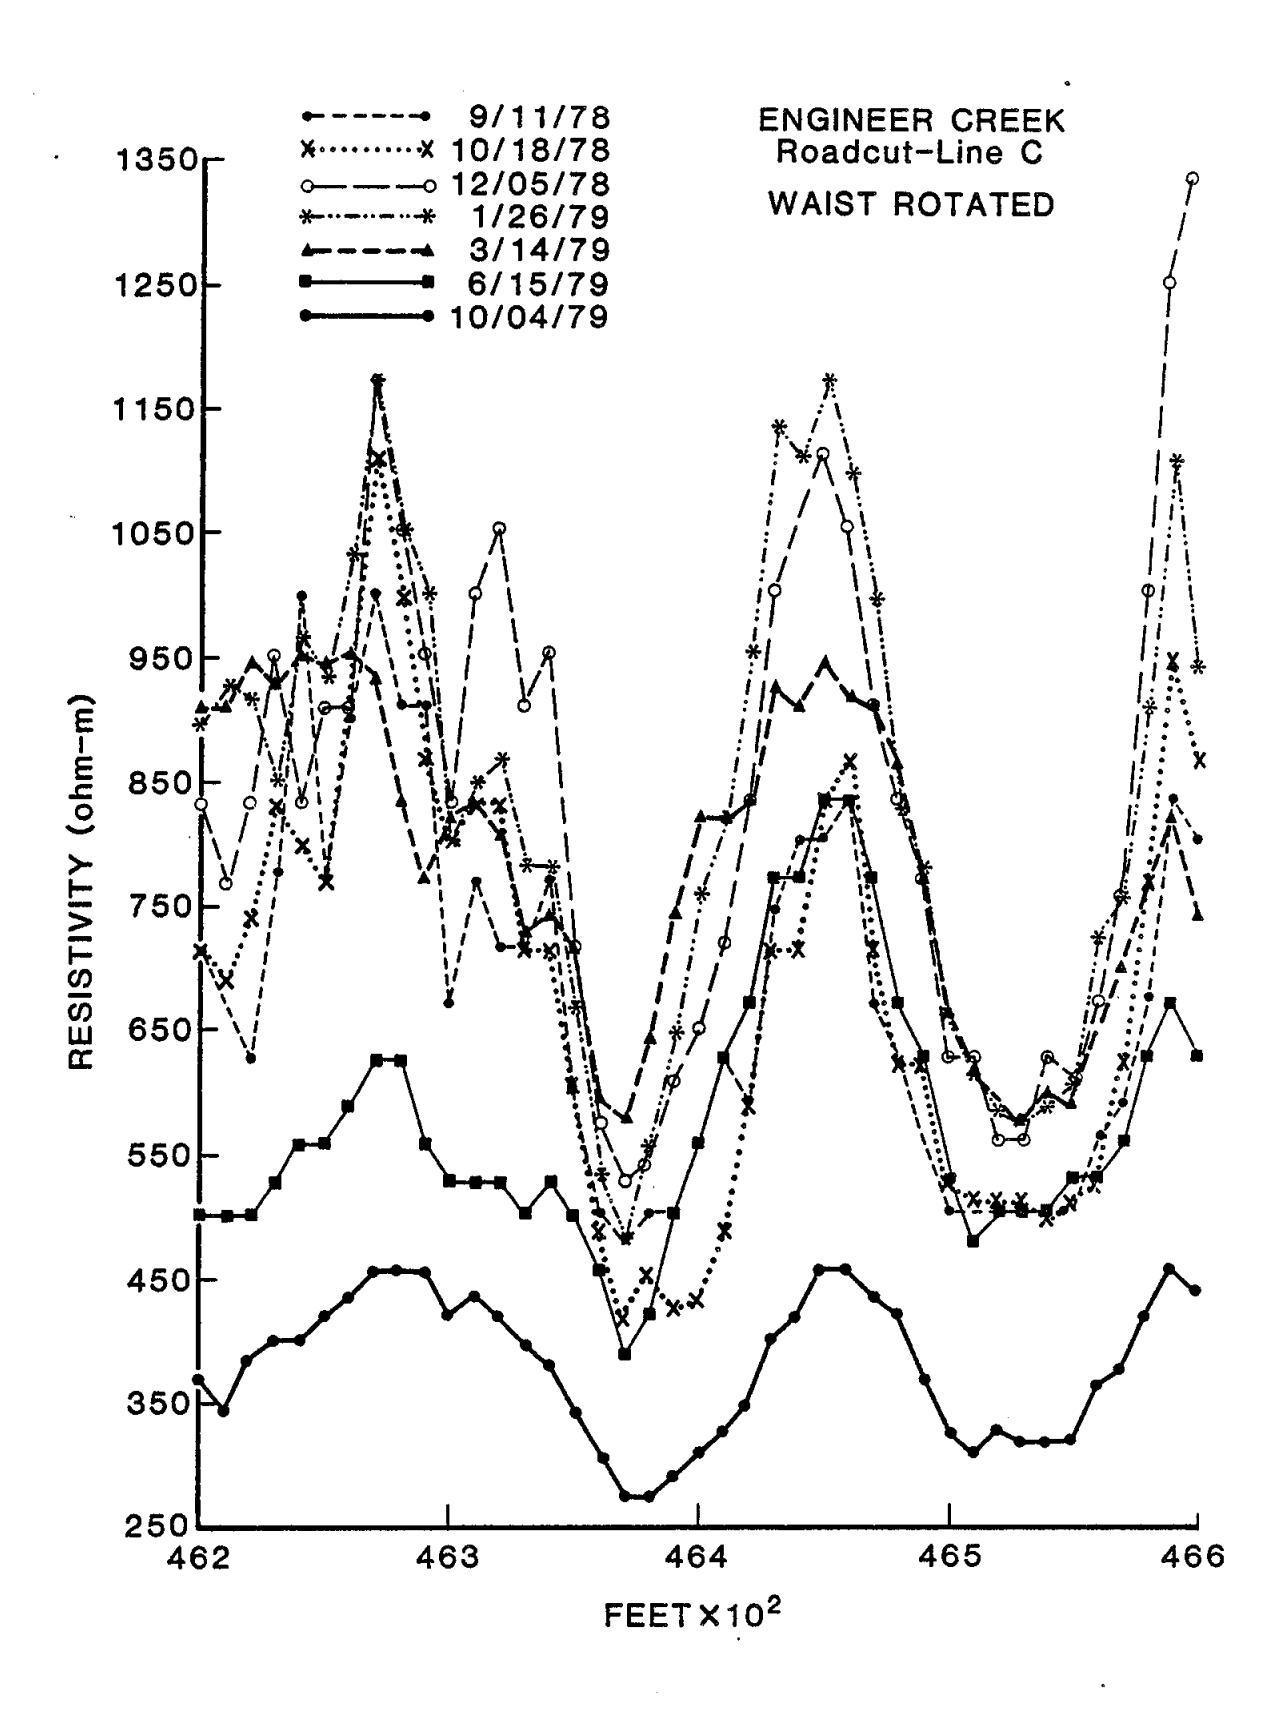
Figure 47. Resistivity profiles for waist high rotated mode corresponding to normal mode of Figure 46.
