ELECTROMAGNETIC INDUCTION MEASUREMENTS IN PERMAFROST TERRAIN FOR DETECTING GROUND ICE AND ICE-RICH SOILS

FINAL REPORT

Koji Kawasaki and Thomas E. Osterkamp Geophysical Institute University of Alaska Fairbanks, Alaska 99701

December 1984

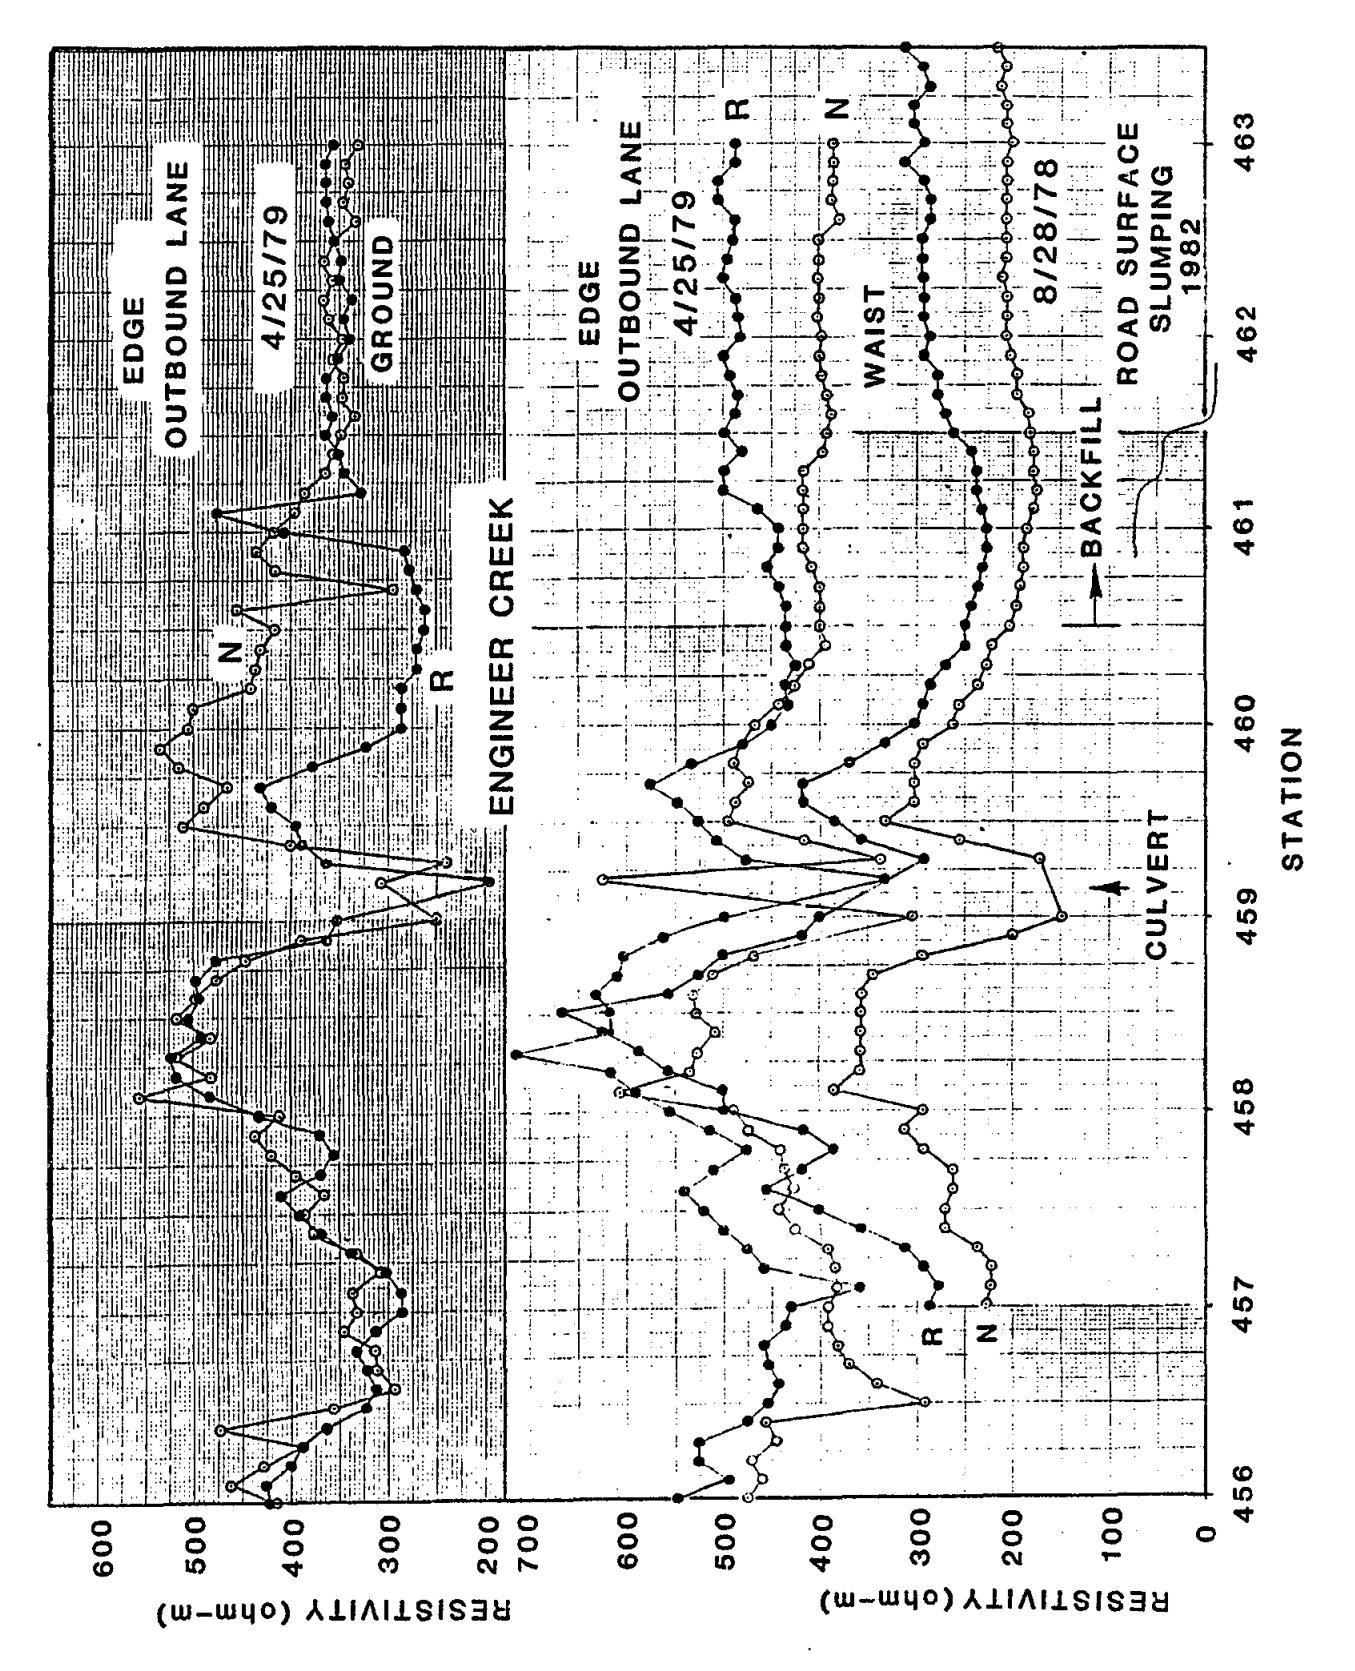
Figure 48. Resistivity profiles in spring and summer along edge of outbound lane within the Engineer Creek roadcut in waist level normal and rotated modes. Ground level normal and rotated mode profiles for the spring date are also shown.

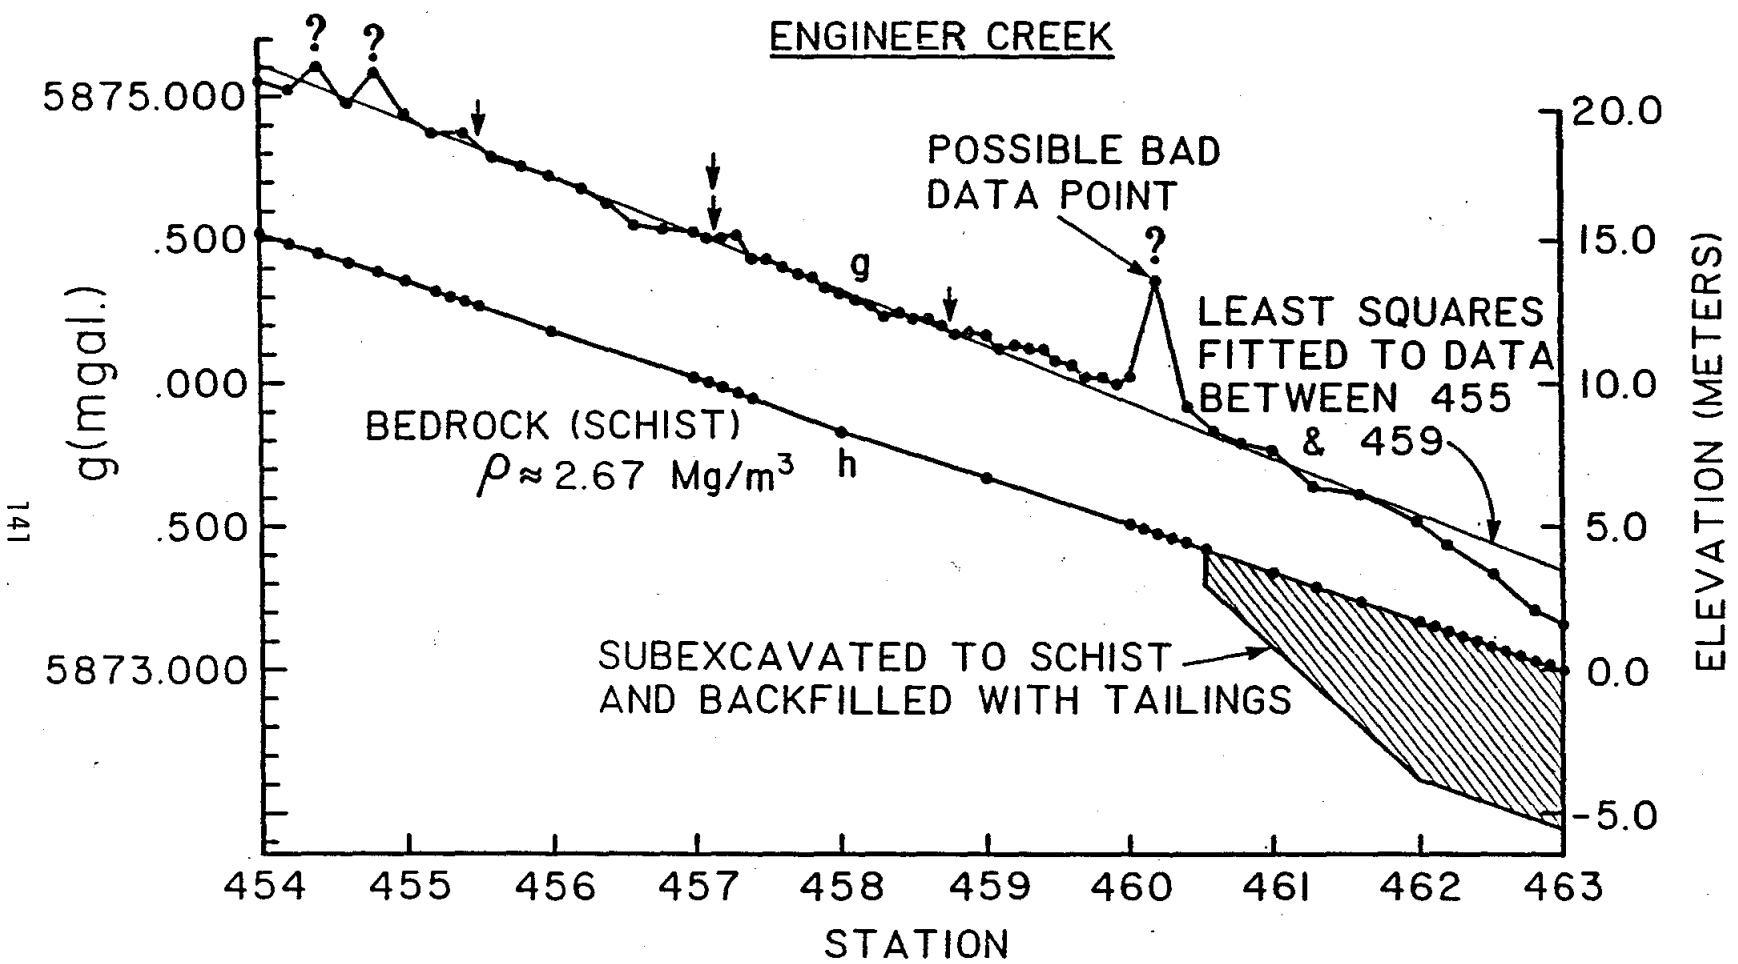
Figure 49. Schematic of 'as built' roadbed, together with gravity values along the same line as Figure 48 (after Kawasaki et al., 1983a).

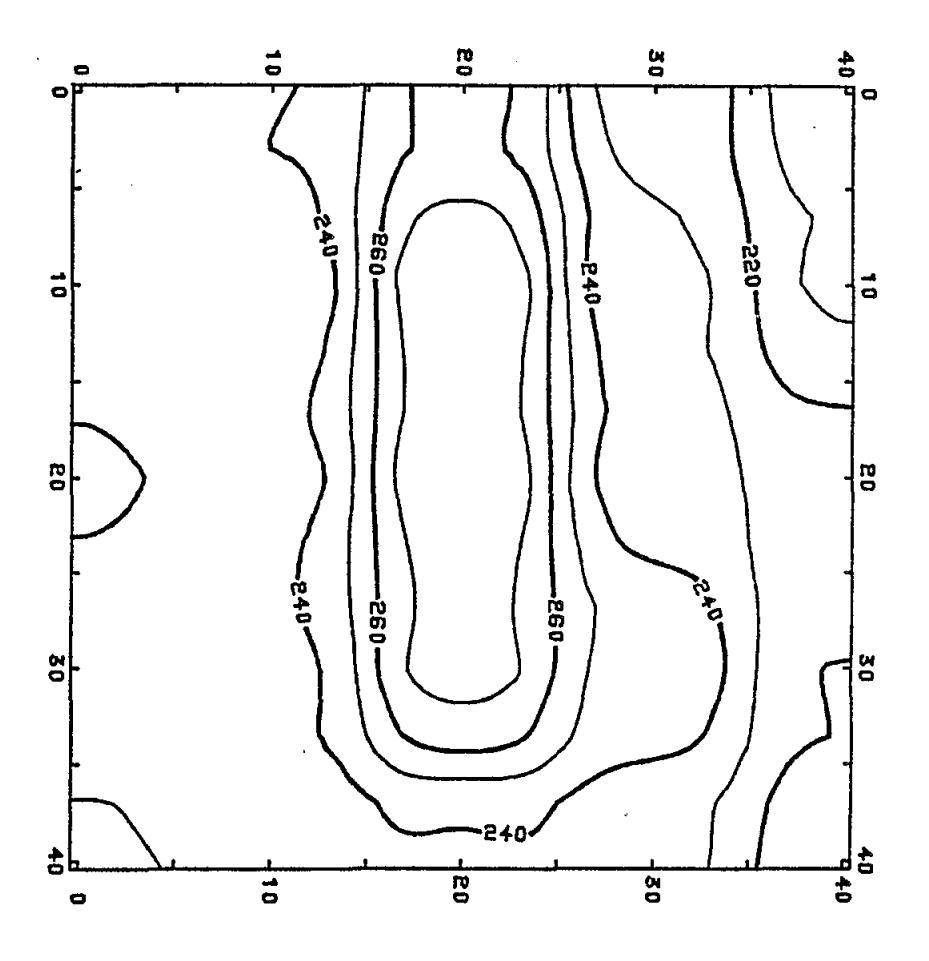
Figure 68. Same as Figure 50, except additional grid points have been removed from line 20E. Note considerable difference in appearance of contours near the line 20E.
