Addendum to Appendix R

Bald Eagle Technical Report

OCTOBER 2005

Prepared by
URS Corporation
2700 Gambell Street, Suite 200
Anchorage, Alaska 99503

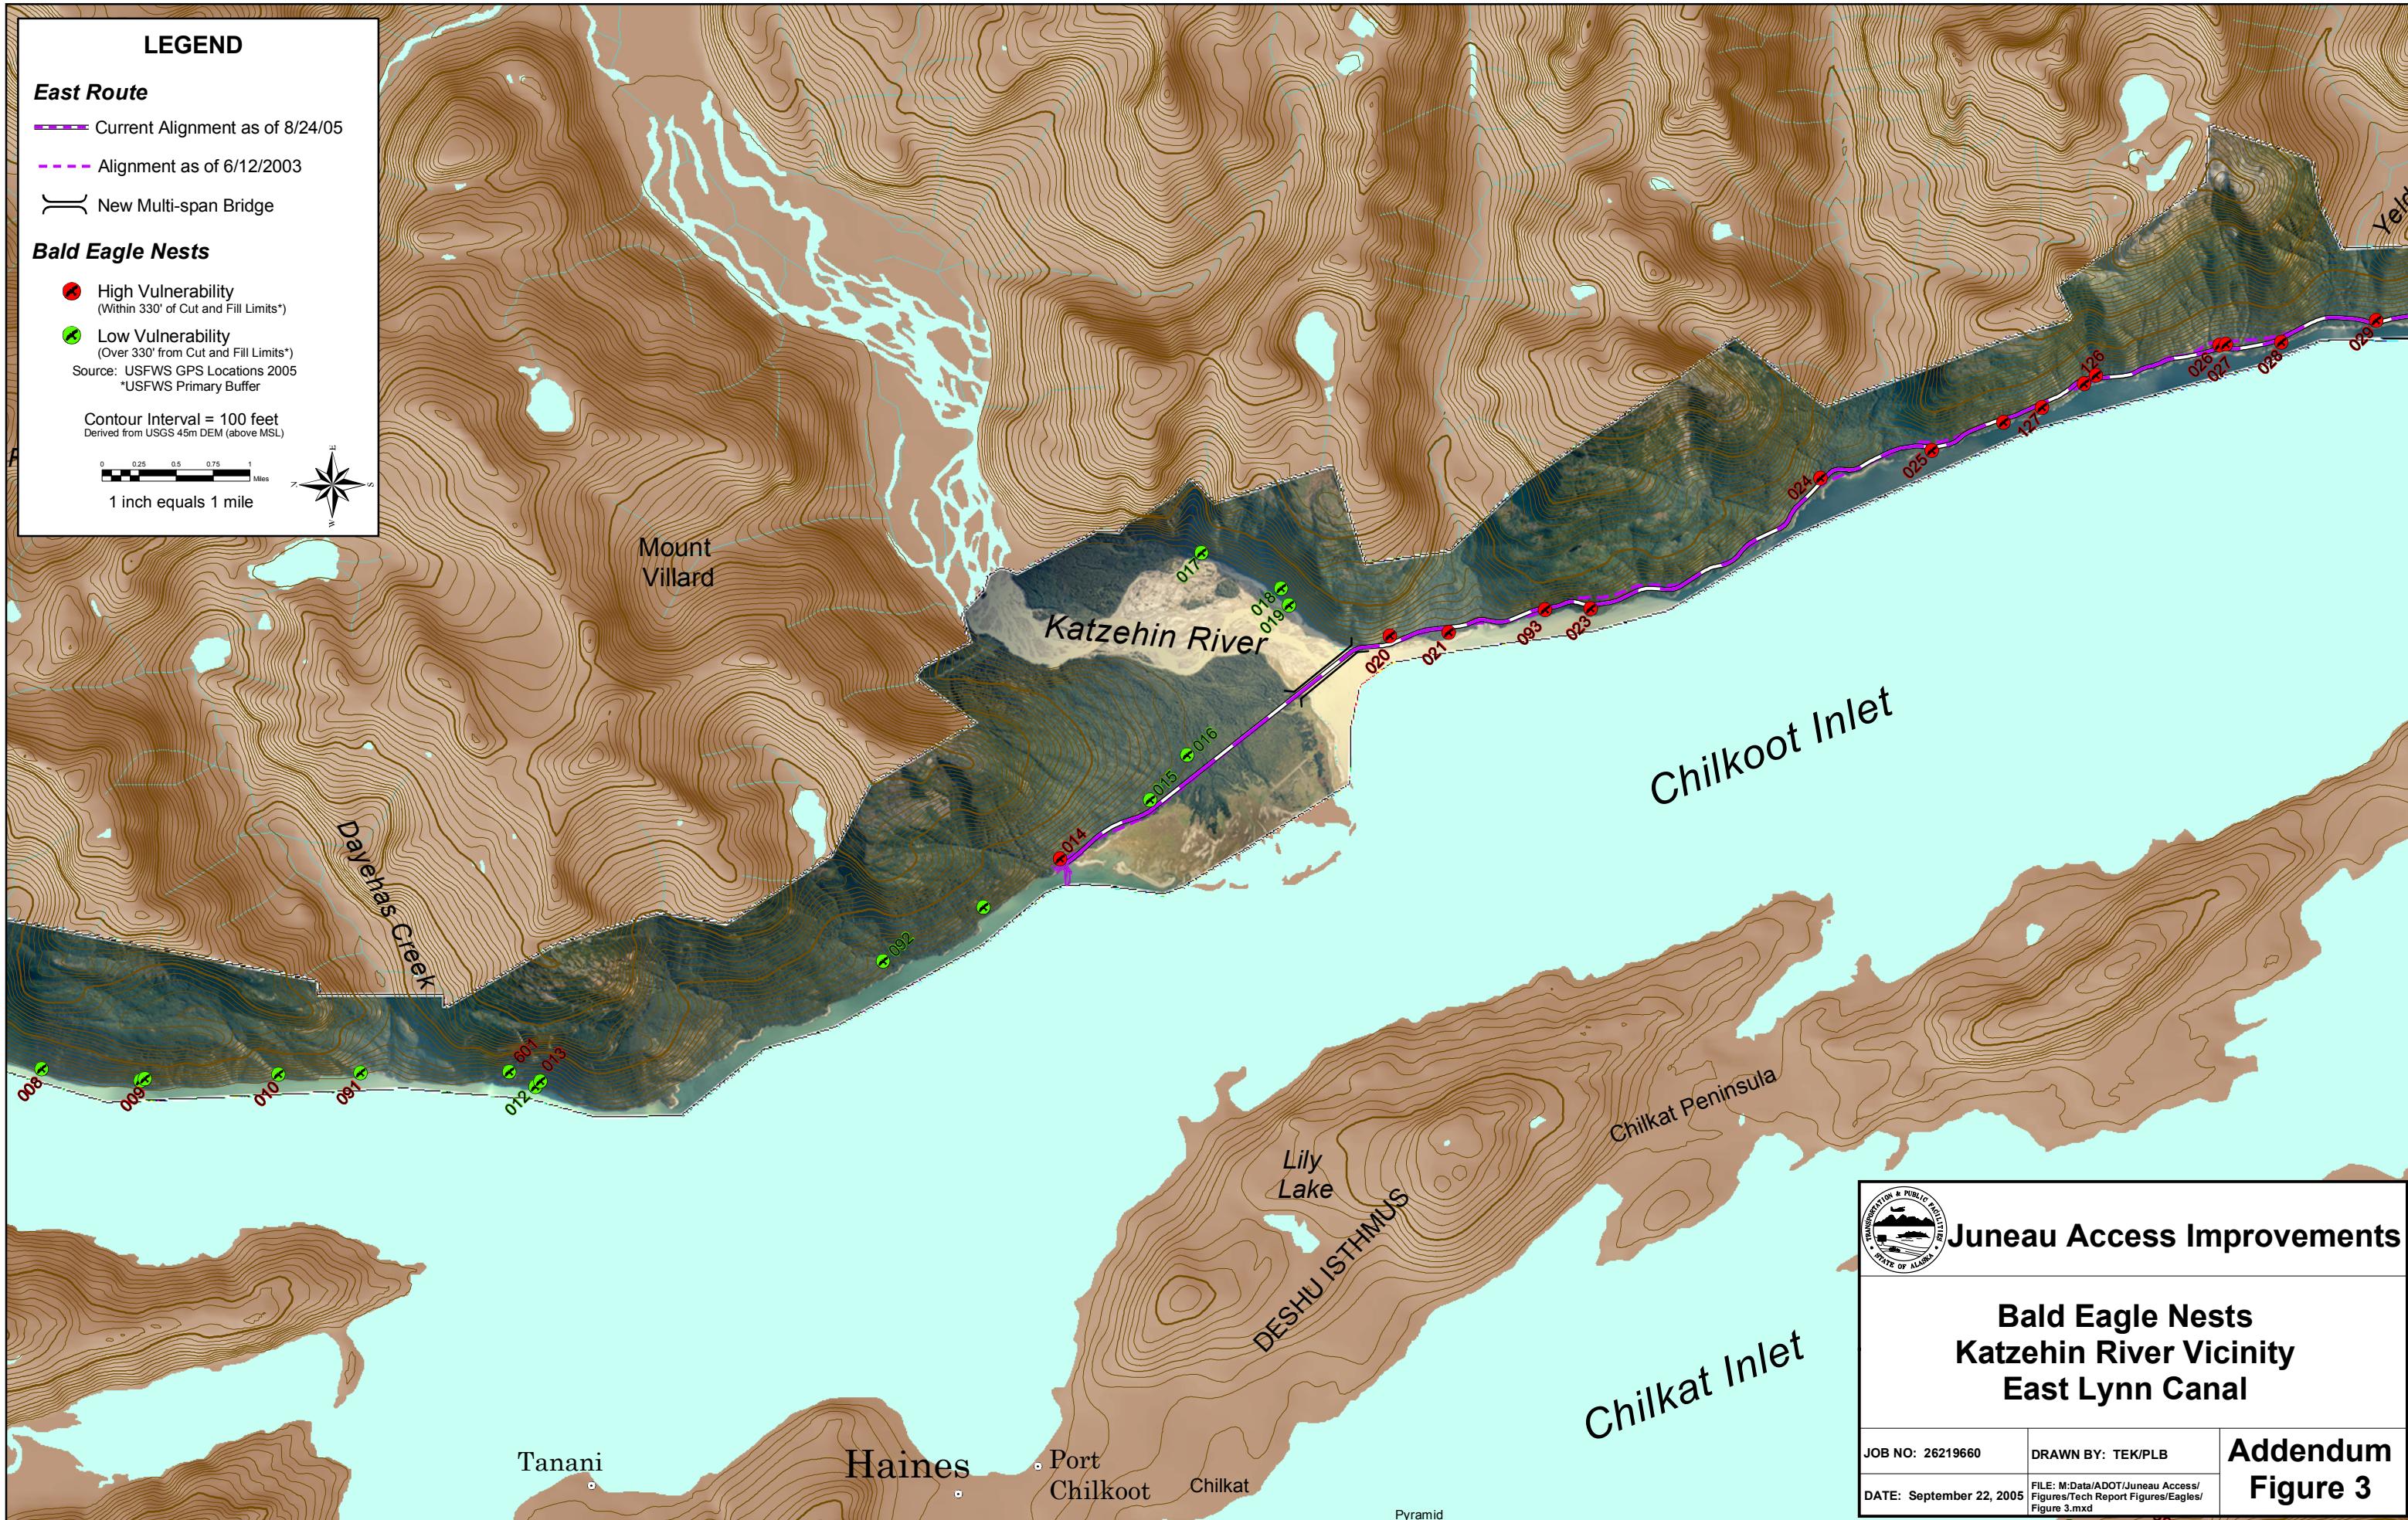
**Addendum
Figure 3**

**Bald Eagle Nests
Katzehin River Vicinity
East Lynn Canal**

● Within 330' of Cut and Fill Limits*

● Over 330' from Cut and Fill Limits*

Proximity of construction activities to eagle nests – For Alternative 2B, 49 out of 92 nests (53 percent) could not be reasonably avoided by more than 330 feet. Of these 49 nests, 3 are within 31 to 90 feet of the proposed slope limits, 20 are within 91 to 180 feet, and 8 are within 181 to 300 feet (Table 1). Figures 1 through 5 include bald eagle nest tree locations from the 2004 and 2005 surveys on the east side of Lynn Canal.

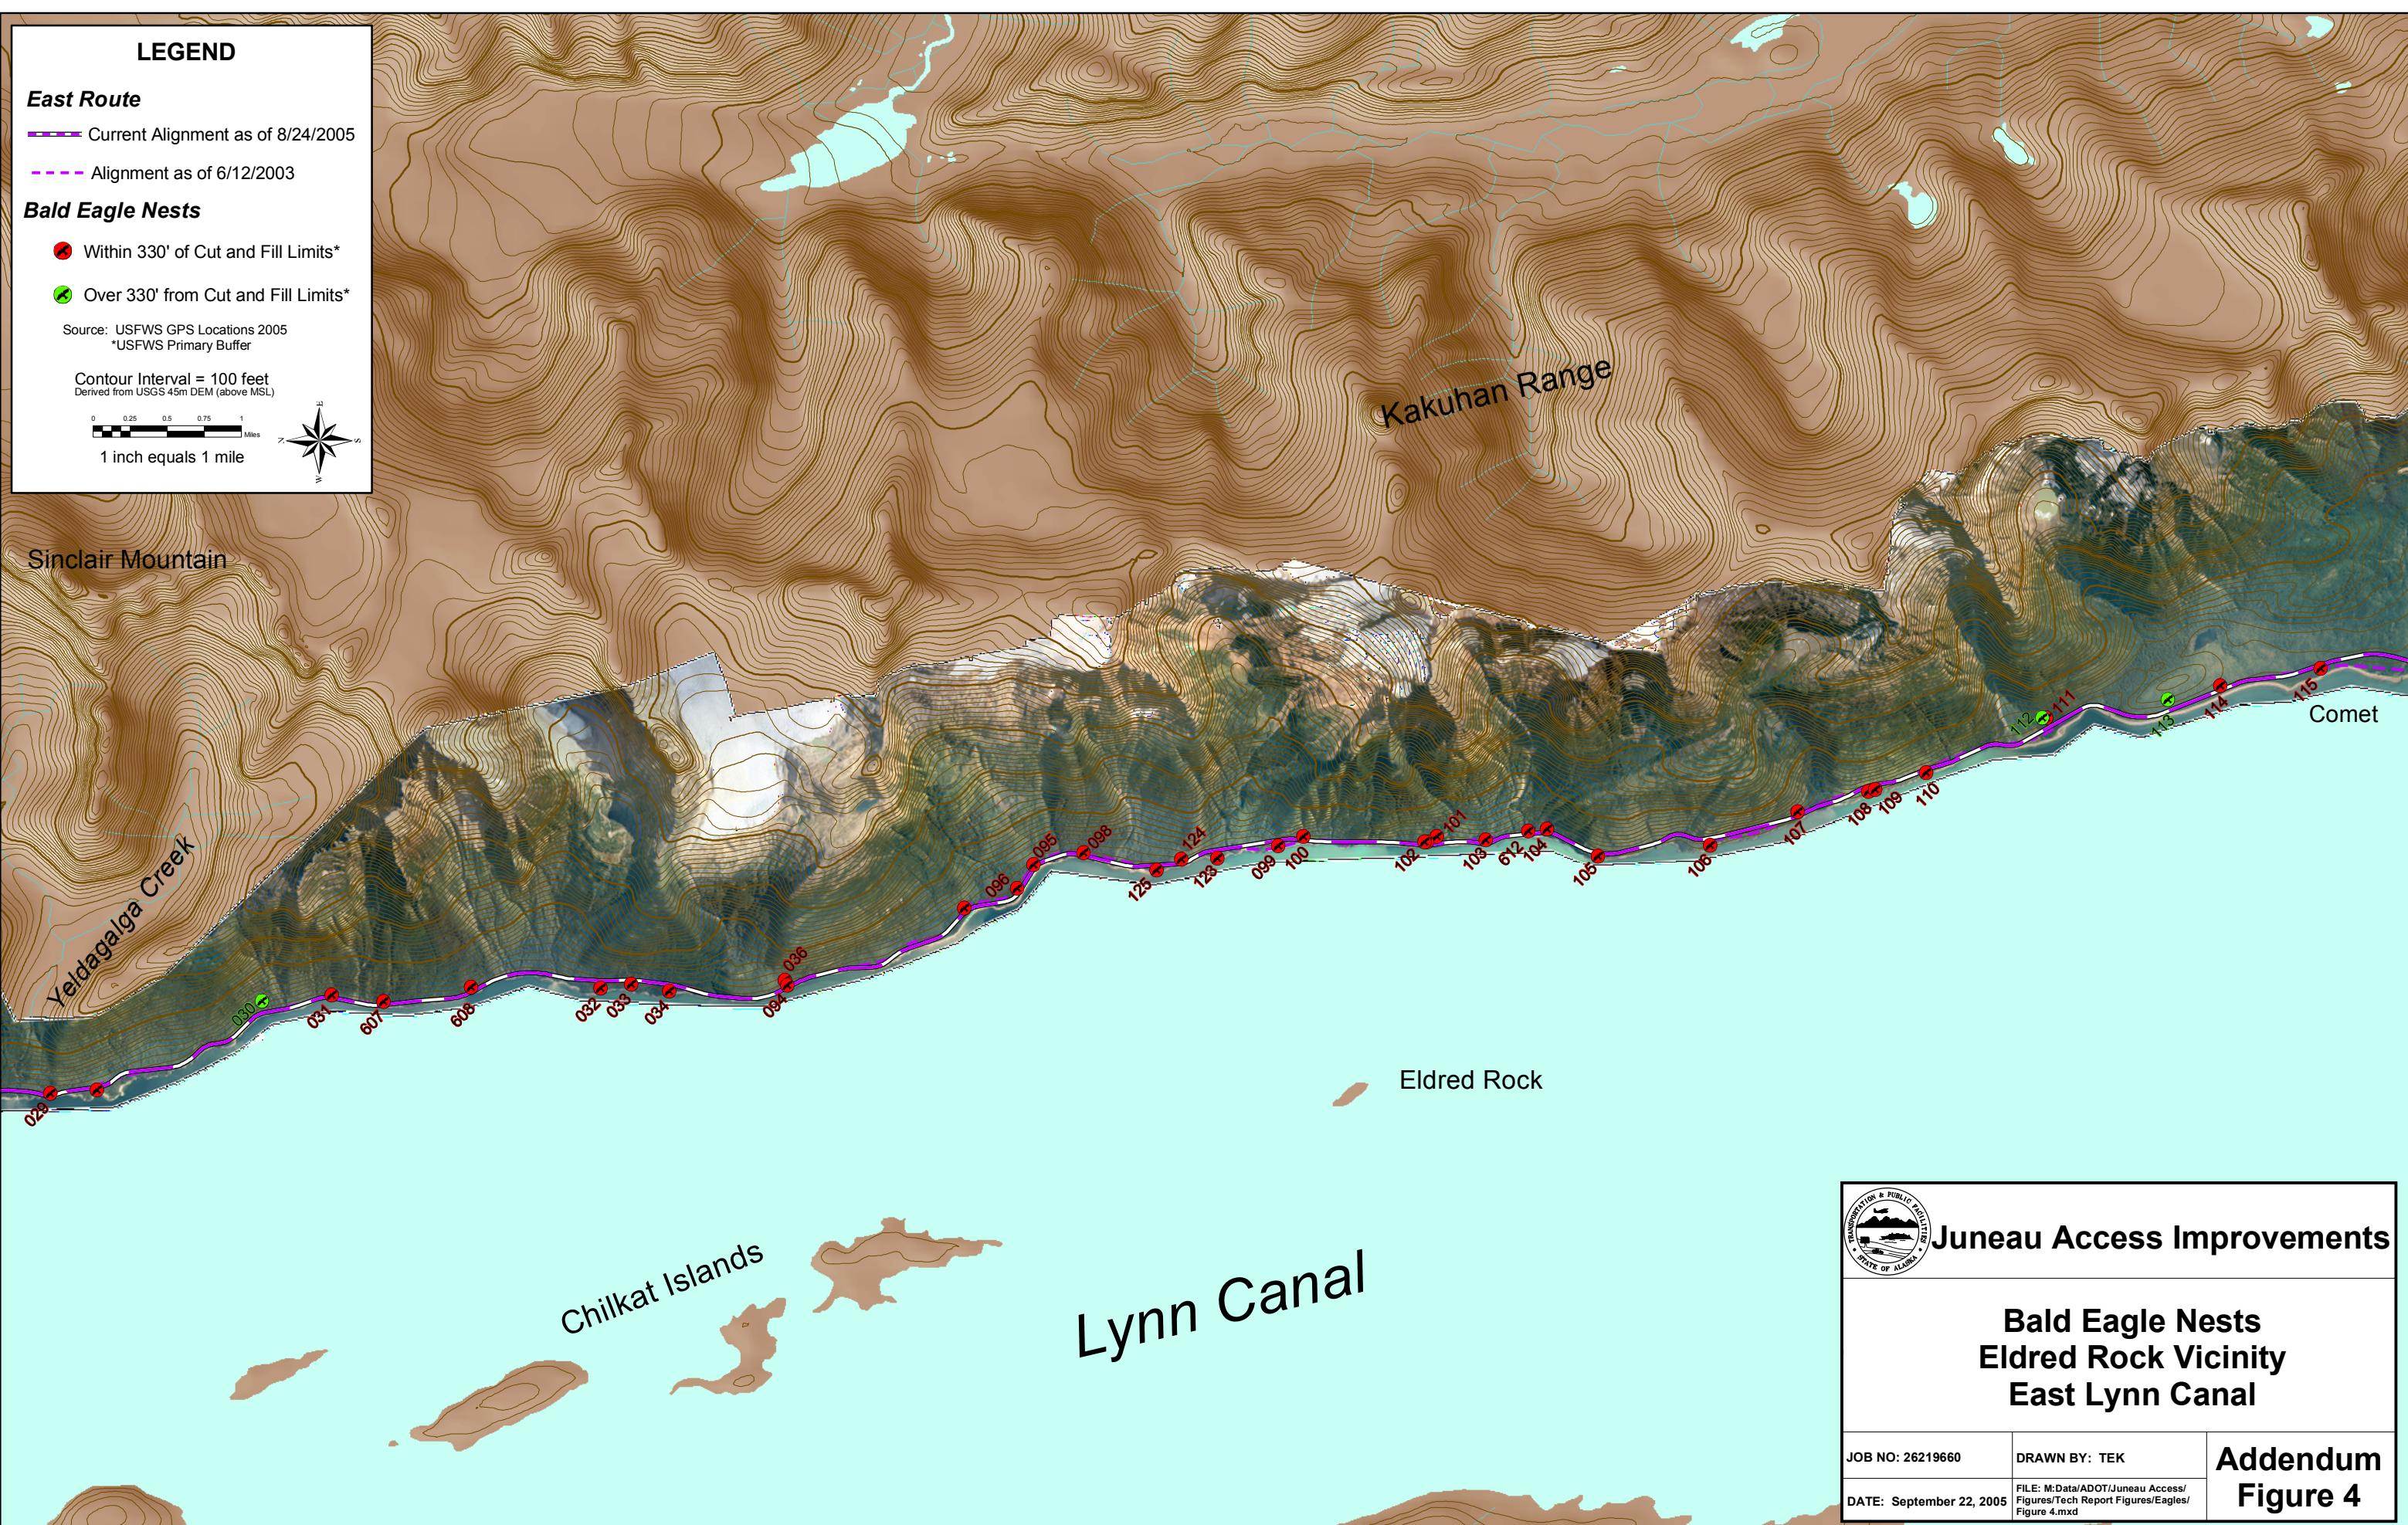
FILE: M:/Data/ADOT/Juneau Access/
Figures/Tech Report Figures/Eagles/
Figure 4.mxd**Addendum
Figure 4**

**Juneau Access Improvements****Bald Eagle Nests
Eldred Rock Vicinity
East Lynn Canal**

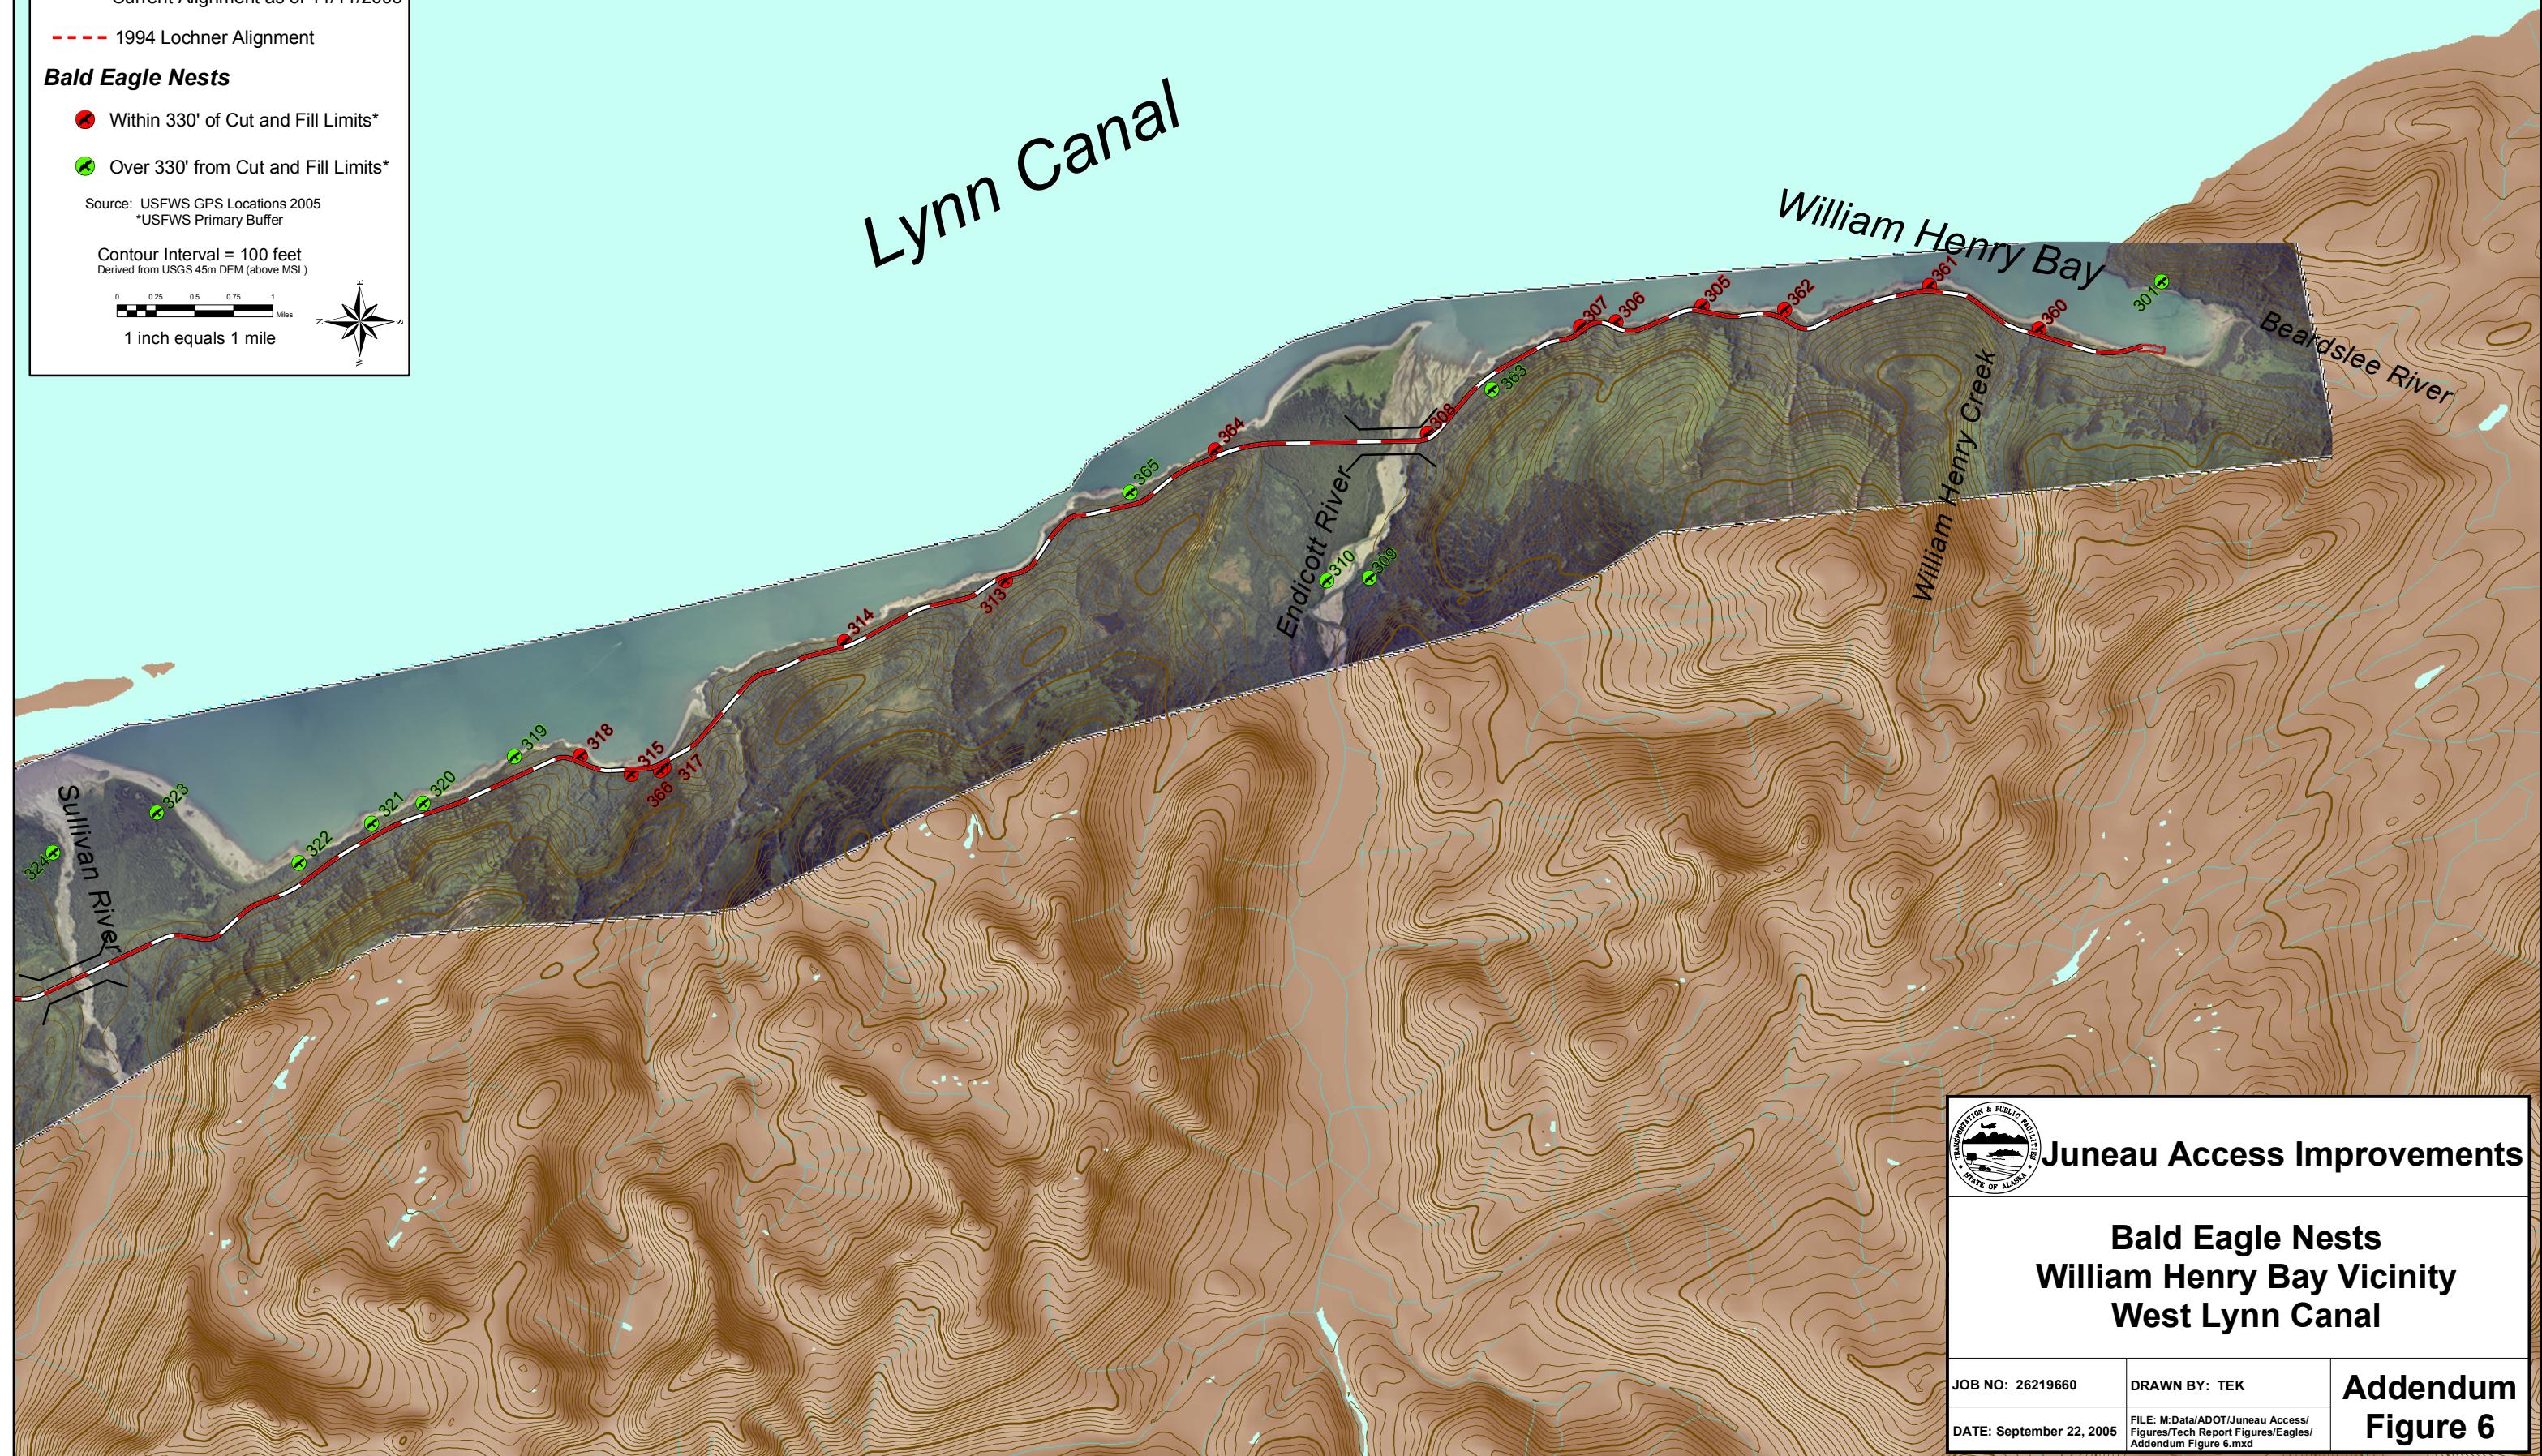
Addendum
Figure 6

Bald Eagle Nests William Henry Bay Vicinity West Lynn Canal

Proximity of construction activities to eagle nests – Fifty bald eagle nest sites were recorded within 0.5 mile of the highway alignment for this alternative during USFWS surveys in 2004. This total includes 10 nests on the east side of Lynn Canal between Echo Cove and Sawmill Cove. Of the total nests surveyed in 2004, 52 percent were found to be active (Table 1). After adjusting the highway alignment and ferry terminal locations to avoid nest sites to the extent feasible, a total of 24 nests (48 percent) remained within 330 feet of the slope limits, all of which are on the west side of Lynn Canal. Of these 24 nests, none are within 31 to 90 feet of the slope limits, 8 are within 91 to 180 feet, and 8 are within 181 to 300 feet (Table 1). Figures 1 and 6 through 8 include bald eagle nest tree locations for west Lynn Canal.
