**Pre-PIH
REVIEW**

PROJECT NAME: Muldoon Road: Debarr to 36th Pavement Preservation

PROJECT NUMBER: CFHWY00406

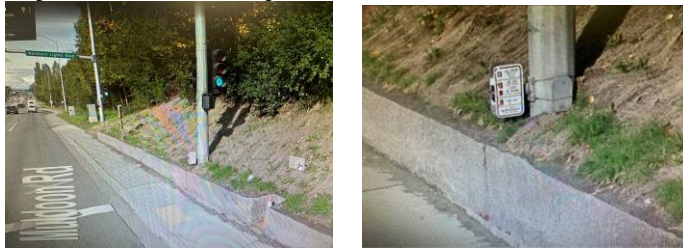
9)	F 03	SM	Northern Lights & Muldoon SE quadrant. Existing signal pole is located behind a retaining wall. Slope allow for snow build up on top of retaining wall and pedestrian signal push button becomes buried in hard pack berm. This berm also impedes access to the pole base hand hole cover.

Noted. We will look at this location closer to see what can be done. Slope options appears limited to available ROW.	JO
