**Air Convection Embankment (ACE)**  
**Experimental Feature in Highway Construction Final Report**

Construction of Road Embankments with Reduced Air Convection Embankment  
(ACE) Shoulder Top-Widths  
Dalton Highway MP 209-222 Reconstruction Project  
Project No. 0655015/NFHwy00144  
June 30, 2022  
Publication No. FHWA-AK-RD-4000(113)

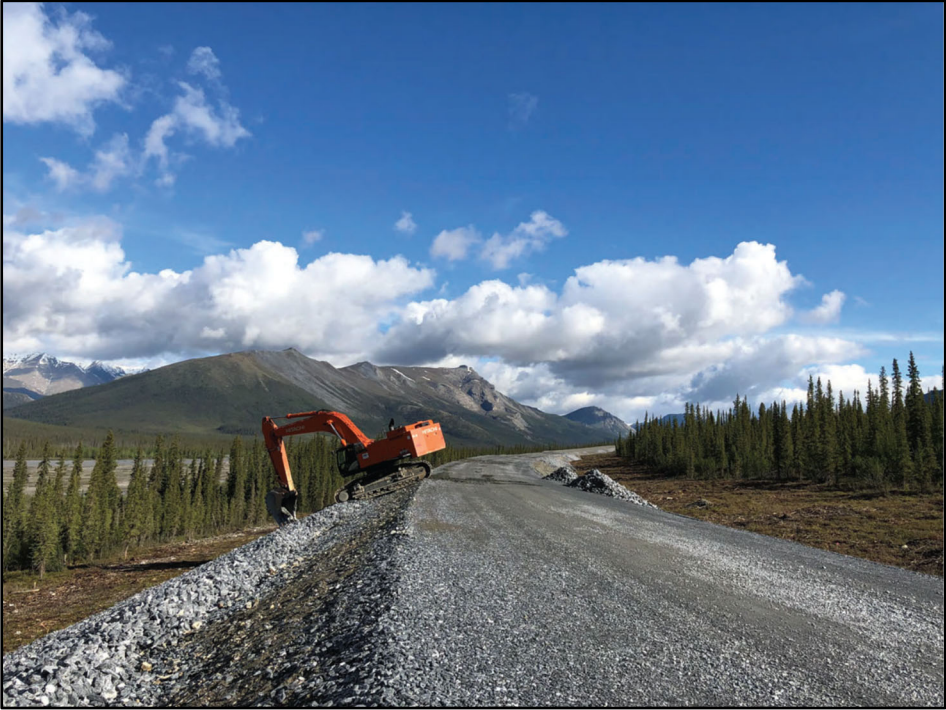
Figure 2: ACE Placement

The ACE aggregate was end-dumped in roughly evenly-placed piles via dump truck. The ACE aggregate was then shaped with a Hitachi, 870, track-mounted excavator. Figures 2 and 3 illustrate the placement and shaping of the ACE aggregate on the conventional aggregate foreslopes.

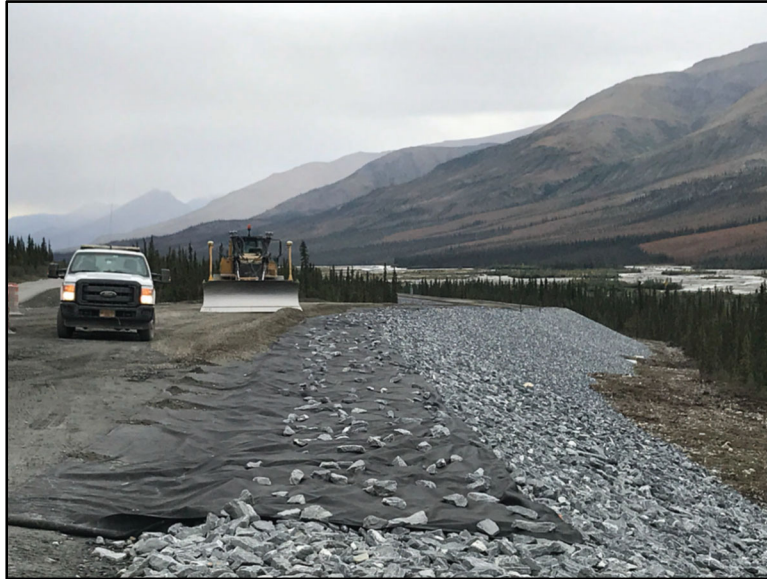
Figure 4: Geotextile Placed on top of ACE Shoulder.

The initial design was to surface the embankment with asphalt. Due to movement observed during construction, however, it was decided to surface the embankment with a gravel surface course. As such, geotextile was placed on top of the shoulder to address concern that normal maintenance operations such as grading, plowing and winter-time sanding would not result in contamination of the upper portions of the ACE shoulders. We were concerned that such contamination would work its way down into the shoulder, cutoff air flow and reduce the shoulder's winter-time performance. We recognized the geotextile may limit the airflow through the top of the shoulder but felt that this adverse effect would be less than that of fines infiltrating deeper into the shoulder. Figure 4 illustrates the geotextile placed on top of the ACE shoulder.

As discussed previously, it was decided to cover the ACE shoulder tops with geotextile in an effort to prevent contamination from surface aggregate due to routine maintenance. We do not know to what degree this geotextile is adversely effecting the thermal performance of the ACE shoulders. However, we speculate the adverse effect is likely minimal, particularly with the taller shoulders. This is supported by the relatively good performance we have observed in these shoulders thus far.

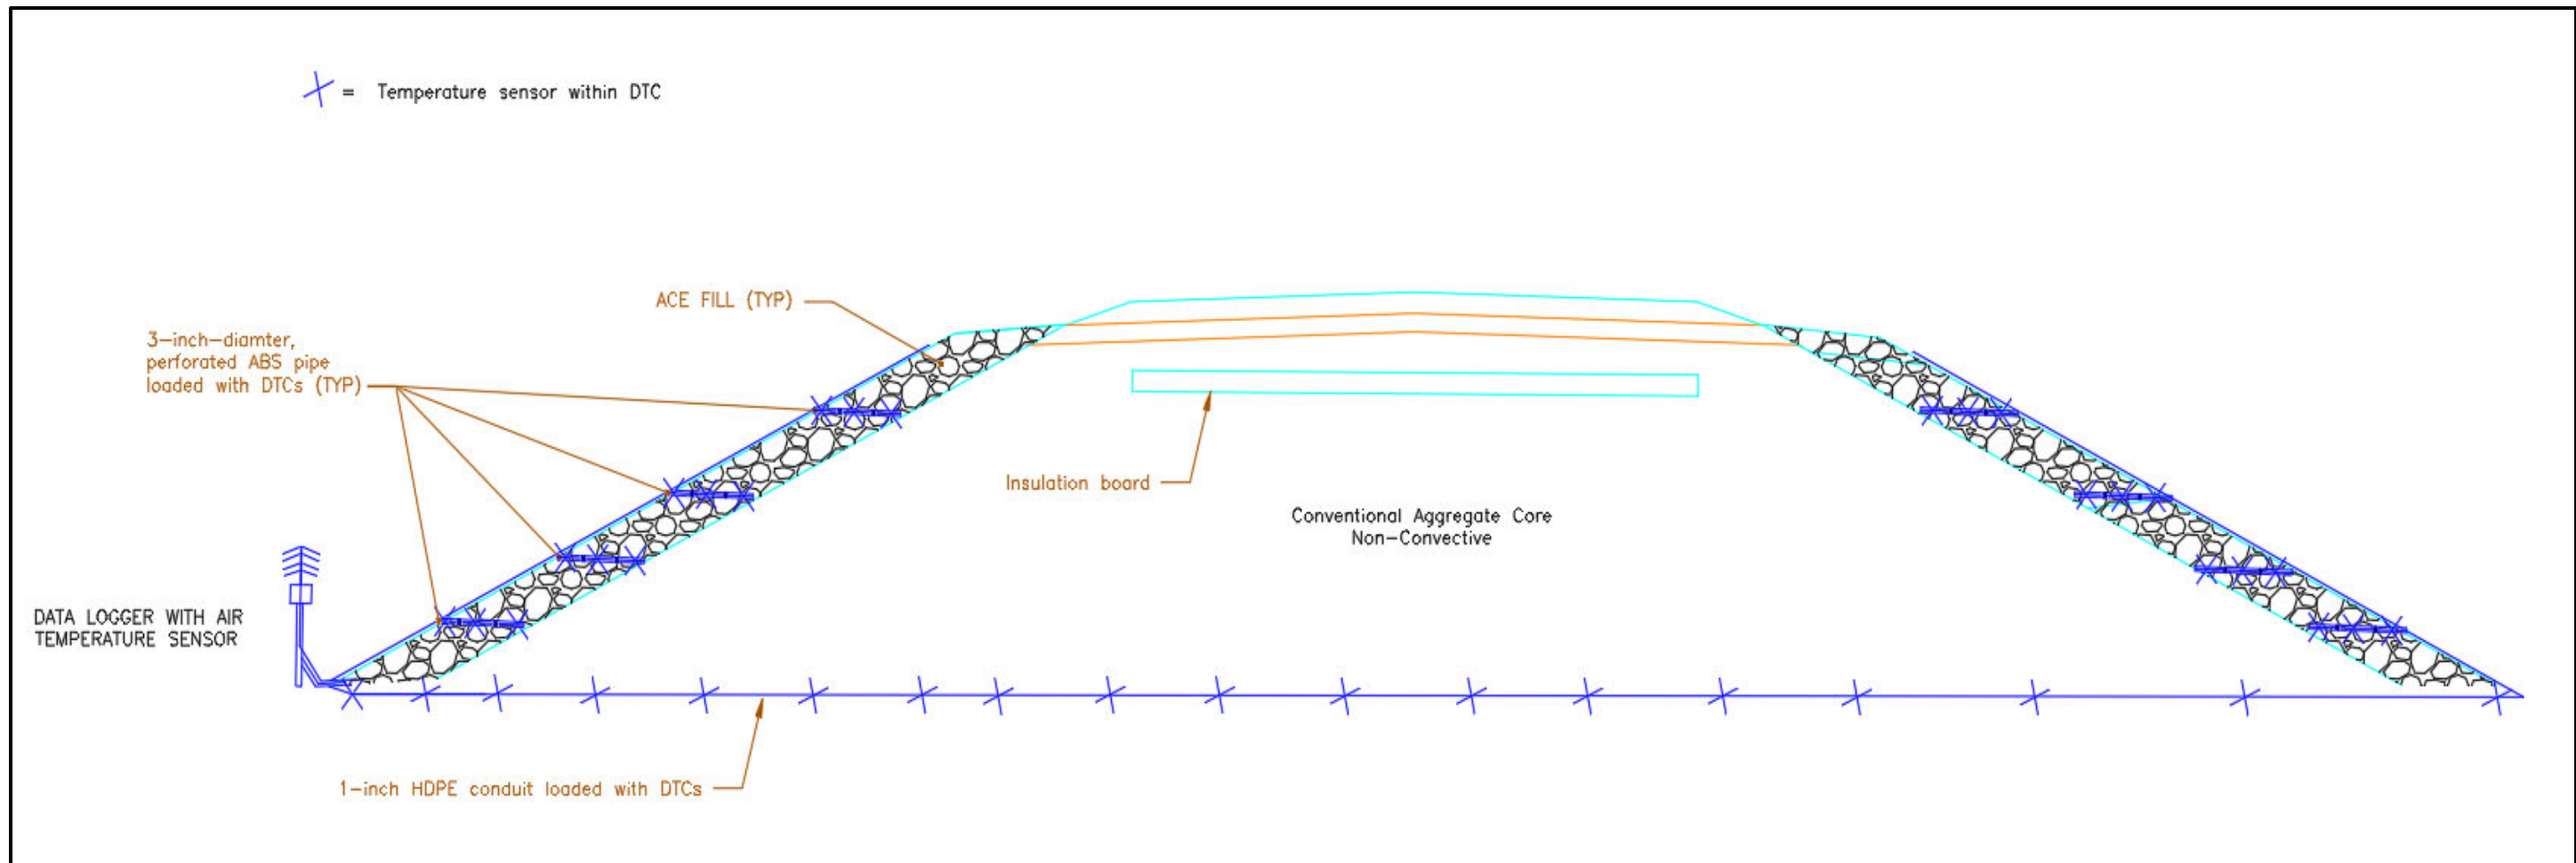
Figure 5: Experimental Feature Typical Section

The instrumentation for these test sections includes single-point Digital Temperature Cables (DTCs) for measuring ambient air temperature and DTCs with multiple temperature sensors for measuring temperatures at select locations within the embankment. The DTCs within the conventional aggregate portions of the embankment are loaded within 1-inch-diameter, HDPE conduit. In an effort to subject temperature sensors to temperature fluxes due to air flow, the DTCs within the ACE aggregate shoulders are loaded within 3-inch-diameter, perforated ABS pipe.

The DTCs for all twelve test sections are attached to three data loggers. These data loggers are attached to 3-inch-diameter, steel posts embedded in the ground near the toe of the embankment. Test Sections 1 through 4 are attached to a datalogger located near station 3234+50. Test Sections 5 through 8 are attached to a datalogger located near station 3240+50. Finally, test sections 9 through 12 are attached to a datalogger located near station 3245+50. Table 3 summarizes the test sections assigned to each datalogger as well as the number of sensors within them. Figure 5 below illustrates the basic Typical Section and DTC string locations for our twelve ACE test sections. More detailed sensor locations are shown in Appendix A.

The purpose of the DTCs located in the ACE shoulders was to characterize the winter-time airflow pattern within the ACE shoulders. The purpose of the DTCs located at the bottom of the embankment was to determine annual average and seasonal temperatures between the embankment and foundations soils and characterize the effect that ACE shoulder cooling has on the temperature of the lower and center portions of the embankment.

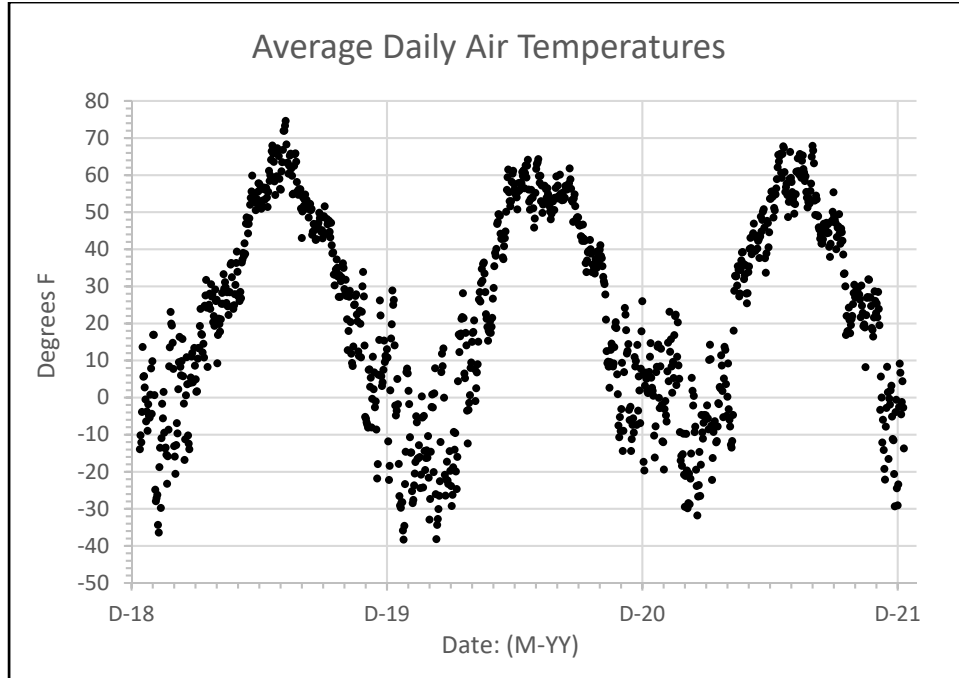
Figure 6: Average Daily Air Temperature Record.

Air temperature was recorded every 2 hours between 12/13/2018 and 01/08/2019, every 4 hours between 01/09/2019 and 05/11/2020, and every 6 hours between 05/12/2020 and 12/12/2022. We decided that average daily temperatures from each of these three record frequencies are likely similarly accurate. As such, we developed an average daily temperature record by calculating average temperature for each day within this record interval. The average daily temperature interval was then “stitched” together in the manner previously detailed and summarized in Table 5. Figure 6 illustrates the average daily temperature record used in our analyses.

Based upon this temperature record, we calculated both the air thawing and freezing indices (ATI and AFI) using Equations 1 through 4. As a check, we compared these climate parameters to those estimated from temperature data for Wiseman (which is roughly 33 miles south of the site) made available through the Alaska Climate Research Center ([https://akclimate.org /data/data-portal/](https://akclimate.org/data/data-portal/)). This data suggests that Wiseman is slightly cooler than the area surrounding our experimental feature. However, the climate data of the two locations is similar enough to make us confident in our data. Table 6 summarizes and compares the climate data between our experimental feature and Wiseman.

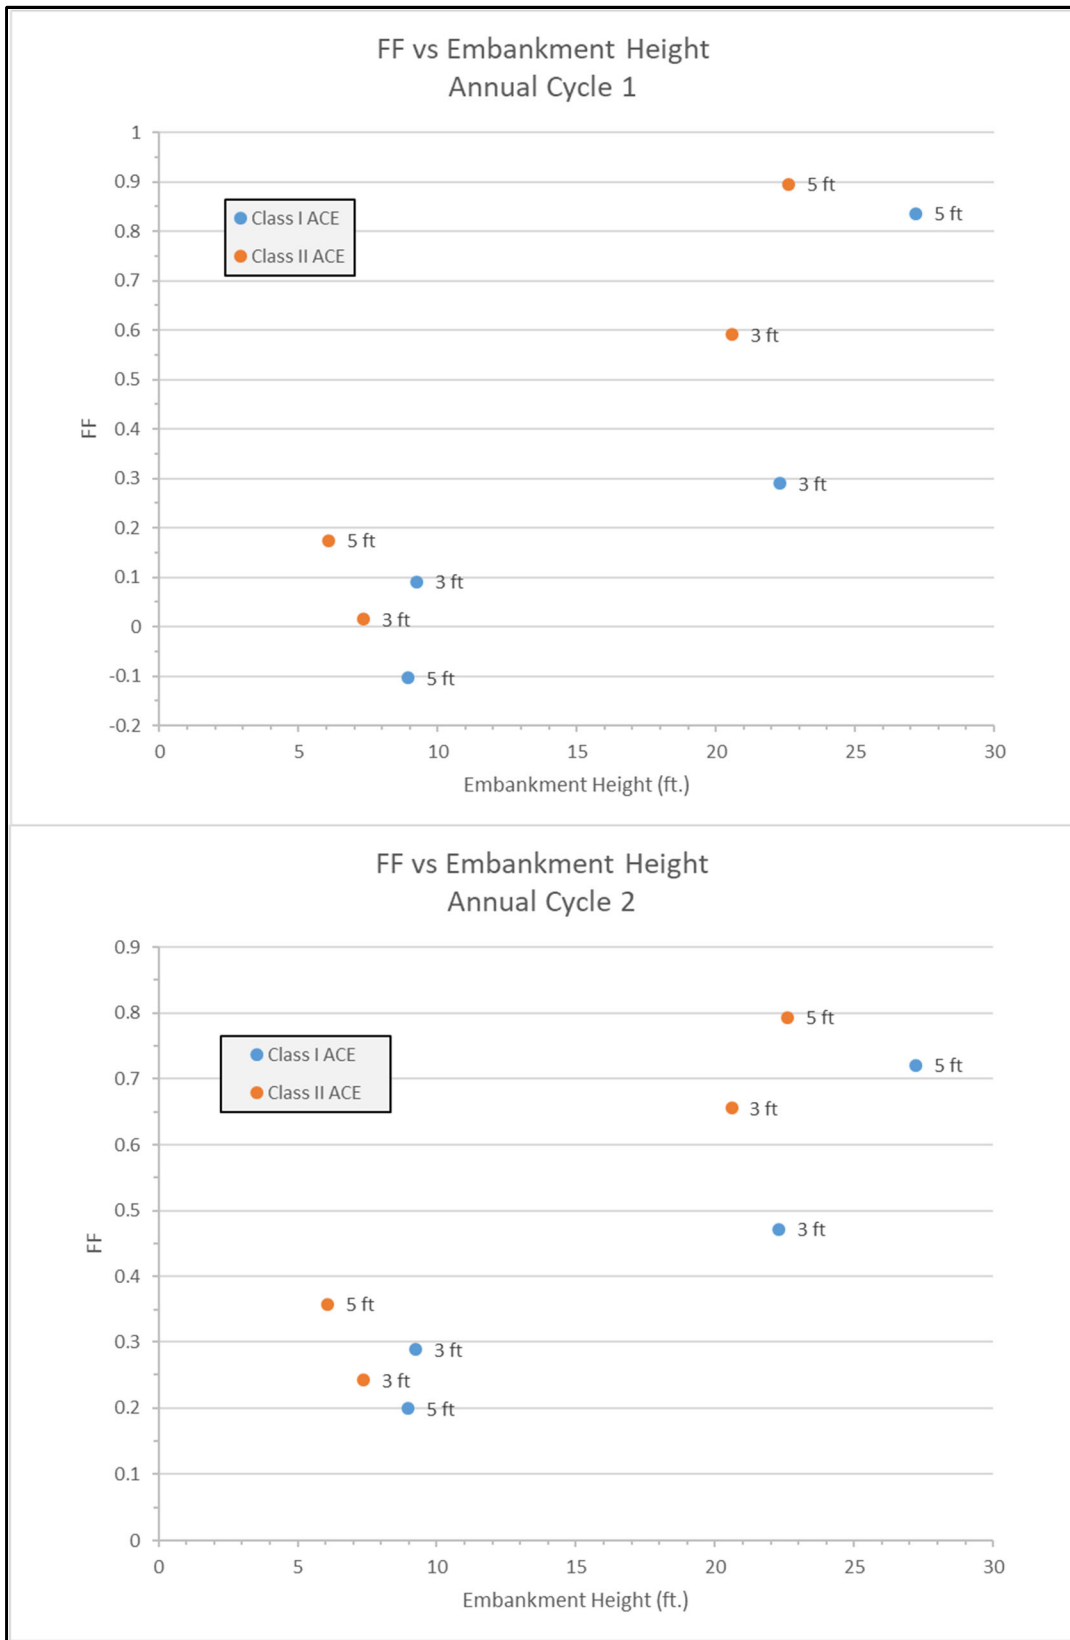
Figure 11: Freeze-Factor vs. Embankment Height and Width, and ACE Class.

In an effort to quantify how much of the ambient air’s cooling the ACE shoulder is utilizing at the ACE/non-convective material interface, we developed what we are calling the freeze-factor (FF). The FF is calculated by Equation 7 and is the ratio of the degrees below freezing at the interface and the degrees below freezing of the ambient air. Figure 11 illustrates the relationship between FF, the embankment geometry and ACE class. Note the value next to each data point in Figure 11 is the top width of that particular shoulder.

$$\text{Equation 7.: } FF = \frac{32 - \text{Temperature at Interface}}{32 - \text{Ambient Air Temperature}}; \text{ for a given Annual Cycle.}$$

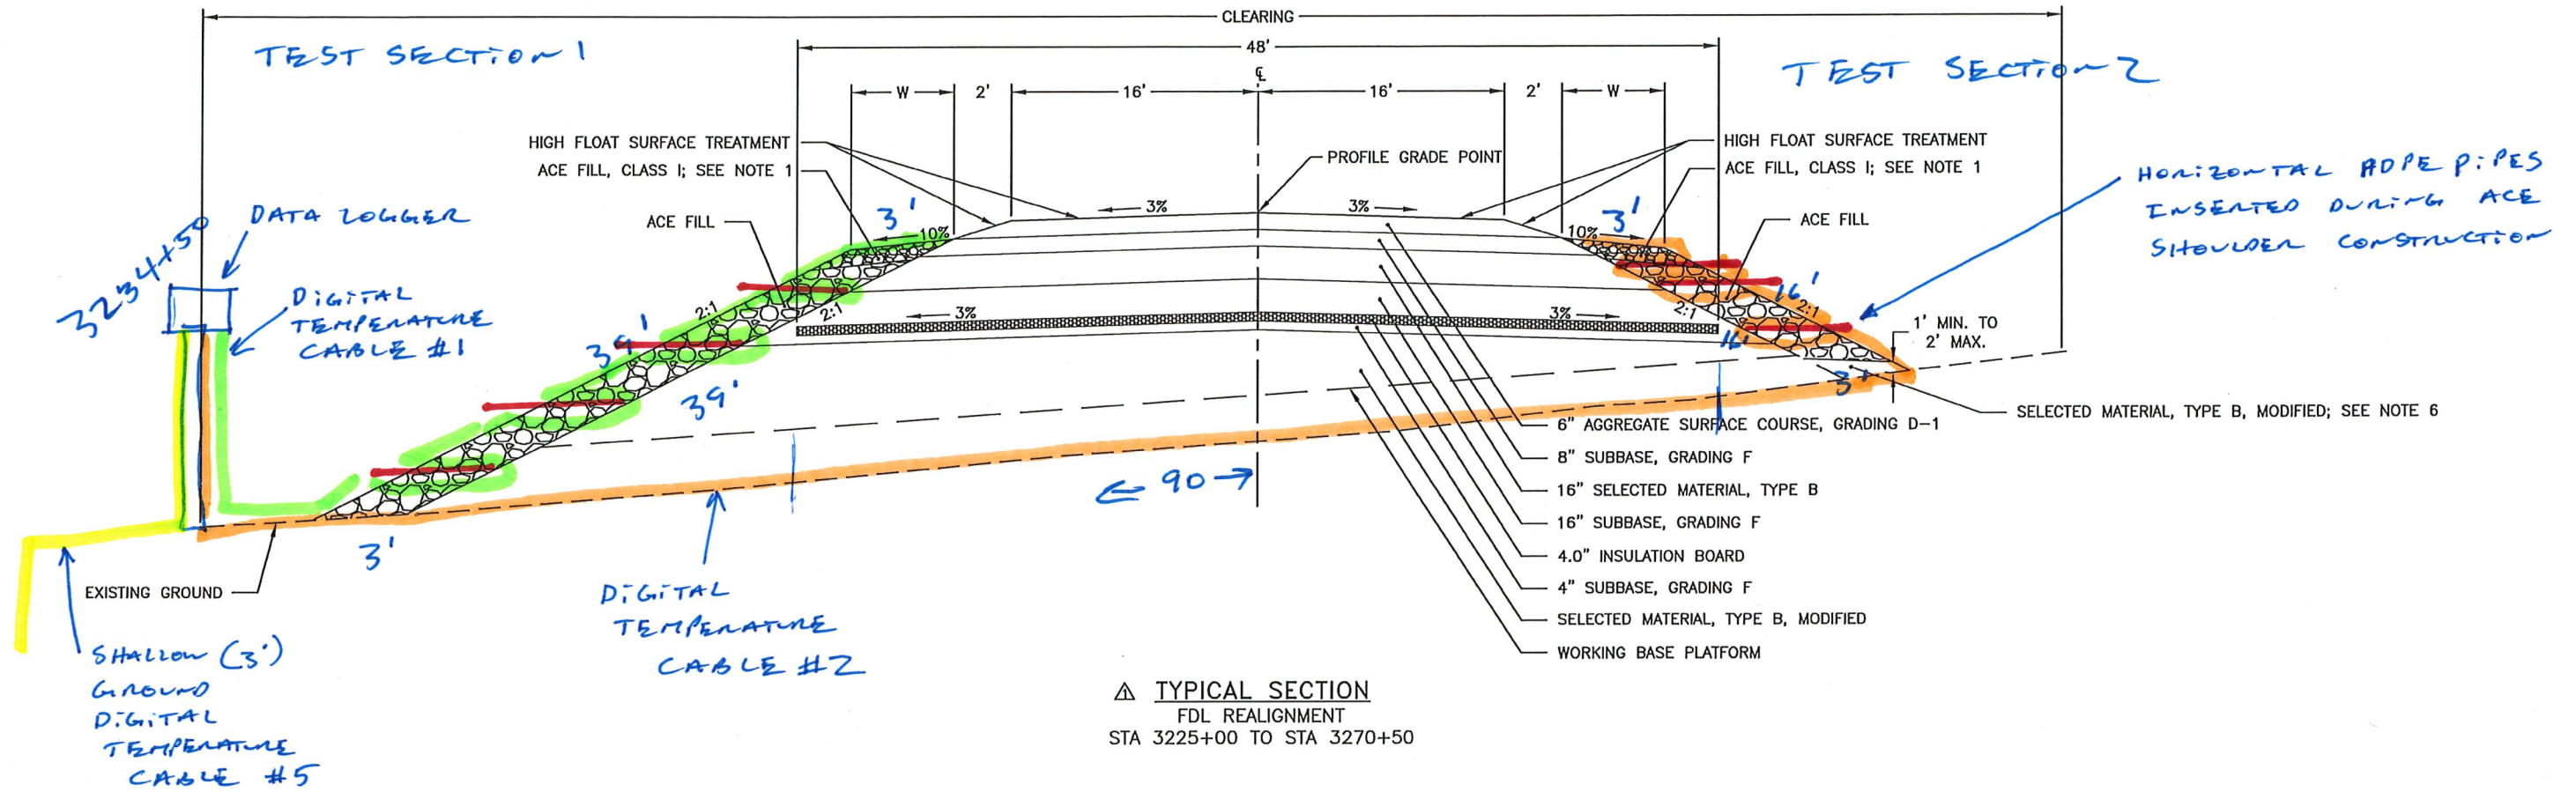
STA 3234+00

1. THE UPPER 1-FOOT OF ACE SHOULDERS SHALL BE CLASS I ACE FILL.
2. BEGIN AND END STATIONS FOR ACE SHOULDERS MAY BE ADJUSTED IN THE FIELD BY THE ENGINEER.
3. ACE FILL BELOW THE UPPER 1-FOOT MAY BE CLASS I OR CLASS II AS PER TABLE 1 AND THE HAULING AND PLACEMENT PLAN APPROVED BY THE ENGINEER.
4. TIE ACE FILL SHOULDERS INTO RIPRAP ON EMBANKMENT FACE ON BOTH SIDES OF 10-FOOT SPP AT DEBRIS LOBE CREEK.
5. W=8.5- FEET EXCEPT FOR TEST SECTIONS WHERE IT WILL BE EITHER 3.0- FEET, 5.0- FEET, OR 8.5- FEET. SEE ACE SHOULDER WIDTH AND ACE FILL CLASS TABLE.
6. PLACE AND COMPACT SELECTED MATERIAL, TYPE B, MODIFIED TO DRAIN AT 5% TO 10%. TO PREVENT SURFACE RUNOFF ON ORIGINAL GROUND FROM ENTERING THE ACE SHOULDER, MAINTAIN A 1' TO 2' LIFT-HEIGHT ON THE RIGHT.

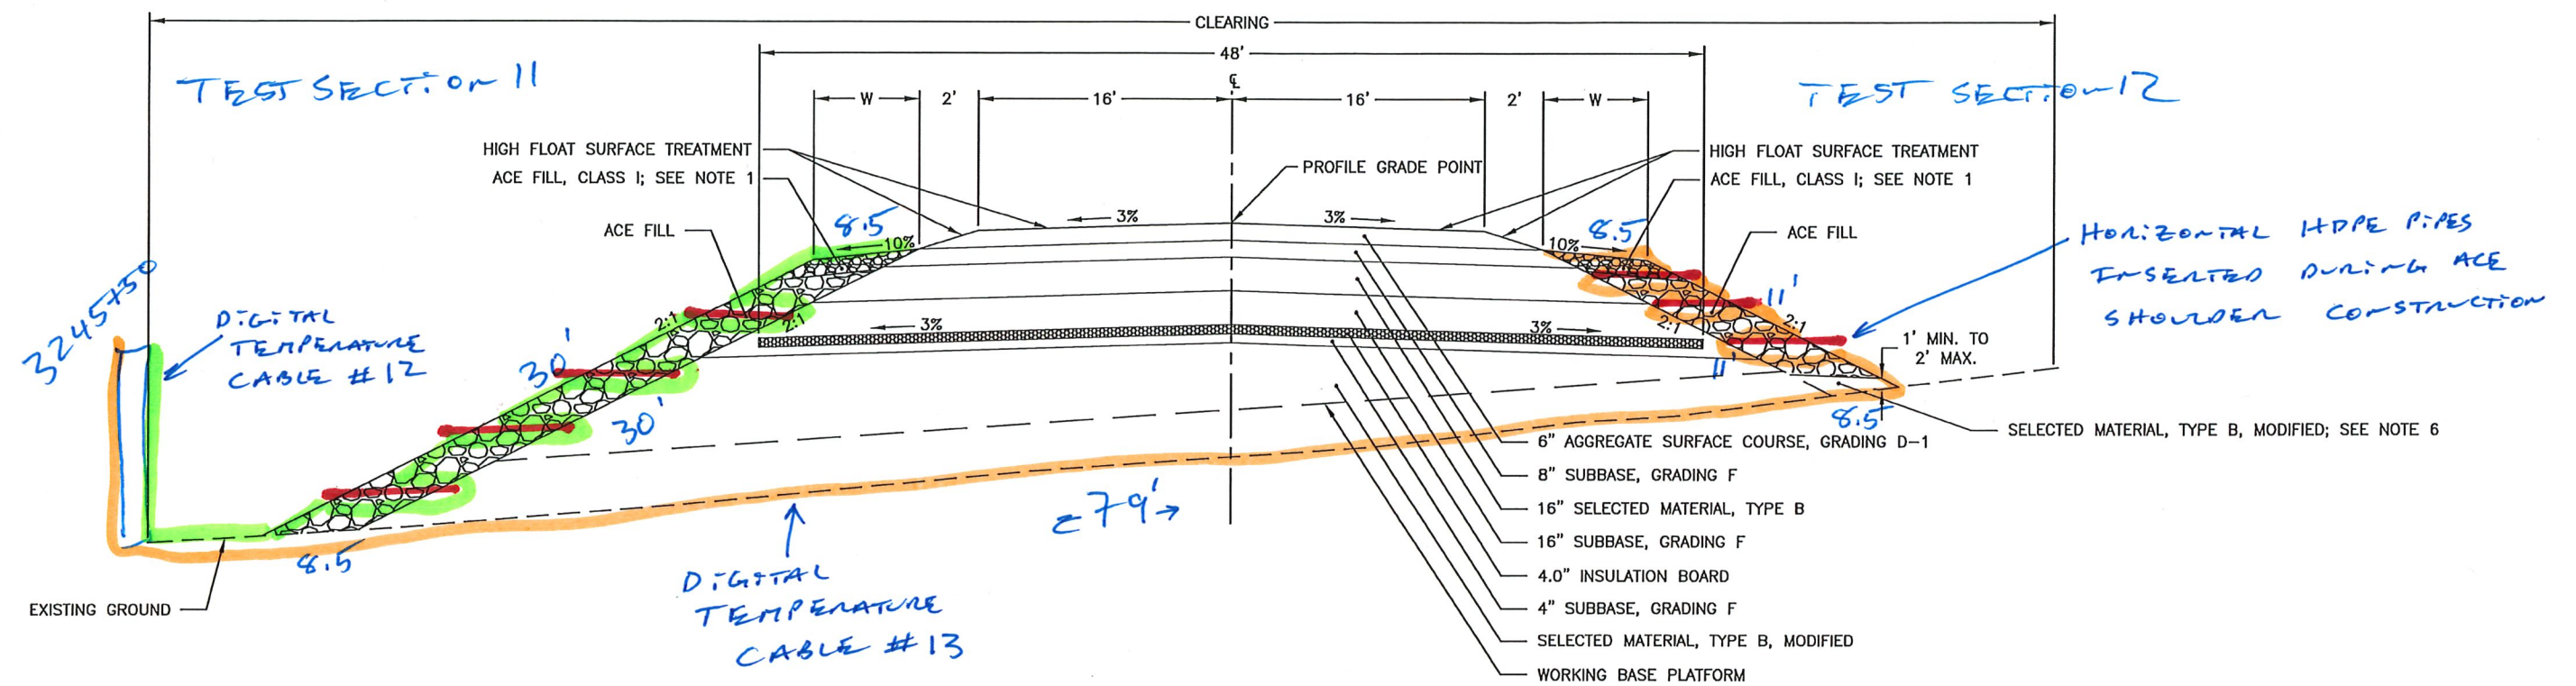
STA 3246+00

- Δ NOTES:
1. THE UPPER 1-FOOT OF ACE SHOULDERS SHALL BE CLASS I ACE FILL.
  2. BEGIN AND END STATIONS FOR ACE SHOULDERS MAY BE ADJUSTED IN THE FIELD BY THE ENGINEER.
  3. ACE FILL BELOW THE UPPER 1-FOOT MAY BE CLASS I OR CLASS II AS PER TABLE 1 AND THE HAULING AND PLACEMENT PLAN APPROVED BY THE ENGINEER.
  4. TIE ACE FILL SHOULDERS INTO RIPRAP ON EMBANKMENT FACE ON BOTH SIDES OF 10-FOOT SPP AT DEBRIS LOBE CREEK.
  5. W=8.5- FEET EXCEPT FOR TEST SECTIONS WHERE IT WILL BE EITHER 3.0- FEET, 5.0- FEET, OR 8.5- FEET. SEE ACE SHOULDER WIDTH AND ACE FILL CLASS TABLE.
  6. PLACE AND COMPACT SELECTED MATERIAL, TYPE B, MODIFIED TO DRAIN AT 5% TO 10%. TO PREVENT SURFACE RUNOFF ON ORIGINAL GROUND FROM ENTERING THE ACE SHOULDER, MAINTAIN A 1' TO 2' LIFT-HEIGHT ON THE RIGHT.
